FLORIDA DEPARTMENT OF TRANSPORTATION
AVIATION AND SPACEPORTS OFFICE

Statewide Airfield Pavement Management Program

Airport Pavement Evaluation Report
November 2019

Punta Gorda Airport (PGD)
Commercial Airport
District 1

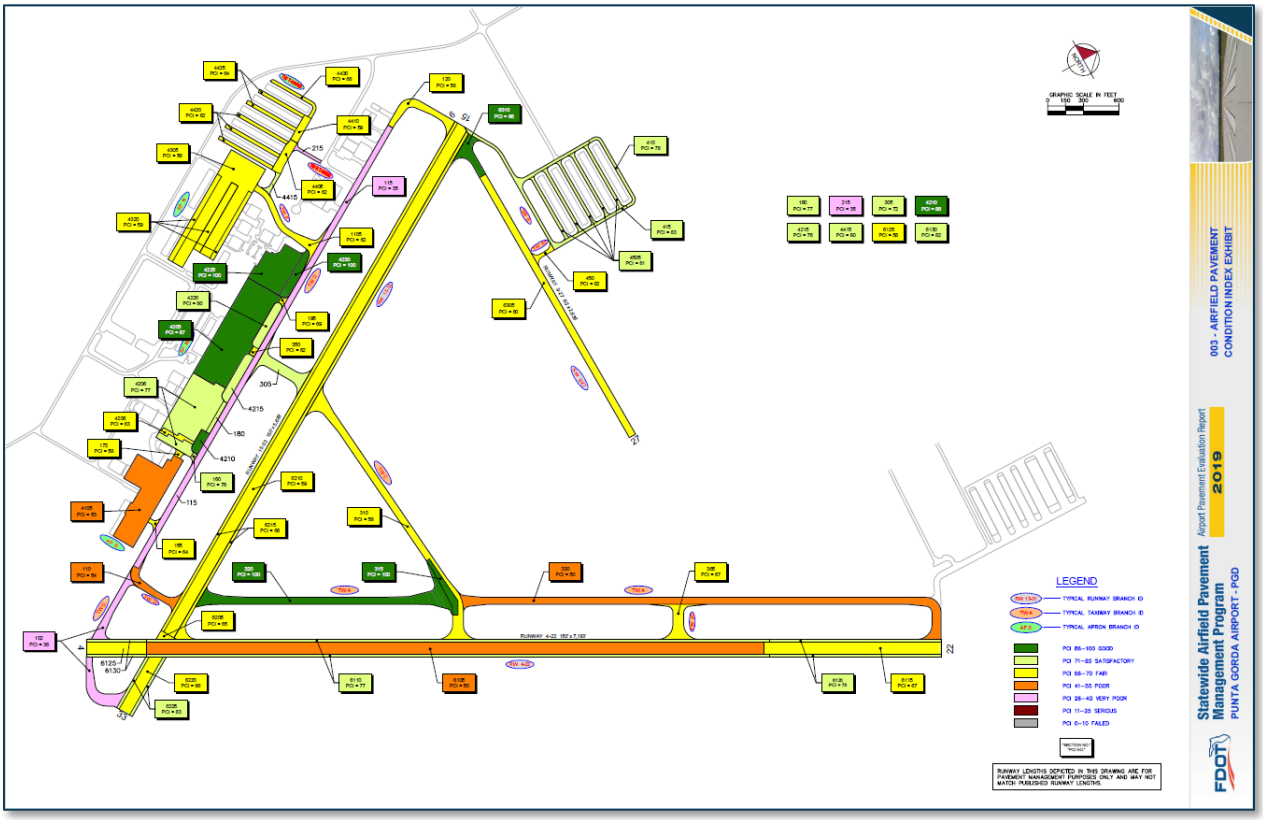
Figure 4.1.3 2019 Airfield Pavement Condition Index Exhibit

Figure 4.1.3 is an inset view of the 2019 Airfield Pavement Condition Index Exhibit that visually represents the results of the latest PCI Survey inspection. A large format exhibit is located in **Appendix C Technical Exhibits.**

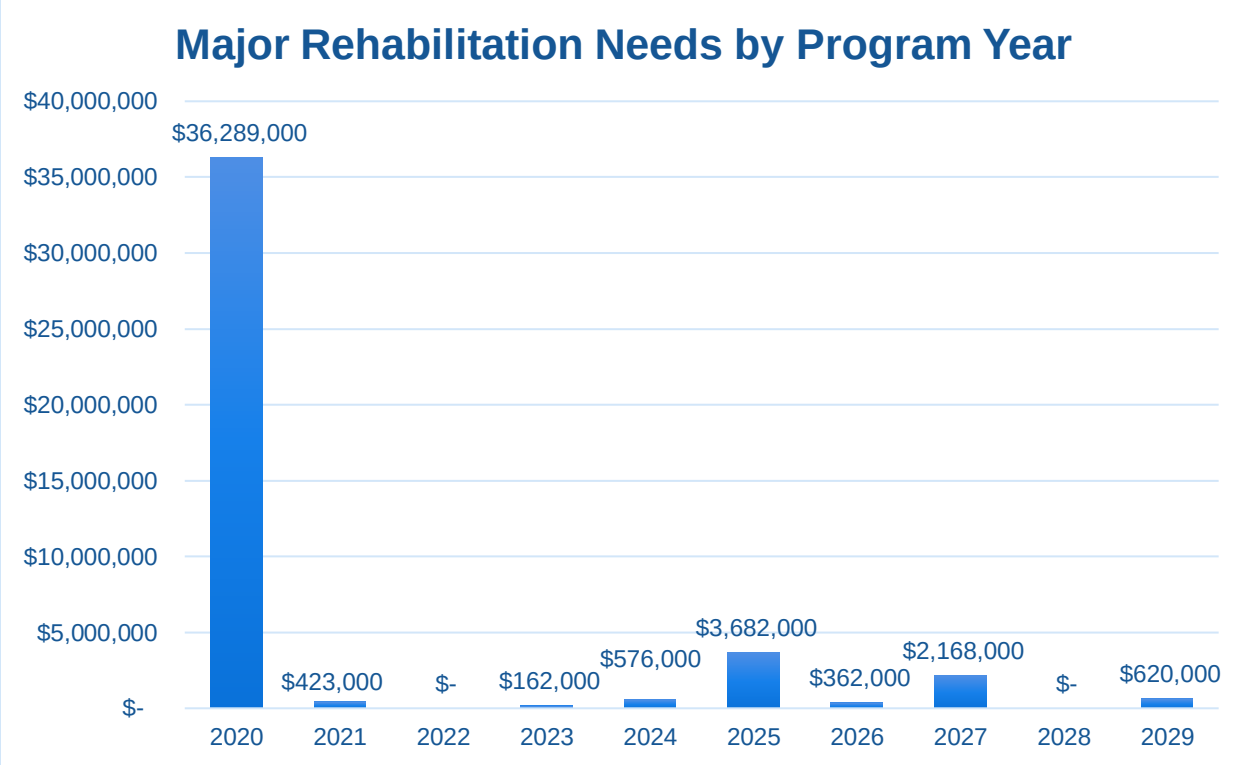
Figure 6.3.1 (a) 10-Year Major Rehabilitation Needs by Program Year

The following **Figure 6.3.1 (a)** summarizes the section-level major rehabilitation needs for a 10-year period between 2020 and 2029. **Figure 6.3.1 (b)** provides an inset view of Airfield Pavement Major Rehabilitation Exhibit, a large format exhibit is located in **Appendix C Technical Exhibits**. The exhibit graphically depicts the Major Rehabilitation Needs with rounded costs.

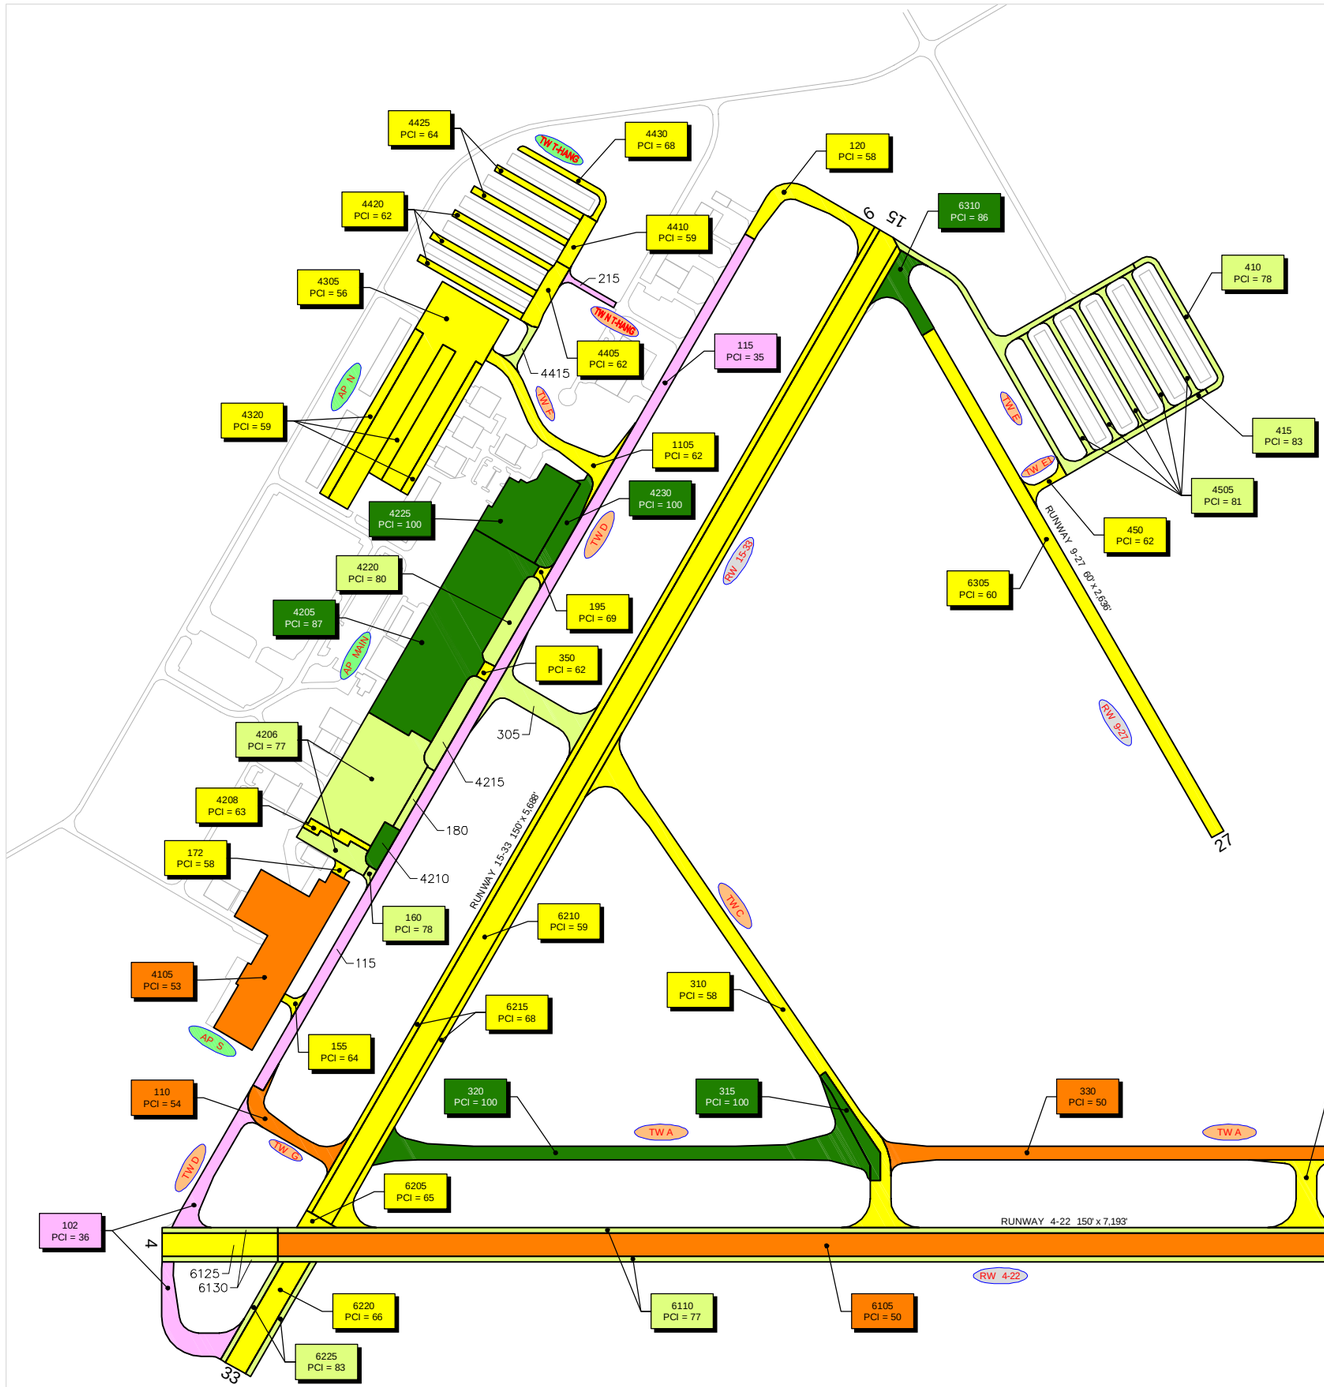
180 PCI = 77	215 PCI = 35	305 PCI = 72	4210 PCI = 88
4215 PCI = 76	4415 PCI = 80	6125 PCI = 58	6130 PCI = 82

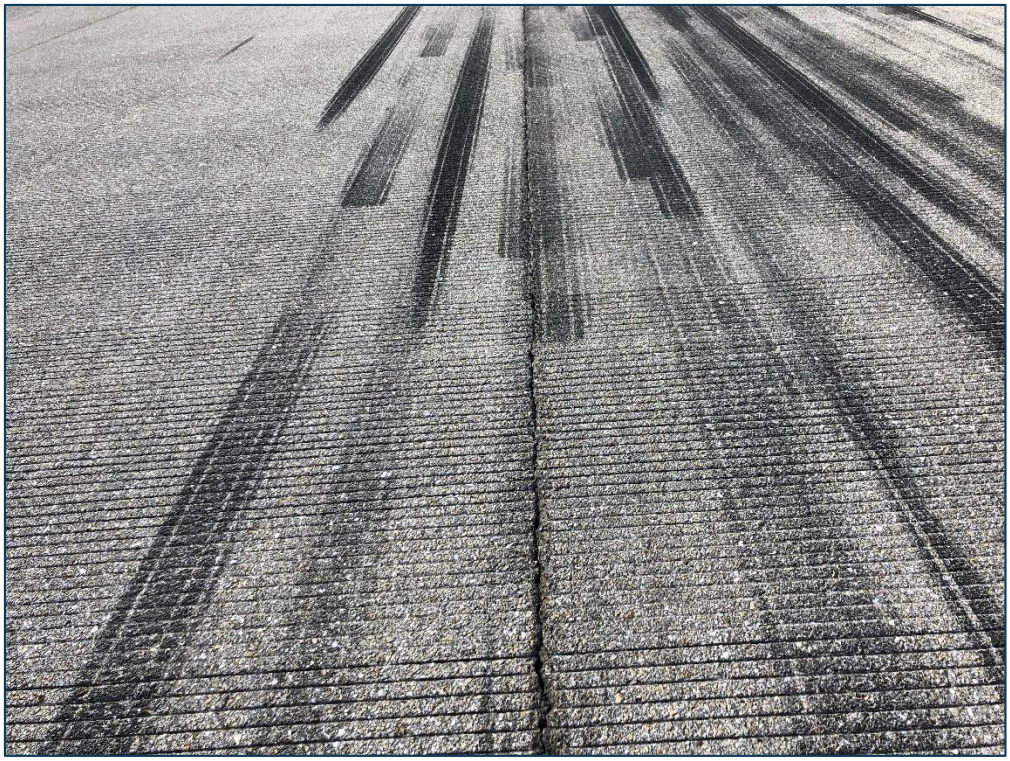
RW 4-22, Section 6105, Sample Unit 387 - Medium Severity (48) Longitudinal & Transverse Cracking, Low Severity (52) Raveling, and Medium Severity (57) Weathering

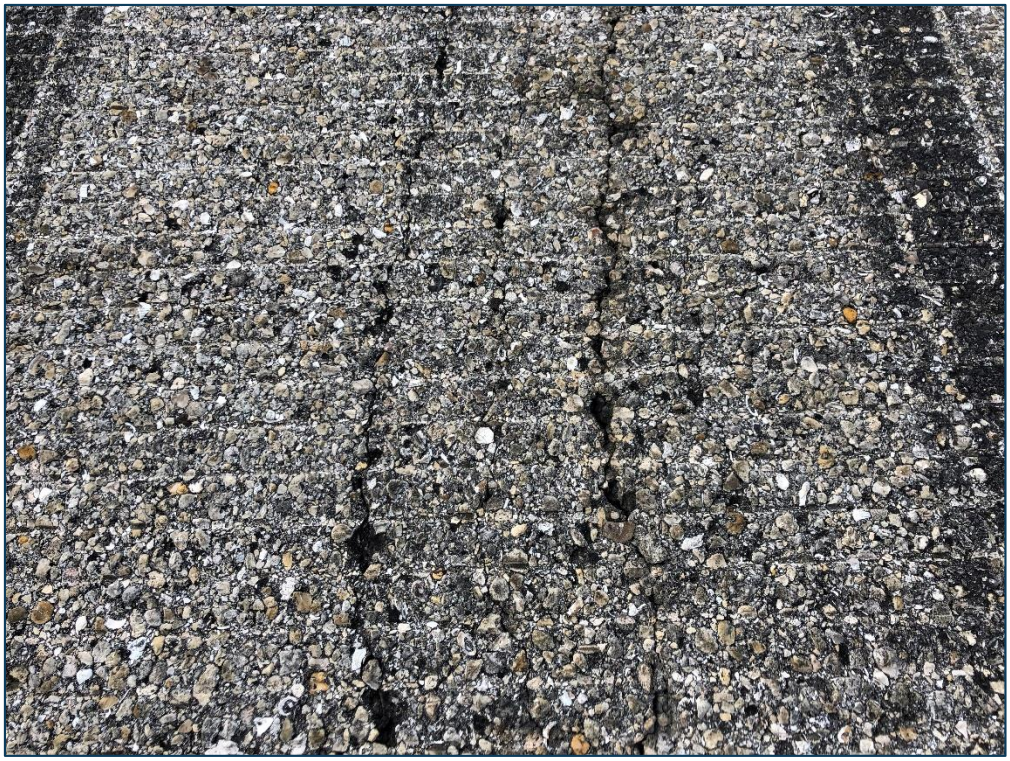
RW 4-22, Section 6105, Sample Unit 313 - Low Severity (41) Alligator Cracking, Low Severity (52) Raveling, and Medium Severity (57) Weathering
