Statewide Airfield Pavement Management Program

Airport Pavement Evaluation Report

November 2019

Albert Whitted Airport (SPG)
Reliever Airport
District 7

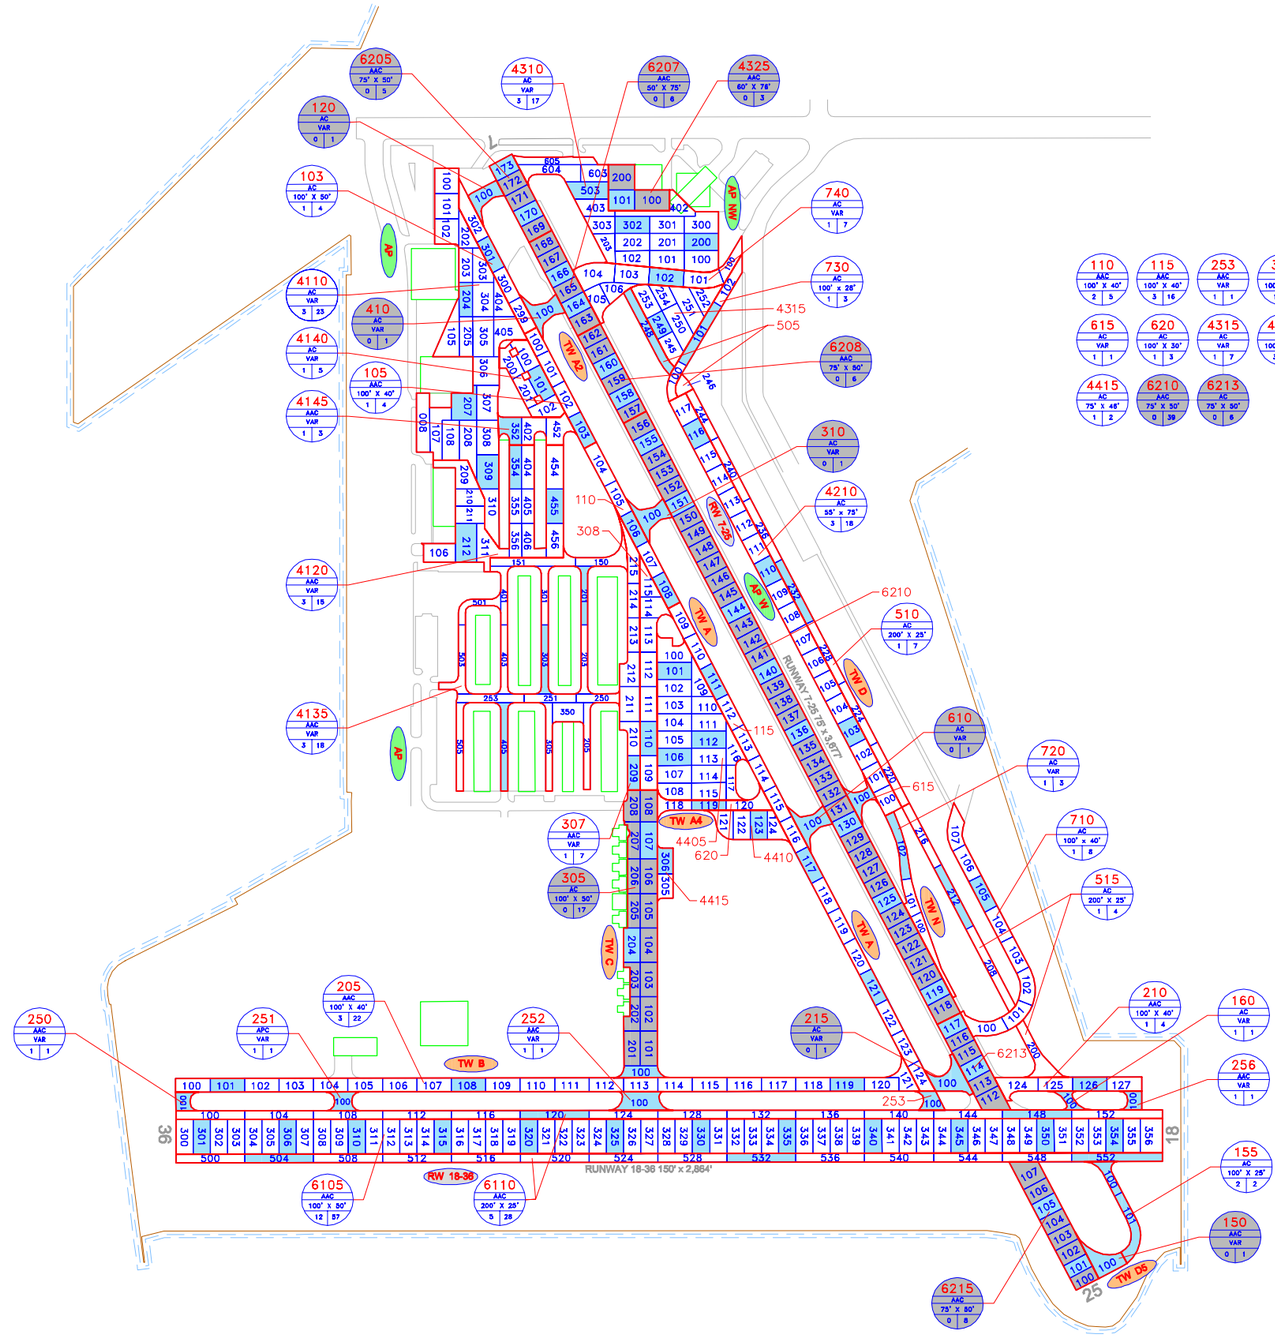
001 - AIRFIELD PAVEMENT
NETWORK DEFINITION EXHIBIT

The Airfield Pavement Network Definition Exhibit is located in **Appendix C Technical Exhibits**. The exhibit depicts the airfield layout in a manner that defines the airfield pavement infrastructure as branches, sections, and sample units in accordance with the ASTM D5340-12. The exhibit is intended for planning purposes only – further detail on facilities can be found on the Airport's adopted Airport Layout Plan. Detailed characteristics are tabulated in **Appendix A Pavement Analysis Tables.**

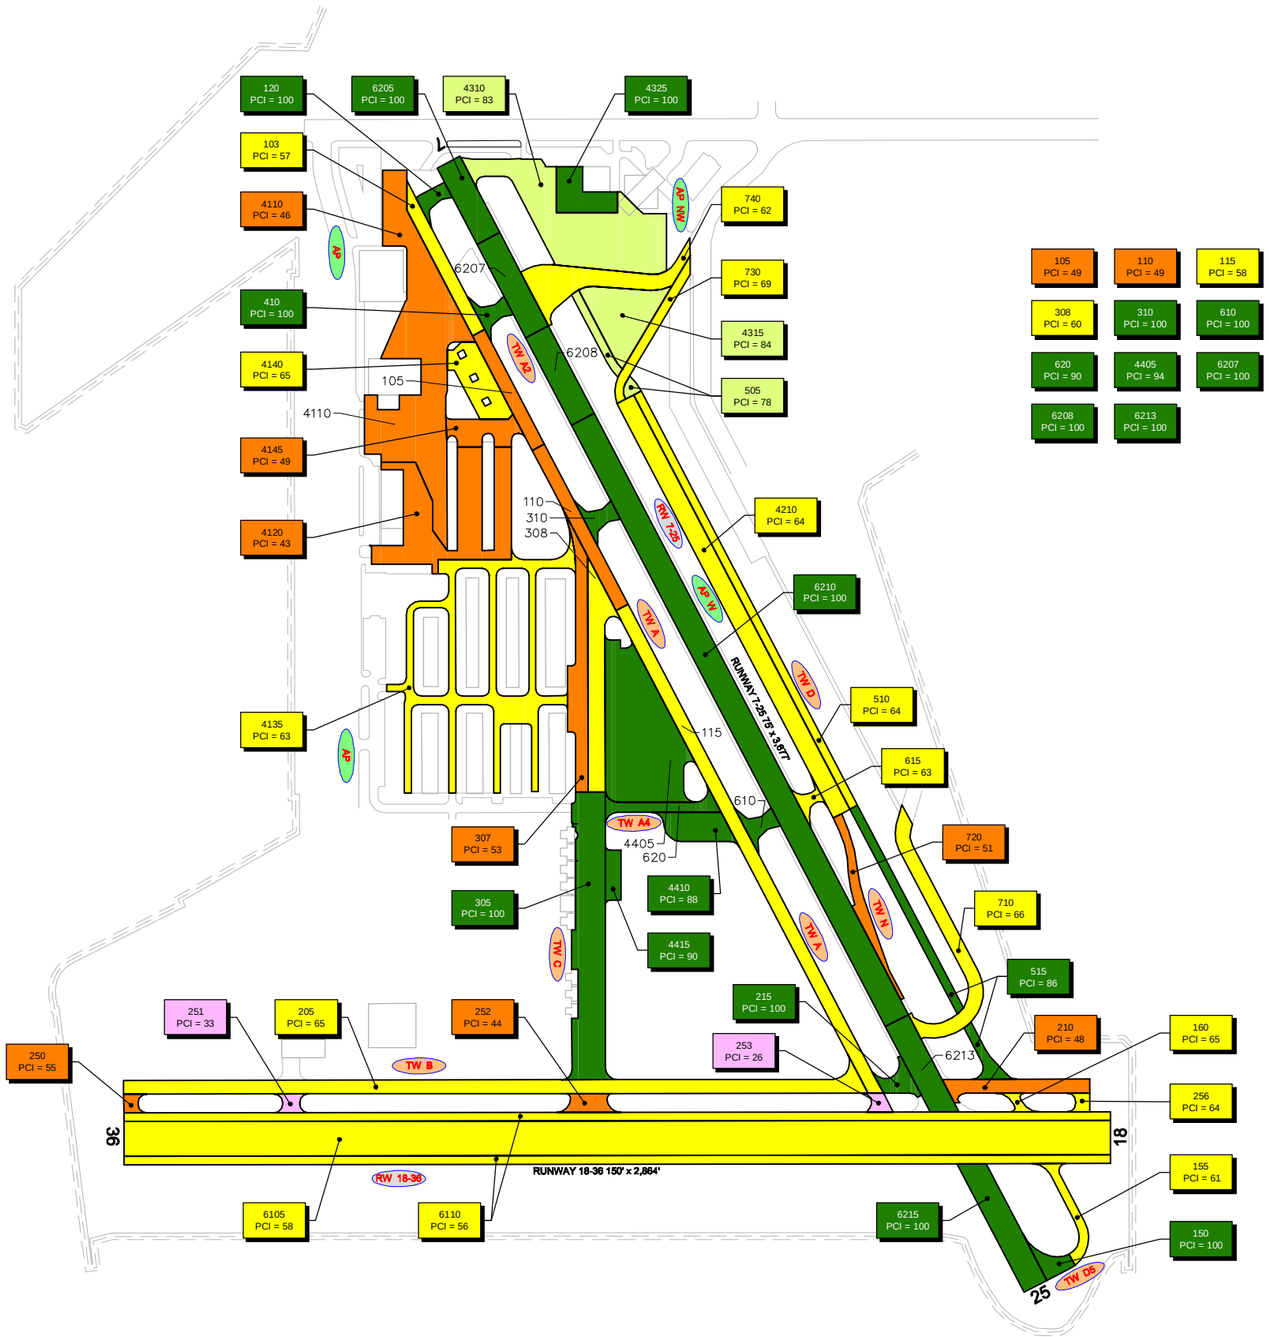
003 - AIRFIELD PAVEMENT
CONDITION INDEX EXHIBIT

The Airfield Pavement Condition Index Exhibit is located in **Appendix C Technical Exhibits**. The exhibit is a visual summary of the latest conditions calculated from the results of the PCI Survey performed at the airport. The analysis of the distresses surveyed in accordance with the ASTM D5340-12 (referenced in **Appendix E Inspection Distress Details**) were analyzed using PAVER™ software to determine PCI values. The PCI values are identified in the exhibit and graphically represented using the standard ASTM D5340-12 colors for condition rating categories.

105 PCI = 49 | 110 PCI = 49 | 115 PCI = 58
308 PCI = 60 | 310 PCI = 100 | 610 PCI = 100
620 PCI = 90 | 4405 PCI = 94 | 6207 PCI = 100
6208 PCI = 100 | 6213 PCI = 100

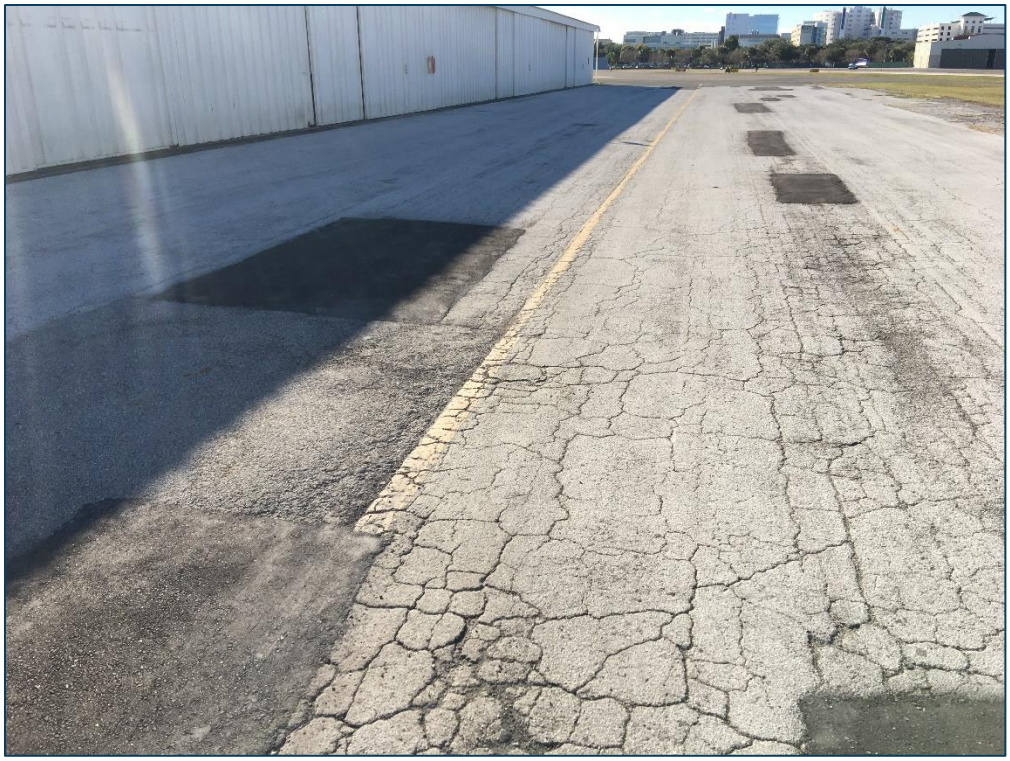
TAXIWAY D, Section 155, Sample Unit 101 - High Severity (45) Depression, Low Severity (48) Longitudinal & Transverse Cracking, Medium Severity (50) Patching, and Low Severity (52) Raveling
