**2021**

*Statewide Airfield Pavement Management Program*

# Airport Pavement Evaluation Report

SUA - Witham Field | *District 4*

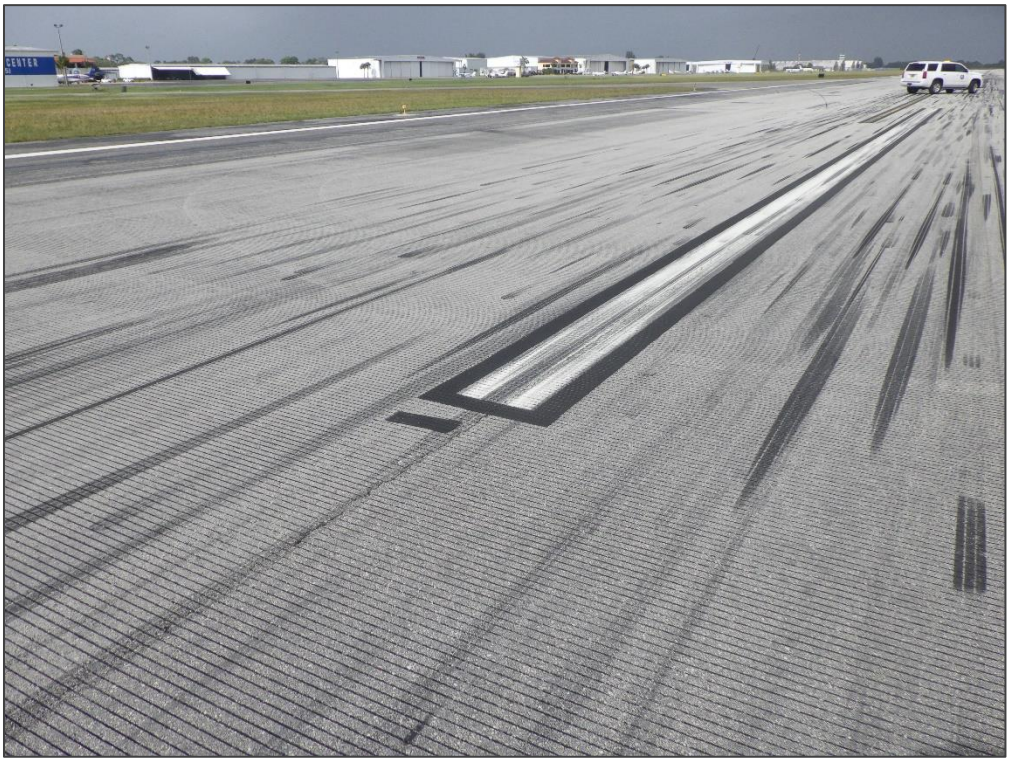
RW 7-25, Section 6205, Sample Unit 334 - Longitudinal & Transverse Cracking

RW 7-25, Section 6205, Sample Unit 395 – Longitudinal and Transverse Cracking and Swelling

RW 7-25, Section 6205, Sample Unit 395 - Longitudinal & Transverse Cracking
