*Statewide Airfield Pavement Management Program*

# Airport Pavement Evaluation Report

FMY - Page Field | *District 1*

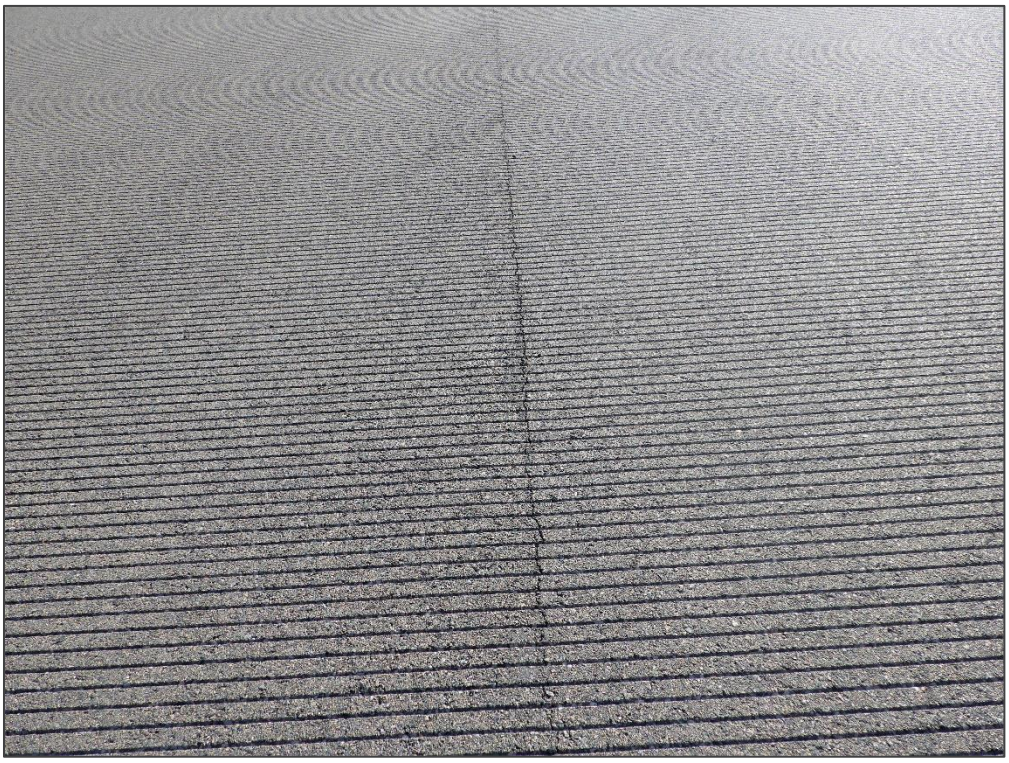
RW 5-23, Section 6115, Sample Unit 346 – Longitudinal & Transverse Cracking

RW 5-23, Section 6140, Sample Unit 180 – Longitudinal & Transverse Cracking

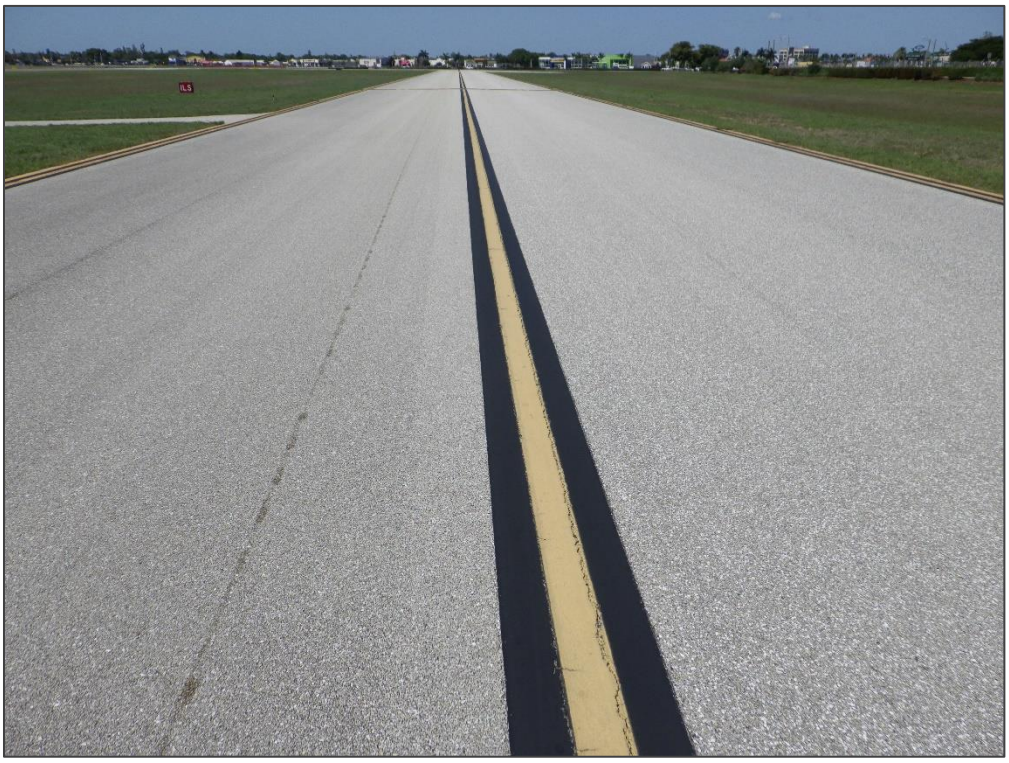
TW C, Section 305, Sample Unit 213 – Longitudinal & Transverse Cracking

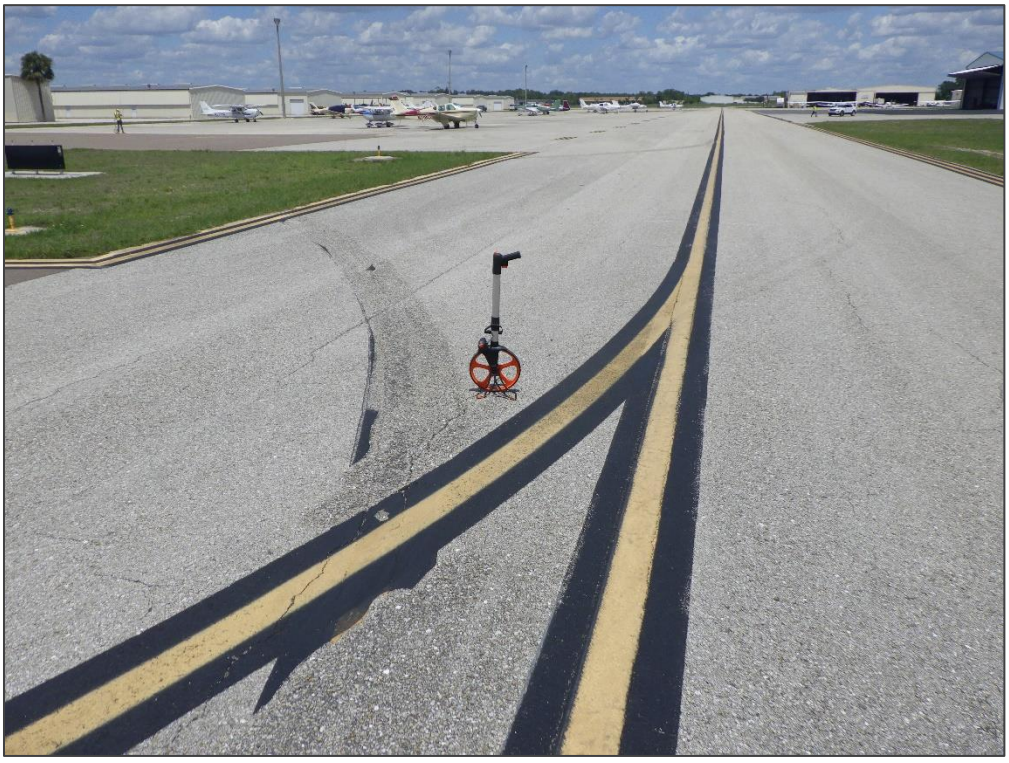
TW D, Section 136, Sample Unit 122 – Vicinity

TW D2, Section 160, Sample 101 – Alligator Cracking
