Statewide Airfield Pavement Management Program

Airport Pavement Evaluation Report

LEE - Leesburg International Airport | *District 5*

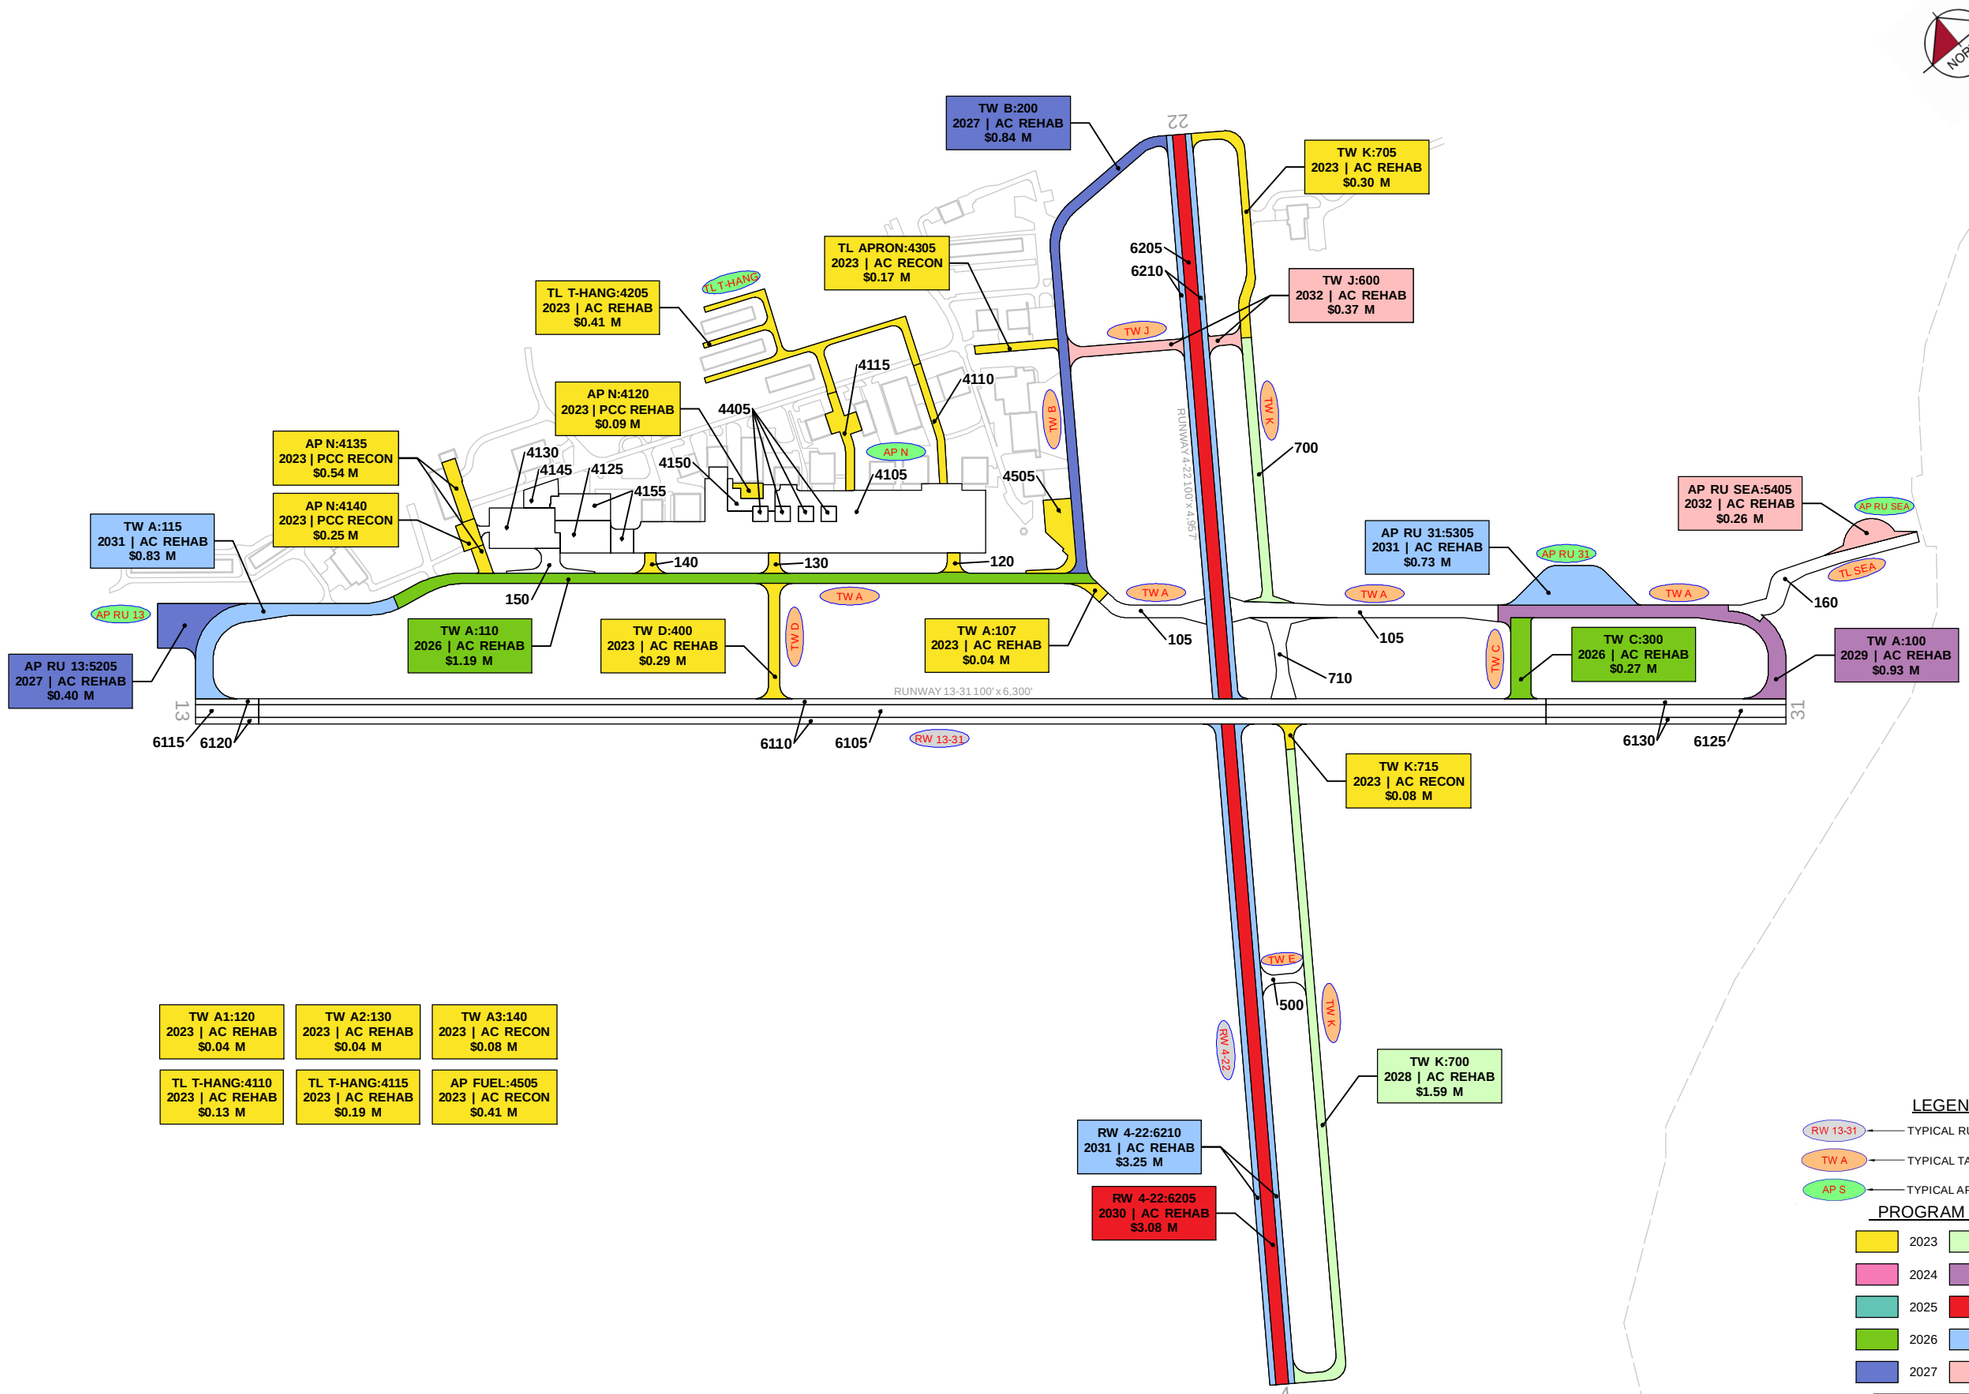
TW B:200
2027 | AC REHAB
$0.84 M
TW K:705
2023 | AC REHAB
$0.30 M
TL APRON:4305
2023 | AC RECON
$0.17 M
TL T-HANG:4205
2023 | AC REHAB
$0.41 M
TW J:600
2032 | AC REHAB
$0.37 M
AP N:4120
2023 | PCC REHAB
$0.09 M
AP N:4135
2023 | PCC RECON
$0.54 M
AP N:4140
2023 | PCC RECON
$0.25 M
TW A:115
2031 | AC REHAB
$0.83 M
AP RU 13:5205
2027 | AC REHAB
$0.40 M
TW A:110
2026 | AC REHAB
$1.19 M
TW D:400
2023 | AC REHAB
$0.29 M
TW A:107
2023 | AC REHAB
$0.04 M
AP RU 31:5305
2031 | AC REHAB
$0.73 M
AP RU SEA:5405
2032 | AC REHAB
$0.26 M
TW C:300
2026 | AC REHAB
$0.27 M
TW A:100
2029 | AC REHAB
$0.93 M
TW K:715
2023 | AC RECON
$0.08 M
TW K:700
2028 | AC REHAB
$1.59 M
RW 4-22:6210
2031 | AC REHAB
$3.25 M
RW 4-22:6205
2030 | AC REHAB
$3.08 M
RUNWAY 13-31 100' x 6,300'
RUNWAY 4-22 100' x 4,957'
TW A1:120
2023 | AC REHAB
$0.04 M
TW A2:130
2023 | AC REHAB
$0.04 M
TW A3:140
2023 | AC RECON
$0.08 M
TL T-HANG:4110
2023 | AC REHAB
$0.13 M
TL T-HANG:4115
2023 | AC REHAB
$0.19 M
AP FUEL:4505

2023 | AC RECON
$0.41 M
LEGEND
TYPICAL RUNWAY BRANCH ID
TYPICAL TAXIWAY BRANCH ID
TYPICAL APRON BRANCH ID
PROGRAM YEAR
2023
2024
2025
2026
2027
2028
2029
2030
2031
2032
"BRANCH":"SECTION"
"YEAR"|"REHAB ACTIVITY"
"EST. COST"
RUNWAY LENGTHS DEPICTED IN THIS DRAWING ARE FOR PAVEMENT MANAGEMENT PURPOSES ONLY AND MAY NOT MATCH PUBLISHED RUNWAY LENGTHS. DRAWING NOT TO SCALE.
NORTH
LEE
AIRFIELD PAVEMENT MAJOR REHABILITATION EXHIBIT
Statewide Airfield Pavement Management Program
LEESBURG INTERNATIONAL AIRPORT
FDOT
2022

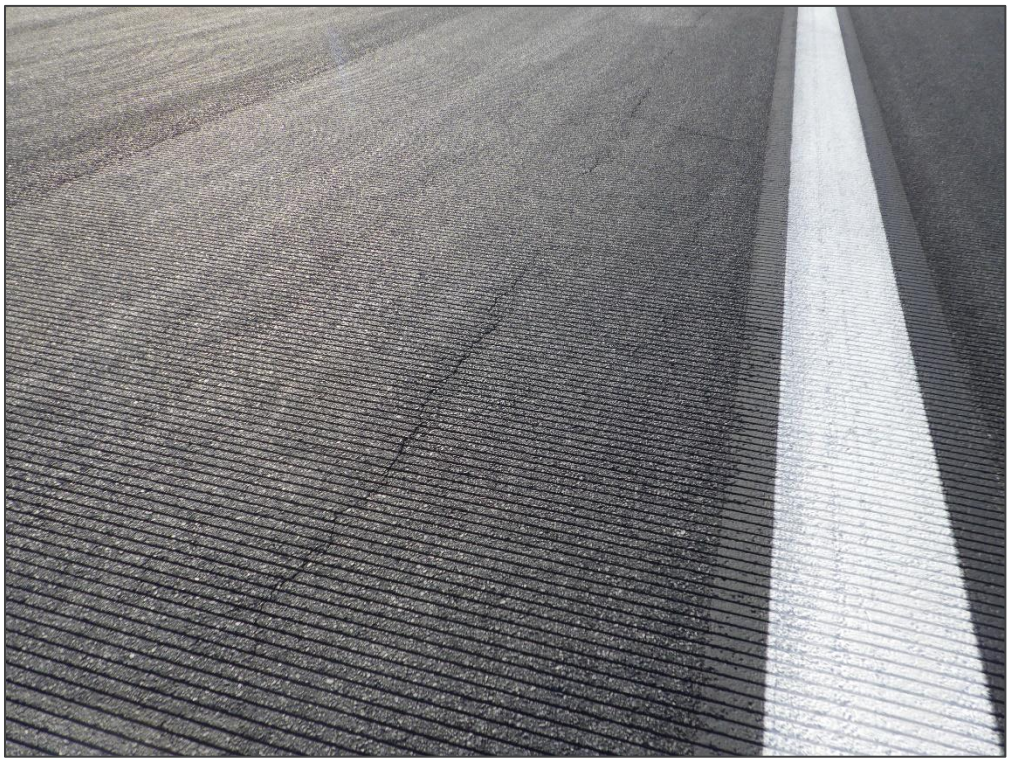
RW 4-22, Section 6205, Sample Unit 301 – Longitudinal & Transverse Cracking

RW 4-22, Section 6210, Sample Unit 500 –- Bleeding
