DISTRICT 2 REPORT
JUNE 2015

STATEWIDE
**Airfield
Pavement
Management**
PROGRAM

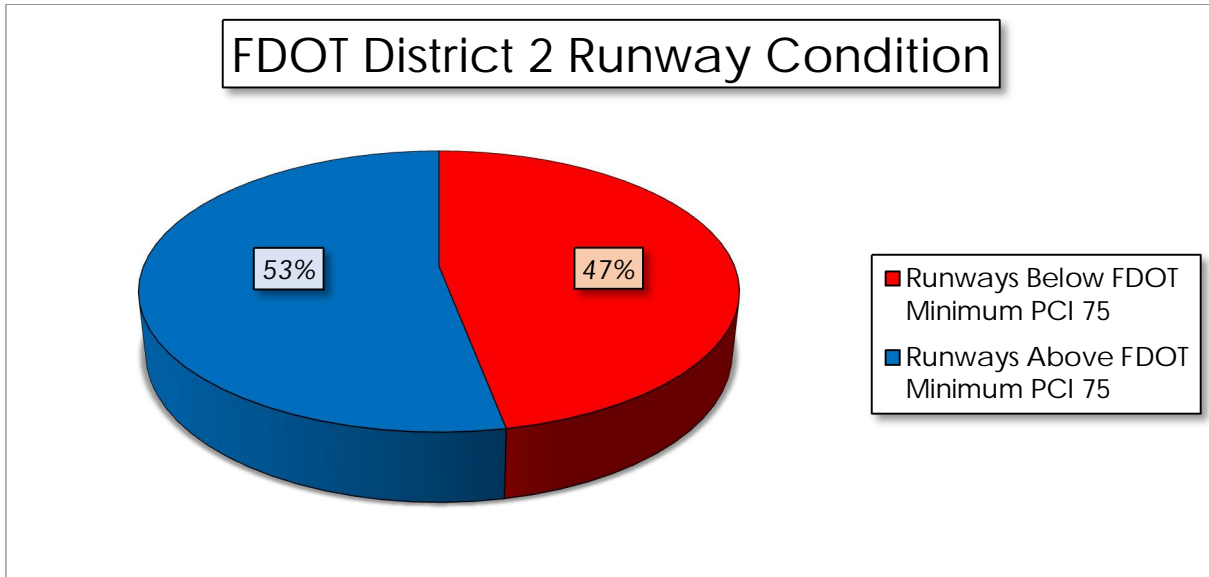
District 2's overall area-weighted Pavement Condition Index (PCI) is at a 77.48 a condition rating of "Satisfactory". Table I: Condition Summary by Airport below represents of the results of the PCI inspection at each airport within the District. The overall area-weighted average PCI values for the participating airport facilities in District 2 ranged from 30 (Very Poor) to 88 (Good). Specific individual airport results are identified in the individual Airport Pavement Evaluation Reports provided to each airport. Table II: Runway Condition Summary by Airport indicates the PCI value for every runway within the District, grouped by Airport. Figure I: Runway Condition graphically depicts the percentage of the District's Runways below the FDOT Minimum PCI of 75 and Figure II: Runway Pavement Condition Comparison to FDOT Minimum PCI conveys the PCI's of the District's runway facilities in comparison to the FDOT Minimum PCI of 75.

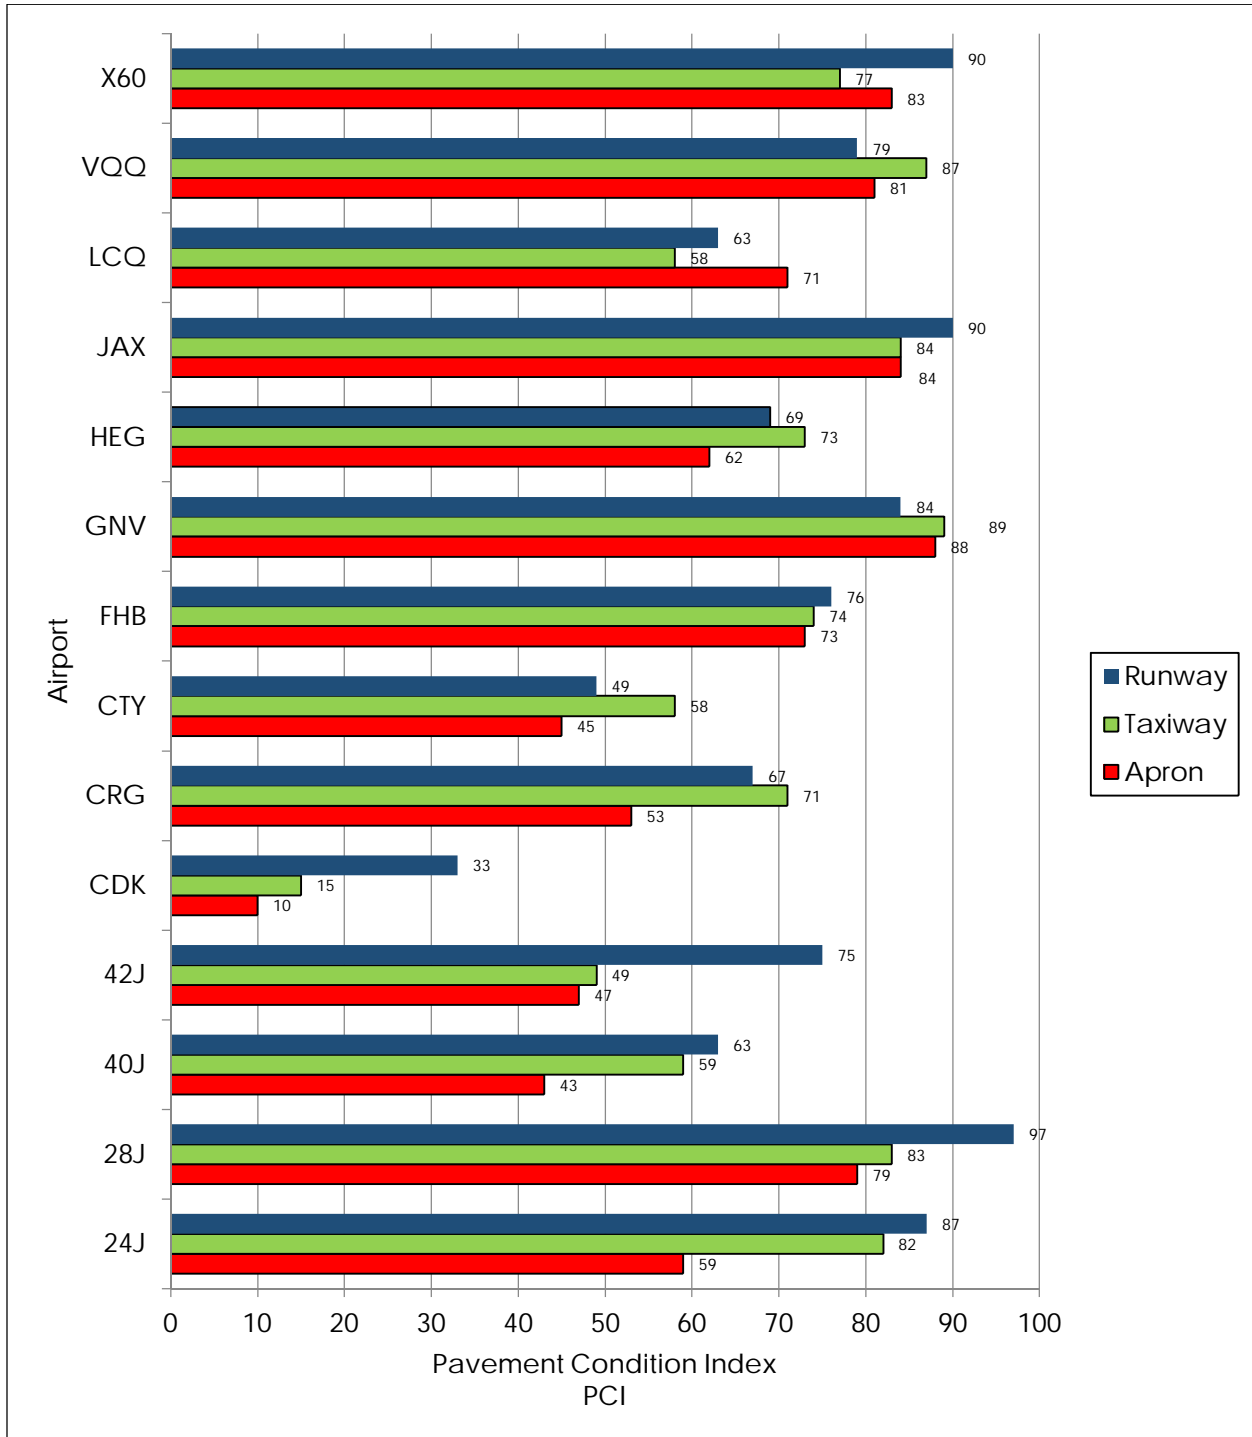
Figure III: PCI by Pavement Facility Use by Airport

runway which may cause heavier aircraft traffic, larger jets, to prefer the primary runway in all but the most severe wind conditions. This would result in the primary runway experiencing a larger percentage of aircraft passes in frequency and heavy load applications. Table III: District Summary of Area Use by Airport provides a breakdown of the airport pavement areas by its facility use. Figure III: PCI by Pavement Use by Airport graphically depicts the PCI for each pavement facility use at each airport.

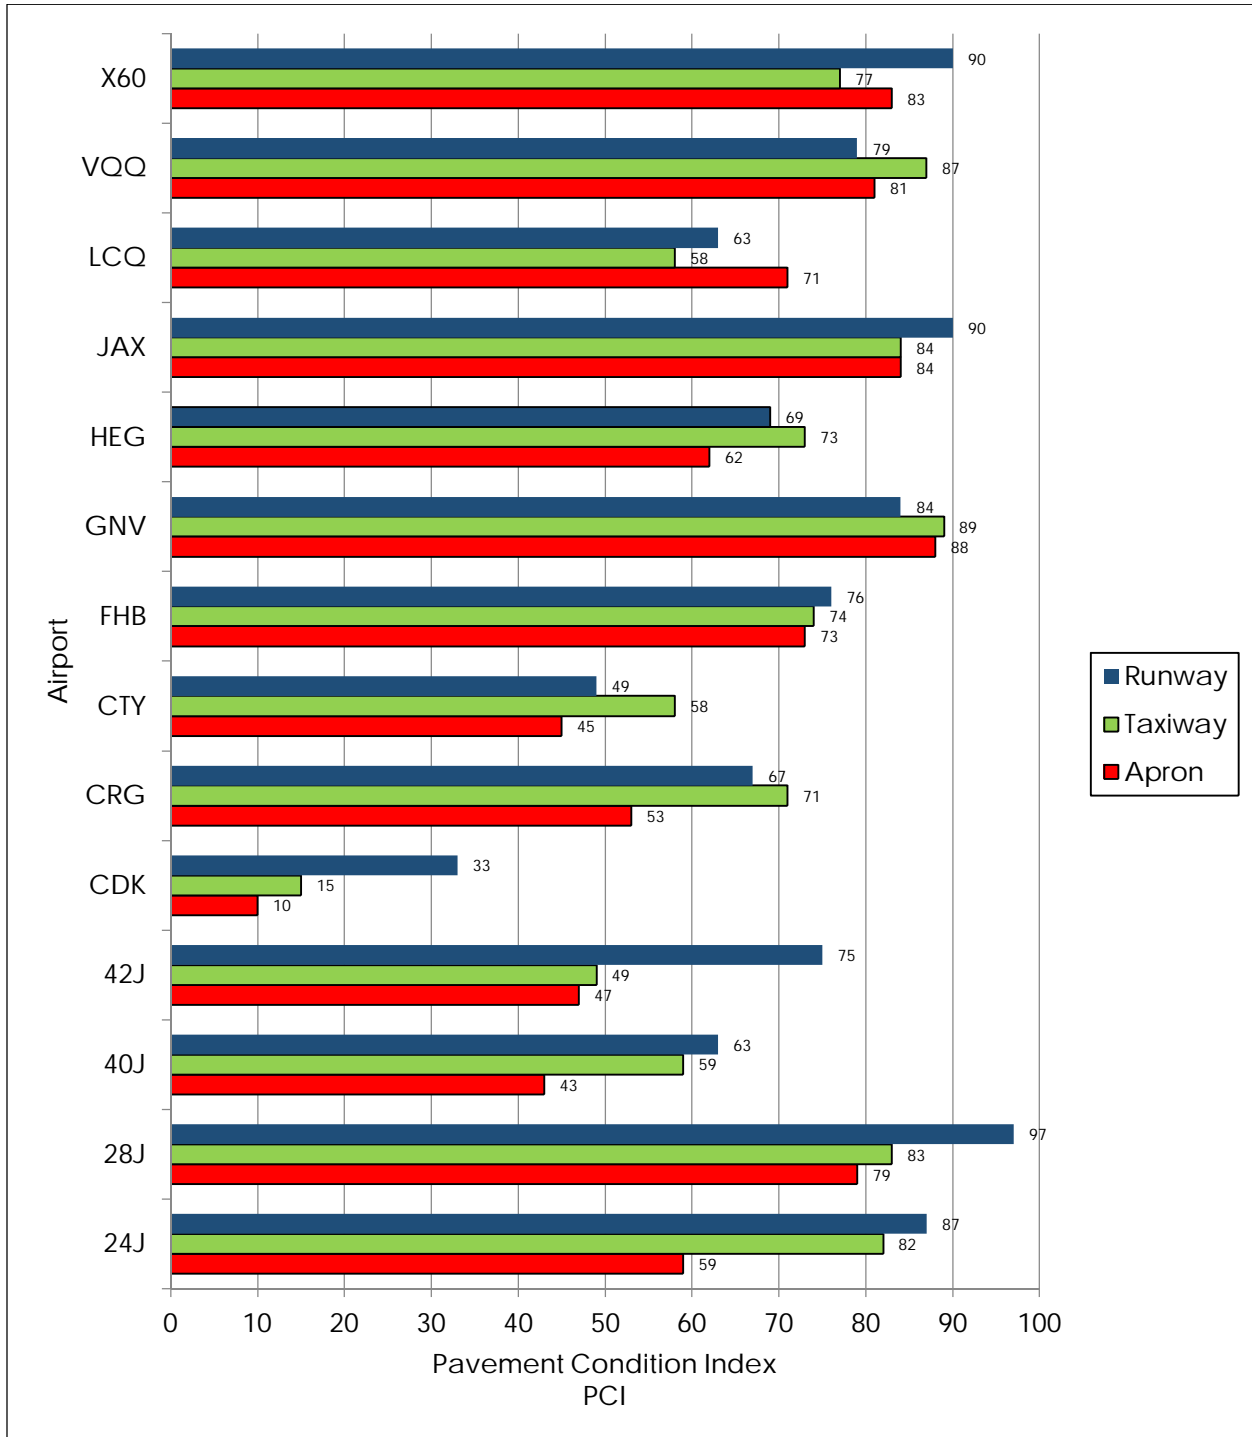
Pavement Facility Use has an influence on the pavement condition each facility. For example, the amount and type of distresses observed on a primary runway can vary from a maintenance apron based on frequency and variety of traffic loads experienced. Figure 3-2: PCI by Pavement Facility Use by Airport graphically depicts the PCI for each pavement facility use (Runway, Taxiway, and Apron) at each participating airport within the District.
