DISTRICT 3 REPORT
JUNE 2015

STATEWIDE
**Airfield
Pavement
Management**
PROGRAM

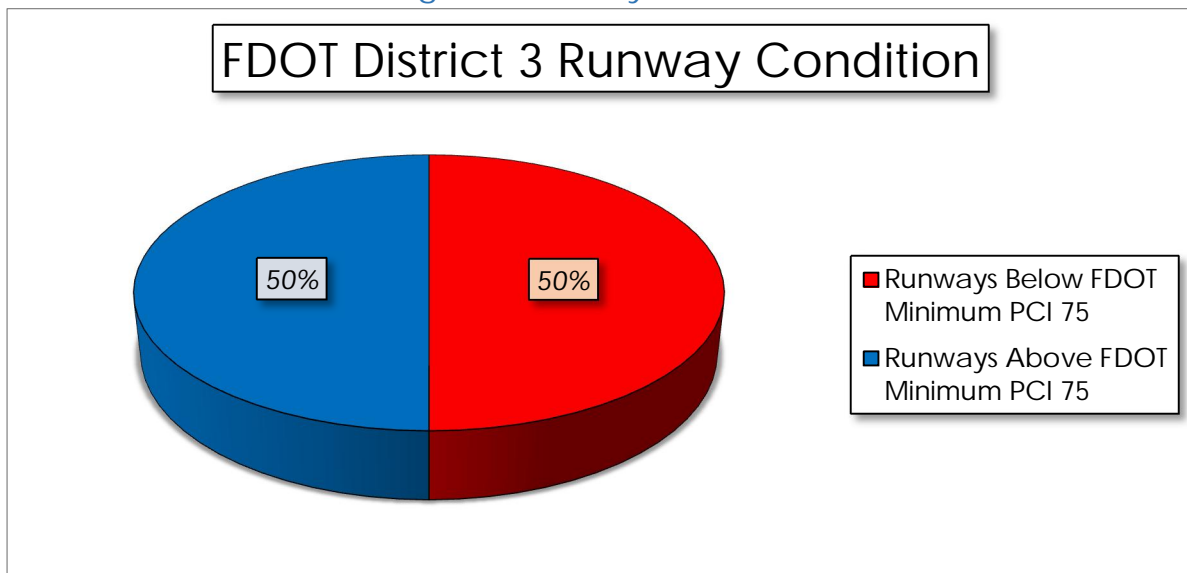
District 3’s overall area-weighted Pavement Condition Index (PCI) is at a 76.16, a condition rating of “Satisfactory”. Table I: Condition Summary by Airport below represents of the results of the PCI inspection at each airport within the District. The overall area-weighted average PCI values for the participating airport facilities in District 3 ranged from 42 (Poor) to 93 (Good). Specific individual airport results are identified in the individual Airport Pavement Evaluation Reports provided to each airport. Table II: Runway Condition Summary by Airport indicates the PCI value for every runway within the District, grouped by Airport. Figure I: Runway Condition graphically depicts the percentage of the District’s Runways below the FDOT Minimum PCI of 75 and Figure II: Runway Pavement Condition Comparison to FDOT Minimum PCI conveys the PCI’s of the District’s runway facilities in comparison to the FDOT Minimum PCI of 75.

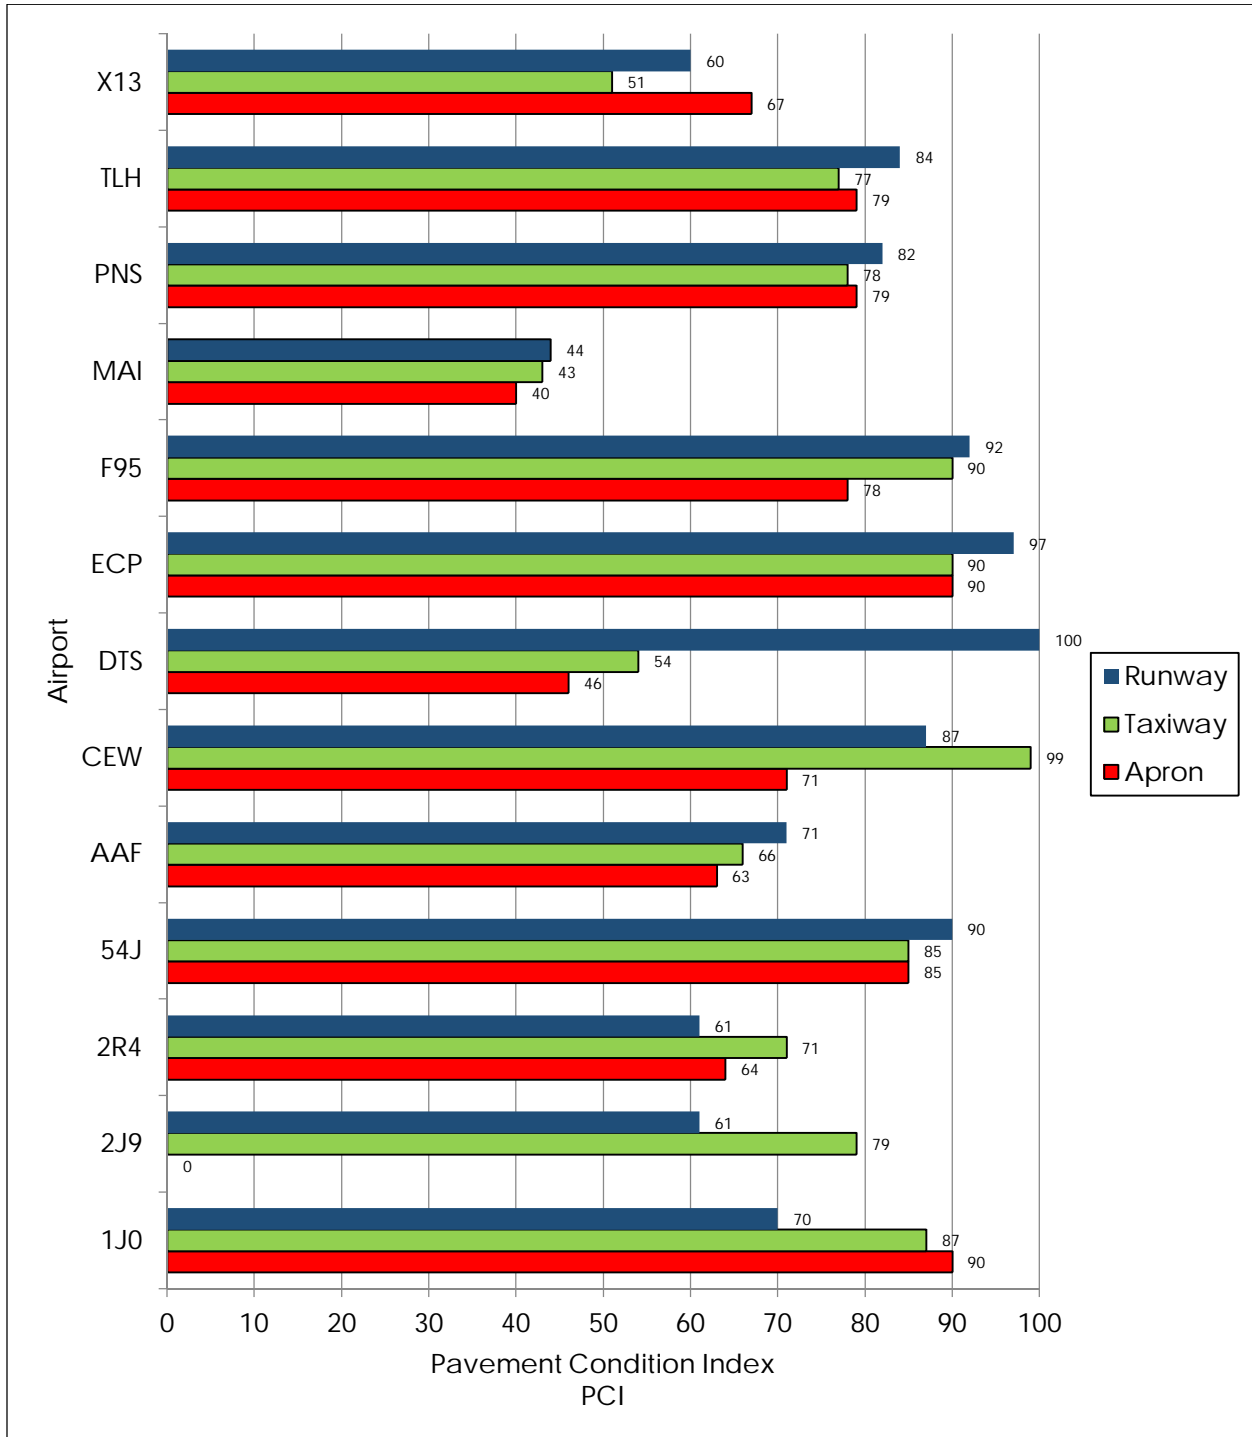
Figure III: PCI by Pavement Facility Use by Airport

Pavement use has an influence on the pavement condition of each facility. For example, the amount and type of distresses observed on a primary runway can vary from a crosswind runway based on the frequency and variety of traffic loads experienced due to the aircraft fleet mix. In this example, the crosswind runway would be exposed to less aircraft operational traffic due to wind coverage. In many cases, the crosswind runway is also shorter than the primary

runway which may cause heavier aircraft traffic, larger jets, to prefer the primary runway in all but the most severe wind conditions. This would result in the primary runway experiencing a larger percentage of aircraft passes in frequency and heavy load applications. Table III: District Summary of Area Use by Airport provides a breakdown of the airport pavement areas by its facility use. Figure III: PCI by Pavement Use by Airport graphically depicts the PCI for each pavement facility use at each airport.

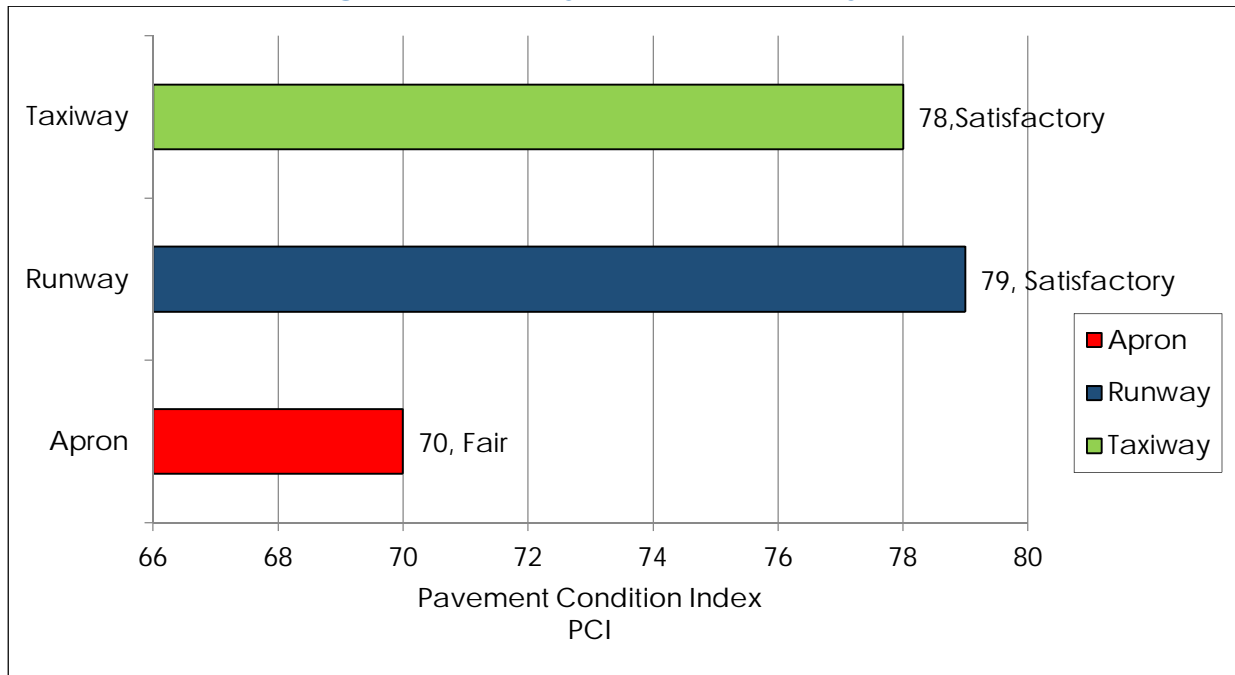
Figure 3-3: PCI by Pavement Facility Use

A summary of the District’s area-weighted PCI for each pavement facility use for all airfield pavement sections throughout the participating airports are shown below in Figure 3-3: PCI by Pavement Facility Use.

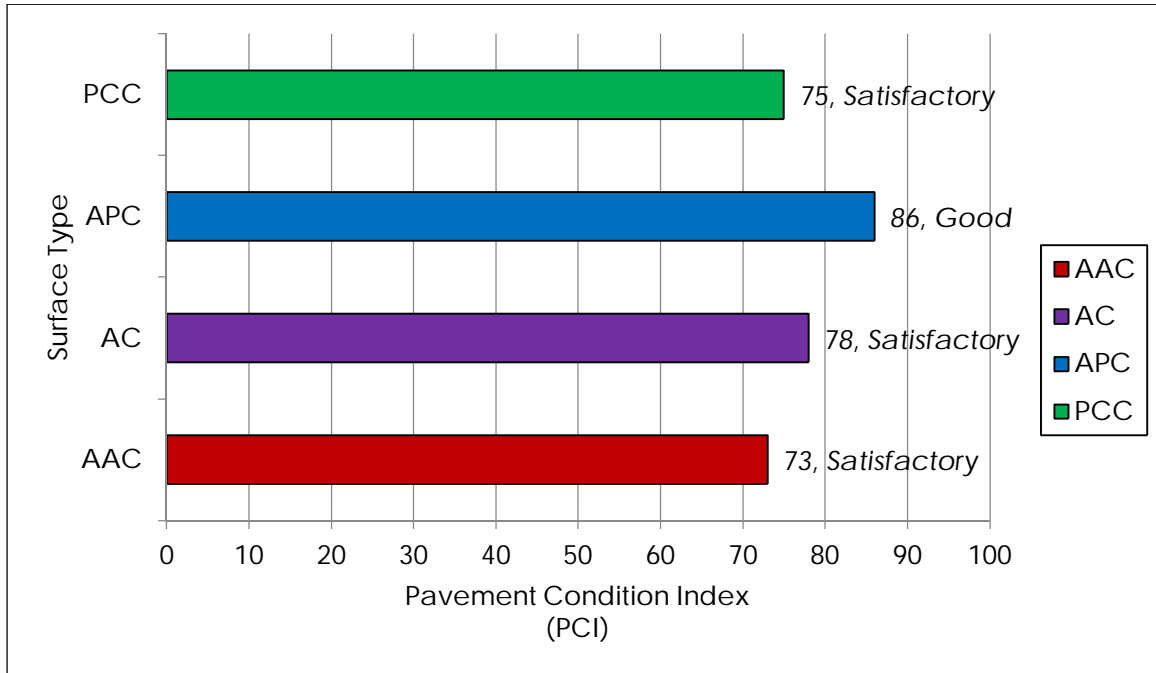
Pavement facility surface types considered for the SAPMP update consist of the four common types within the Florida Airport System: Portland Cement Concrete (PCC), Asphalt Concrete Overlayed on Portland Cement Concrete Pavement (APC), Asphalt Concrete Pavement (AC), and Asphalt Concrete Overlayed on Asphalt Concrete (AAC). Figure 3-4: PCI by Pavement Surface Type summarizes the PCI determined based on the various pavement types within the participating District airports. Whitetopping, a composite pavement type that consists of a thin concrete overlay on asphalt concrete pavement exists at certain airports within the Florida Airport System and are discussed at the specific individual airport pavement evaluation report document for those airports.
