DISTRICT 7 REPORT
JUNE 2015

STATEWIDE
**Airfield
Pavement
Management**
PROGRAM

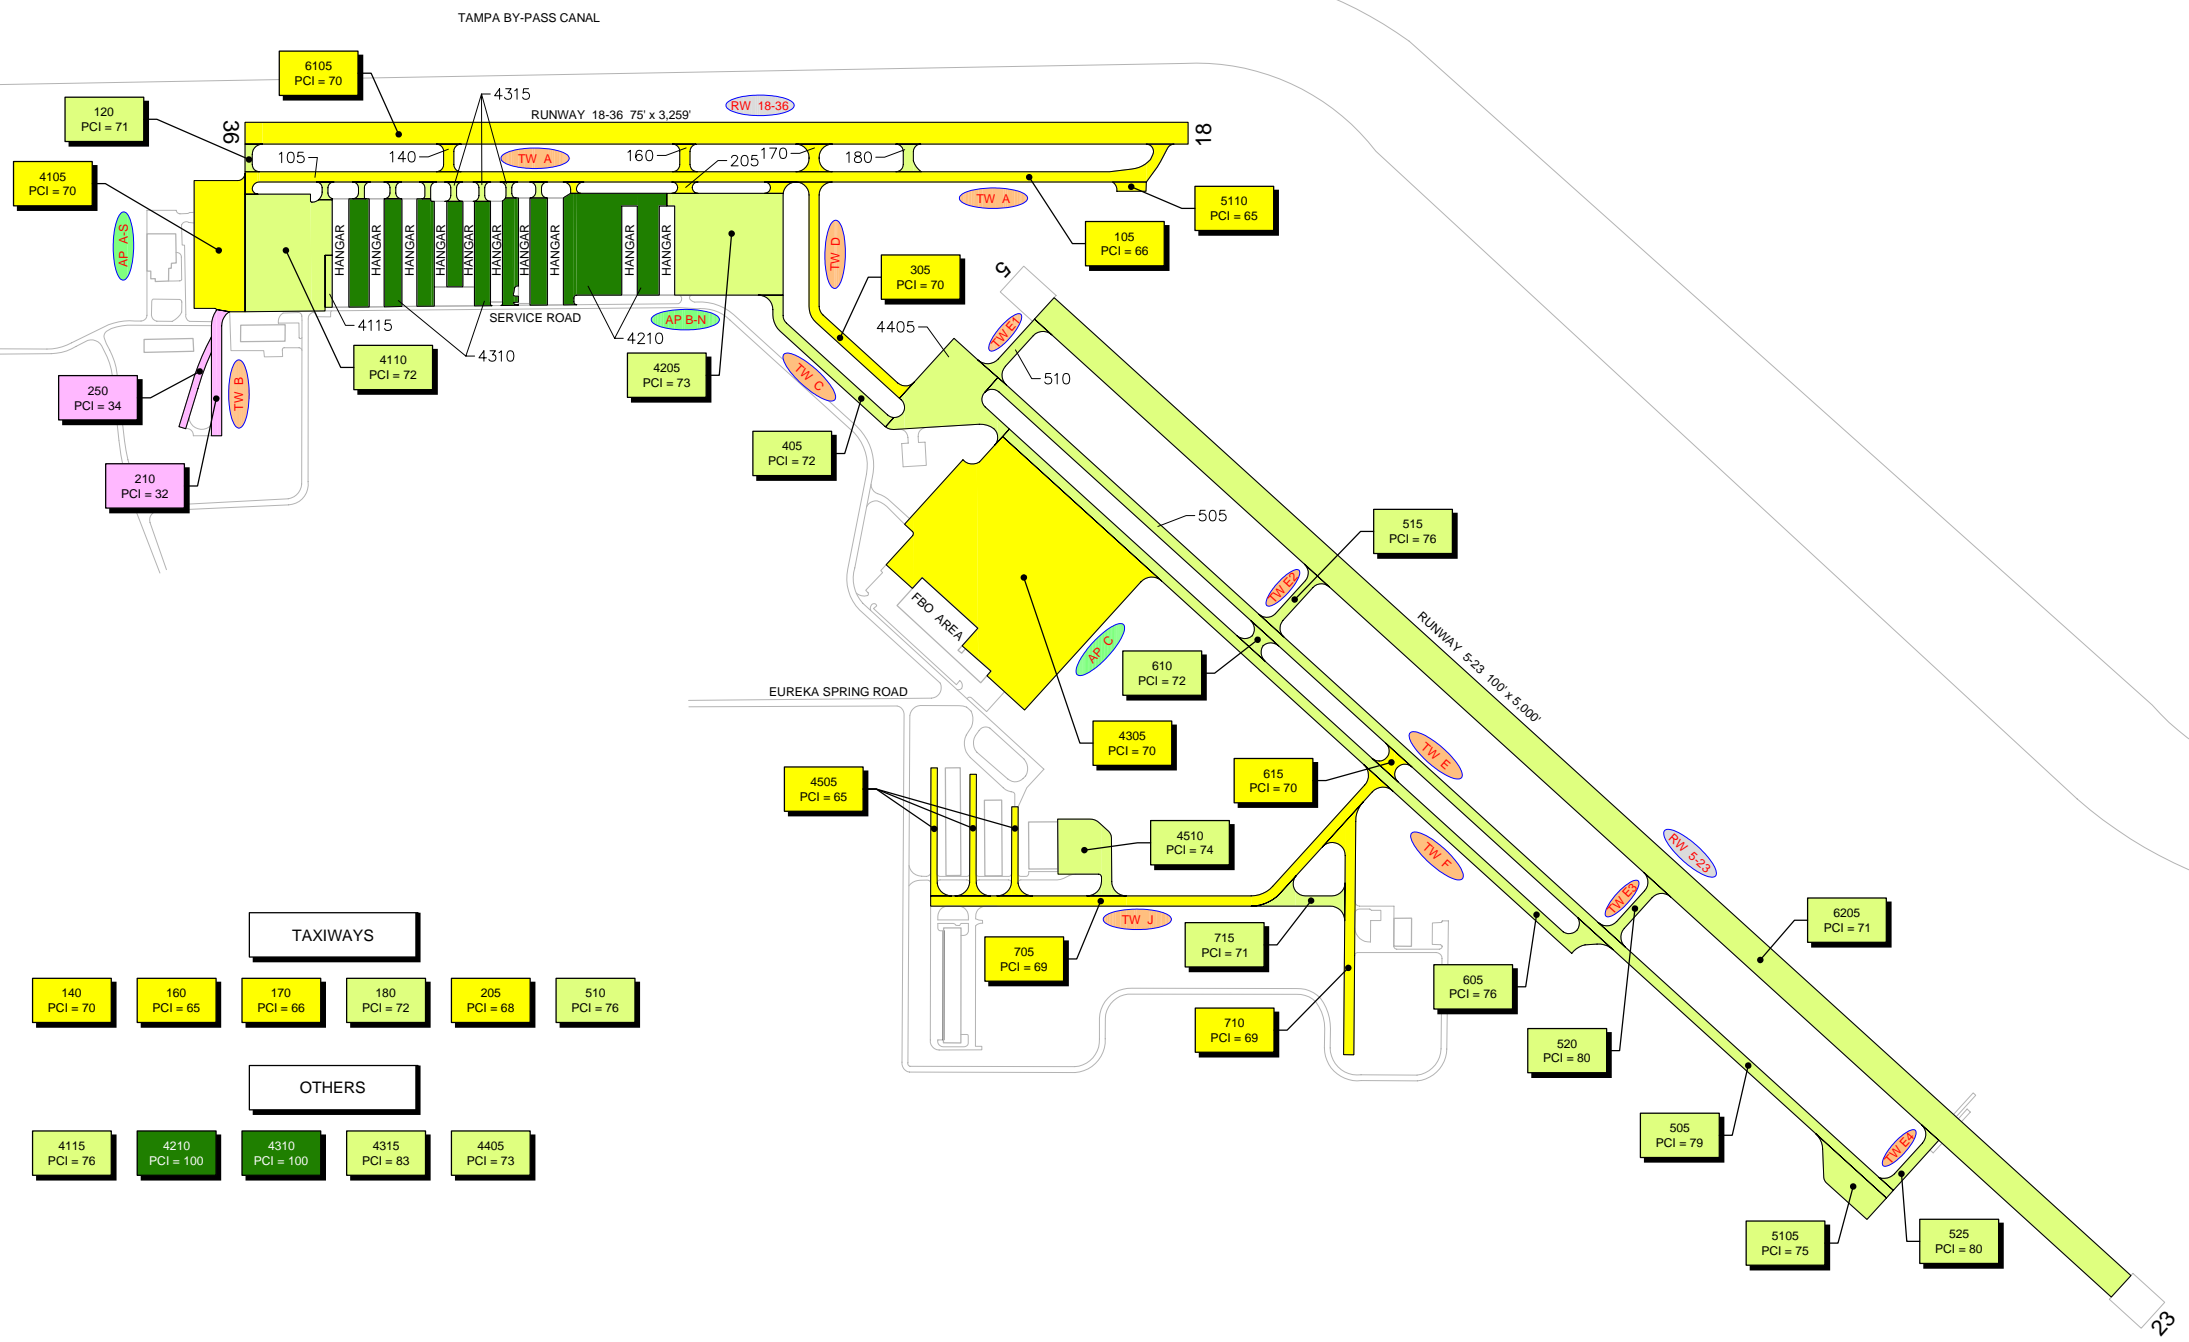
AIRFIELD PAVEMENT CONDITION INDEX RATING EXHIBIT
 PETER O. KNIGHT AIRPORT
 HILLSBOROUGH COUNTY, FLORIDA
 FLORIDA DEPARTMENT OF TRANSPORTATION - AVIATION AND SPACEPORT OFFICE

| TAXIWAYS | | | | | |
|---|---|---|---|---|---|
| 140 PCI = 70 | 160 PCI = 65 | 170 PCI = 66 | 180 PCI = 72 | 205 PCI = 68 | 510 PCI = 76 |
