**STATE OF FLORIDA
DEPARTMENT OF TRANSPORTATION
AVIATION OFFICE**

**Statewide Airfield Pavement Management Program
Palm Beach County Glades Airport
(General Aviation)
Pahokee, Florida
(District 4)**

February 13, 2008

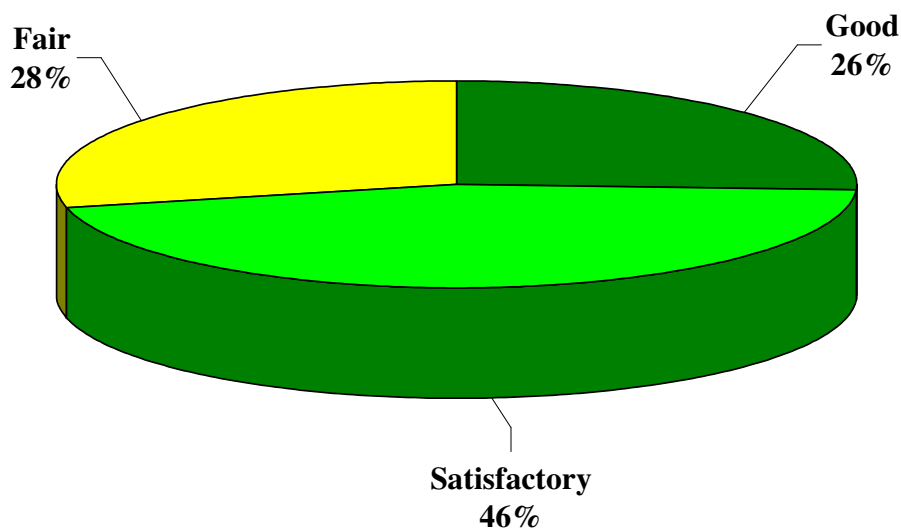
Network PCI Distribution by Rating Category

The figure below provides the PCI distribution by rating category for the network. Approximately 72% of the network is in Good and Satisfactory condition while 28% of the network is in Fair condition.

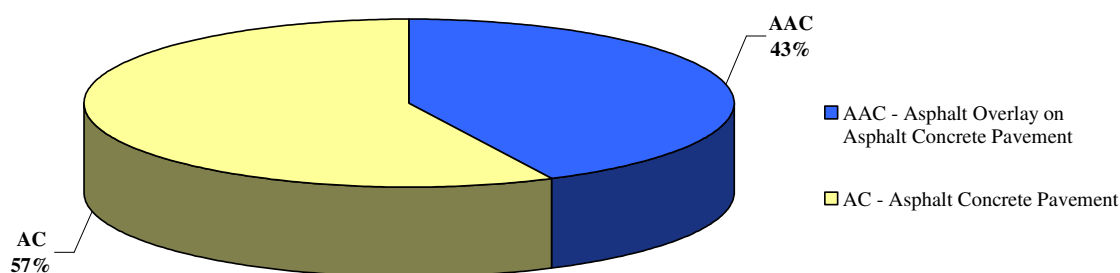
Figure 3-1: Pavement Area by Surface Type

Figure 3-1 presents the breakdown of the pavement area at Palm Beach County Glades Airport by surface type.

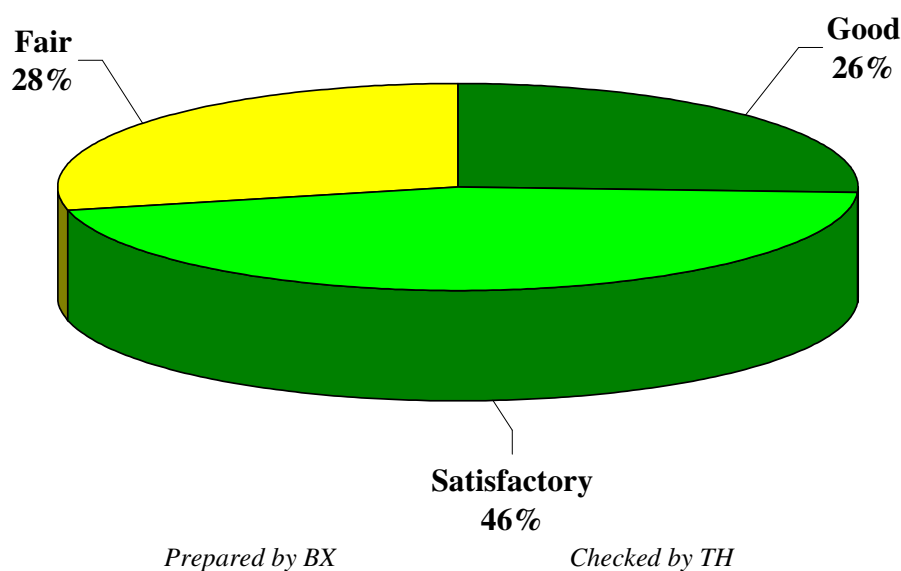
Figure 4-1: Network PCI Distribution by Rating Category

Approximately 72% of the network is in Good and Satisfactory condition while 28% of the network is in Fair condition. Table 4-1 illustrates the area-weighted PCI computed individually for each pavement use.

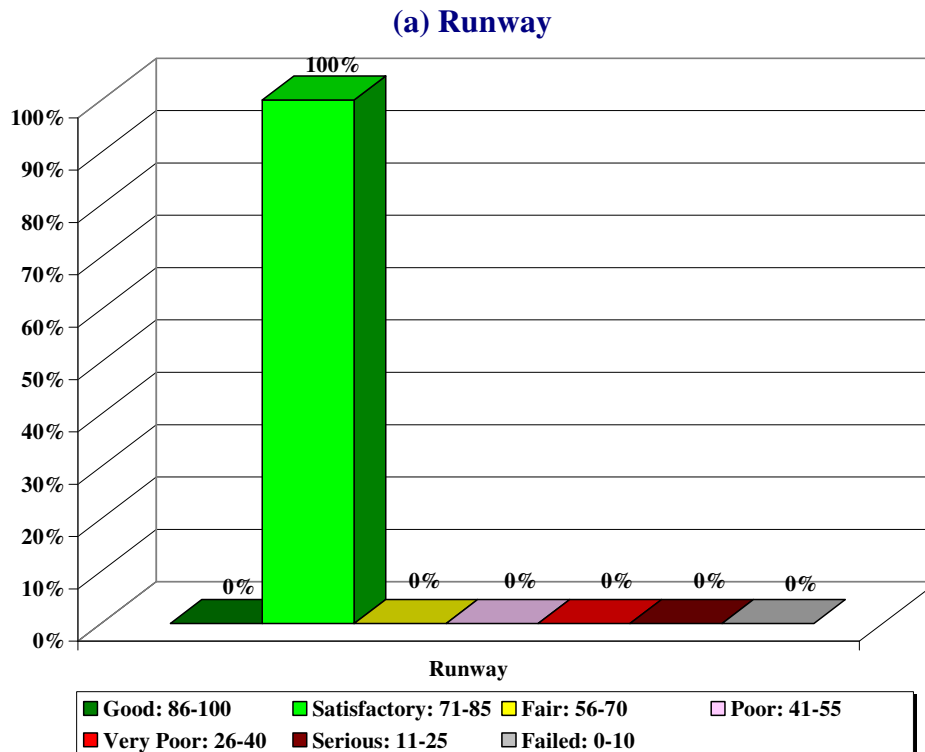
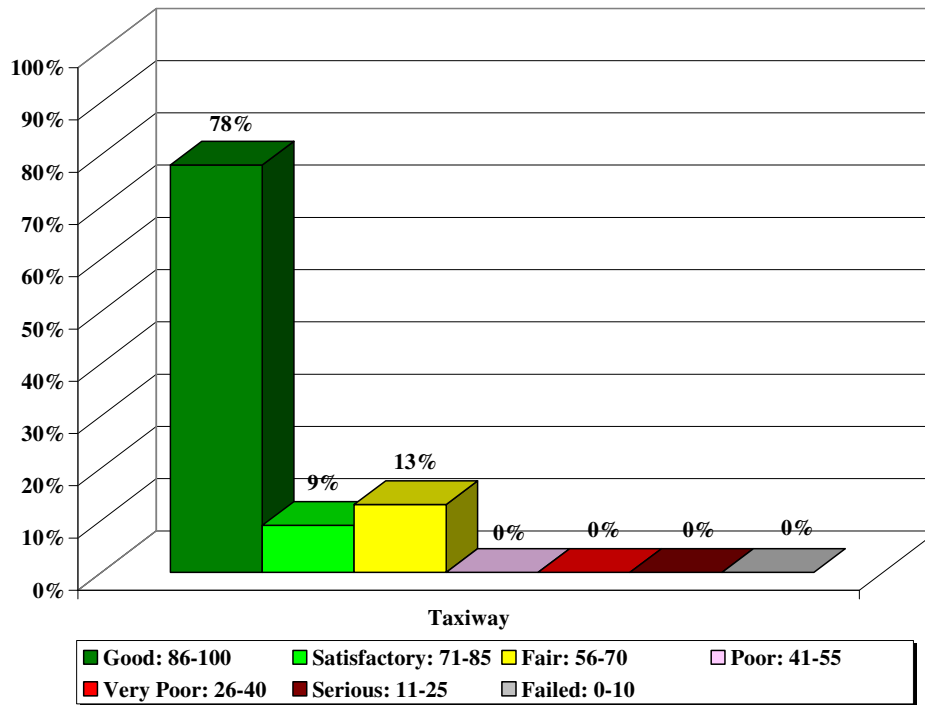
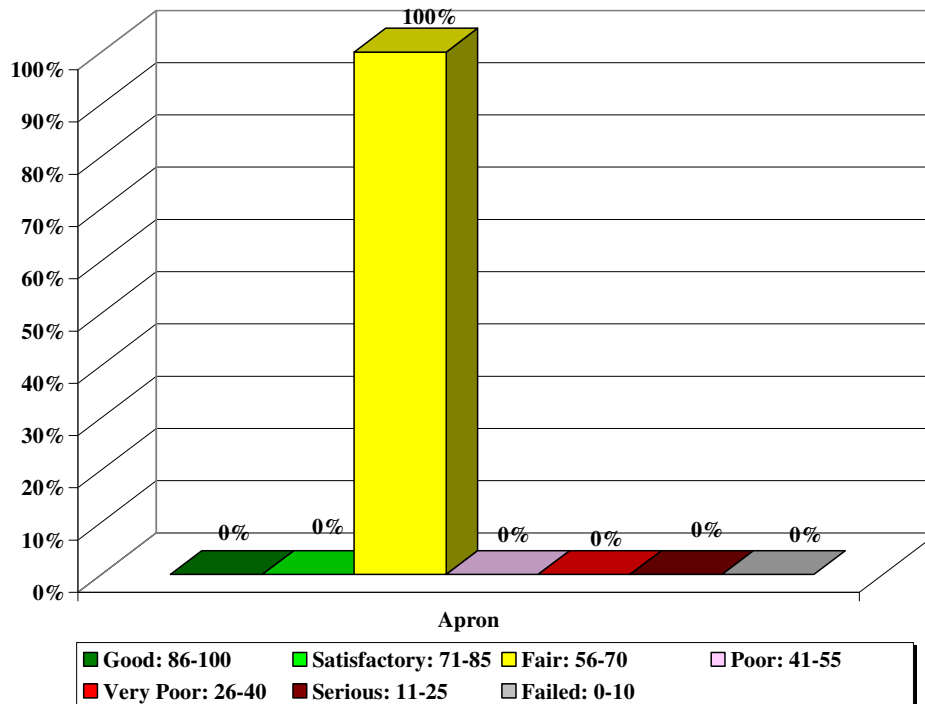
Figure 4-2: Percentage of Pavement Area within Each PCI Range by Pavement Use

Figure 4-2 presents the breakdown of PCI by range for each pavement use.

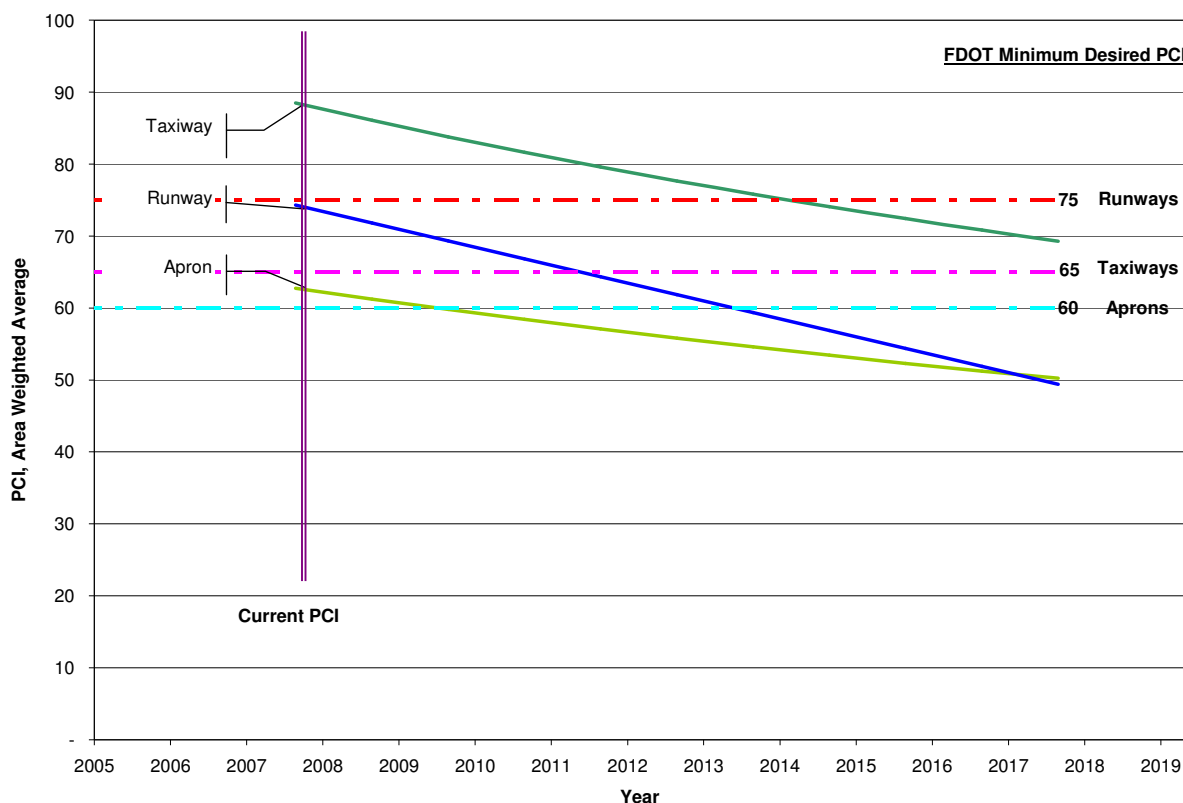
Figure 5-1: Predicted PCI by Pavement Use

Performance prediction models or deterioration curves for PCI were used to develop a condition forecast. The performance models were developed for combinations of variables such as pavement use (runway, taxiway or apron), surface type (AC or PCC) and airport category (GA, RL, or PR). Figure 5-1 illustrates the predicted performance of pavements at Palm Beach County Glades Airport based on current condition, age since last construction and the deterioration model appropriate for the type of pavement. The figure presents the forecast for each pavement use and displays the FDOT minimum condition criteria for General Aviation (GA) airports.

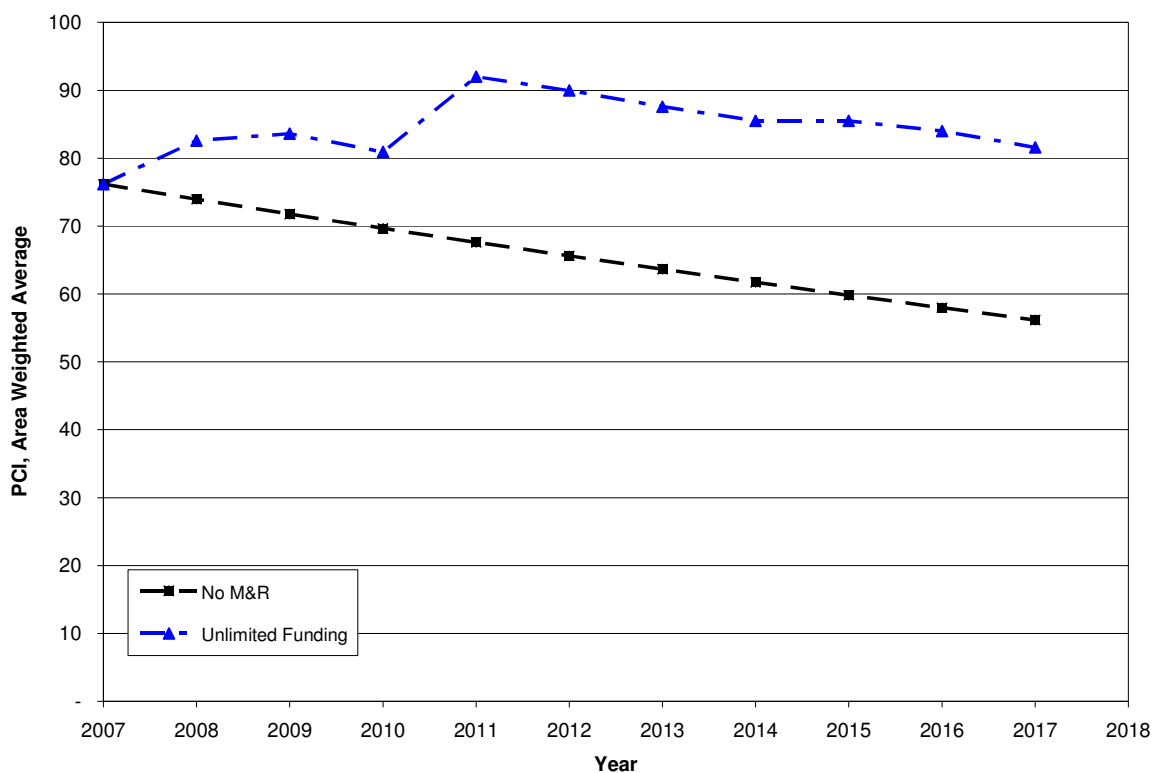
Figure 7-1: Budget Scenario Analysis

The 10 year forecast results are shown in Figure 7-1, illustrating the effect on pavement condition (PCI) of doing no maintenance versus having unlimited funds and performing all M&R actions based on the policies.
