**STATE OF FLORIDA
DEPARTMENT OF TRANSPORTATION
AVIATION OFFICE**

**Statewide Airfield Pavement Management Program
Sebring Regional Airport
(General Aviation)
Sebring, Florida
(District 1)**

February 8, 2008

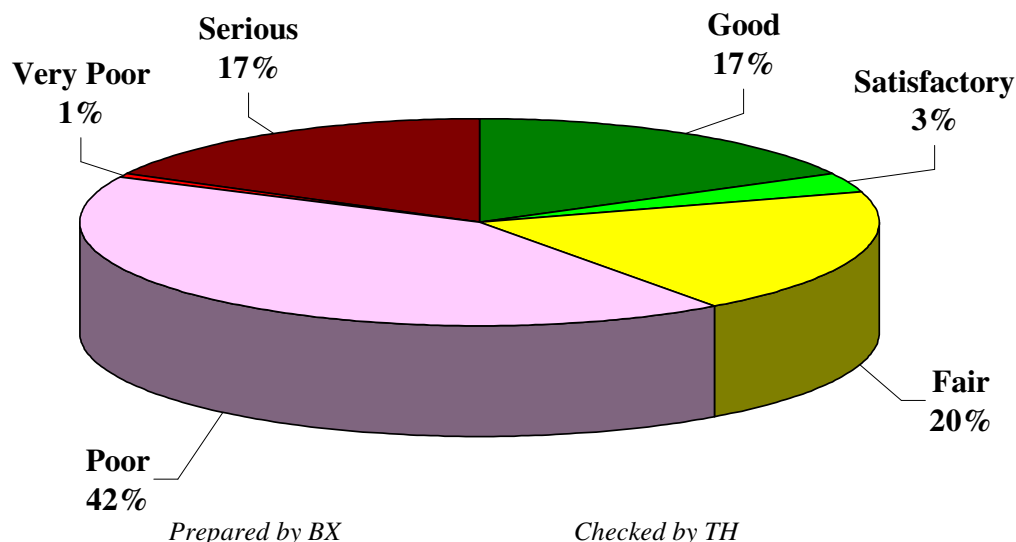
Network PCI Distribution by Rating Category

The figure below provides the PCI distribution by rating category for the network. Approximately 20% of the network is in Good and Satisfactory condition while 60% of the network is in Poor to Serious condition.

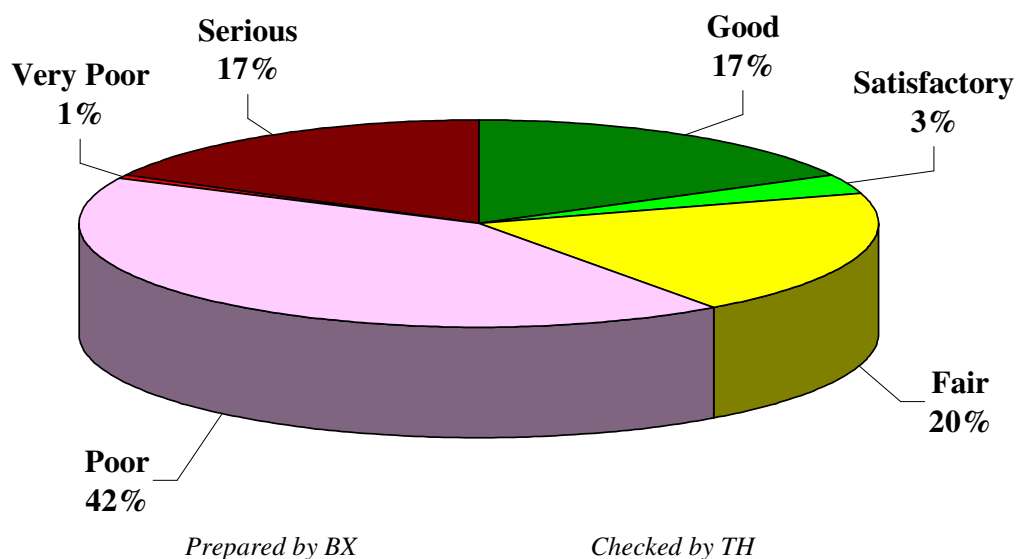
Figure 4-1: Network PCI Distribution by Rating Category

Approximately 20% of the network is in Good and Satisfactory condition while 60% of the network is in Poor to Serious condition. Table 4-1 illustrates the area-weighted PCI computed individually for each pavement use.

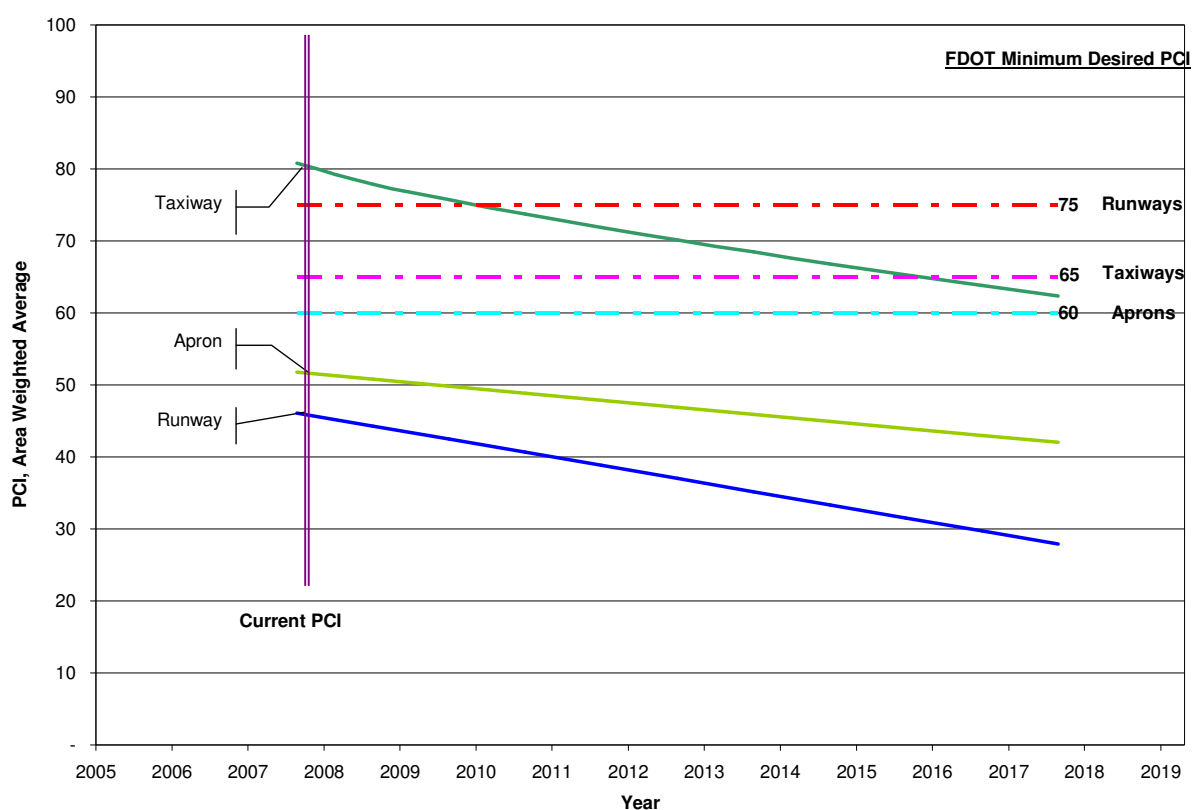
Figure 5-1: Predicted PCI by Pavement Use

Performance prediction models or deterioration curves for PCI were used to develop a condition forecast. The performance models were developed for combinations of variables such as pavement use (runway, taxiway or apron), surface type (AC or PCC) and airport category (GA, RL, or PR). Figure 5-1 illustrates the predicted performance of pavements at Sebring Regional Airport based on current condition, age since last construction and the deterioration model appropriate for the type of pavement. The figure presents the forecast for each pavement use and displays the FDOT minimum condition criteria for General Aviation (GA) airports.

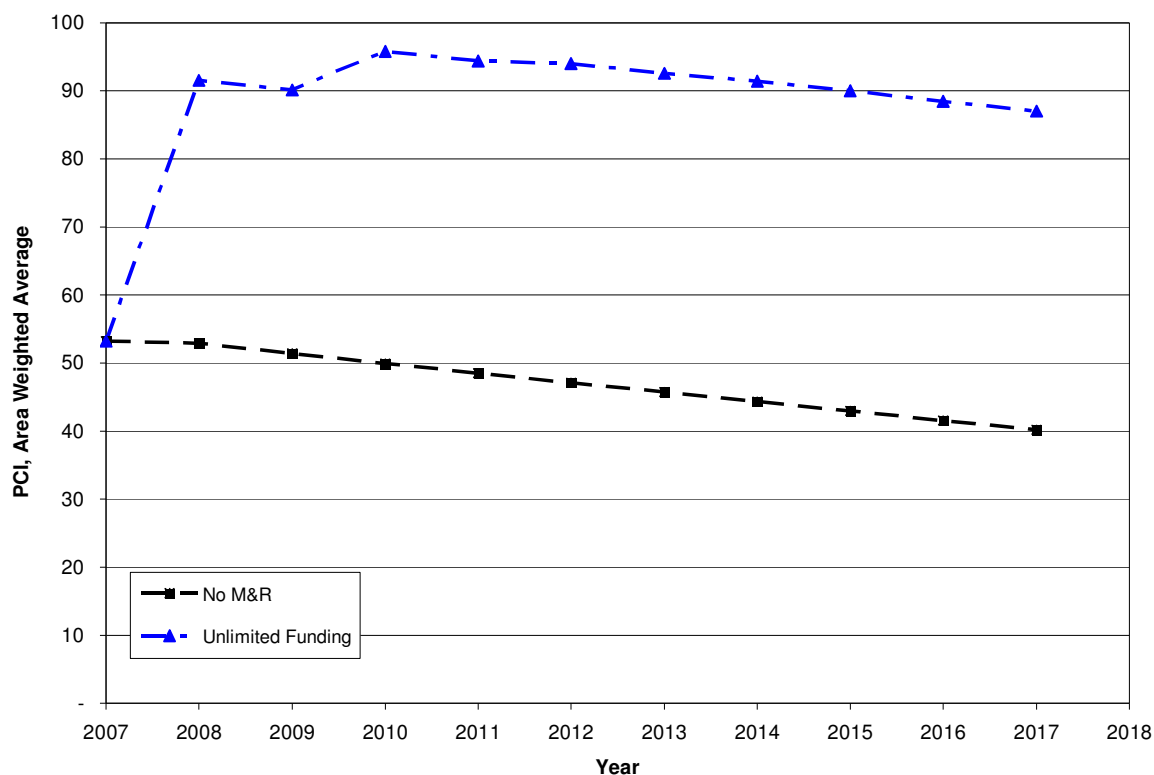
Figure 7-1: Budget Scenario Analysis

The 10 year forecast results are shown in Figure 7-1, illustrating the effect on pavement condition (PCI) of doing no maintenance versus having unlimited funds and performing all M&R actions based on the policies.
