**STATE OF FLORIDA
DEPARTMENT OF TRANSPORTATION
AVIATION OFFICE**

**Statewide Airfield Pavement Management Program
Sebastian Municipal Airport
(General Aviation)
Sebastian, Florida
(District 4)**

January 31, 2008

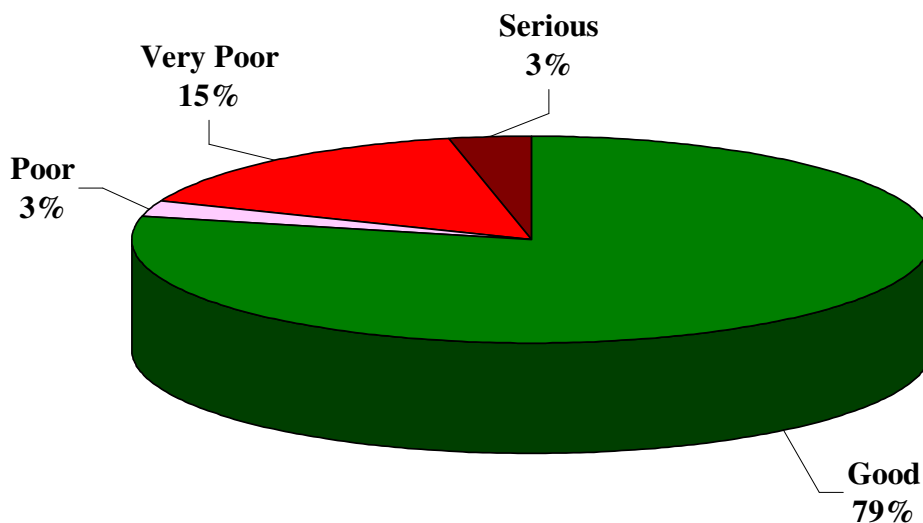
Network PCI Distribution by Rating Category

The overall area-weighted Pavement Condition Index (PCI) of the areas in 2007 is 81, representing a Satisfactory overall network condition.

The figure below provides the PCI distribution by rating category for the network. Approximately 79% of the network is in Good condition while 21% of the network is in Poor to Serious condition.

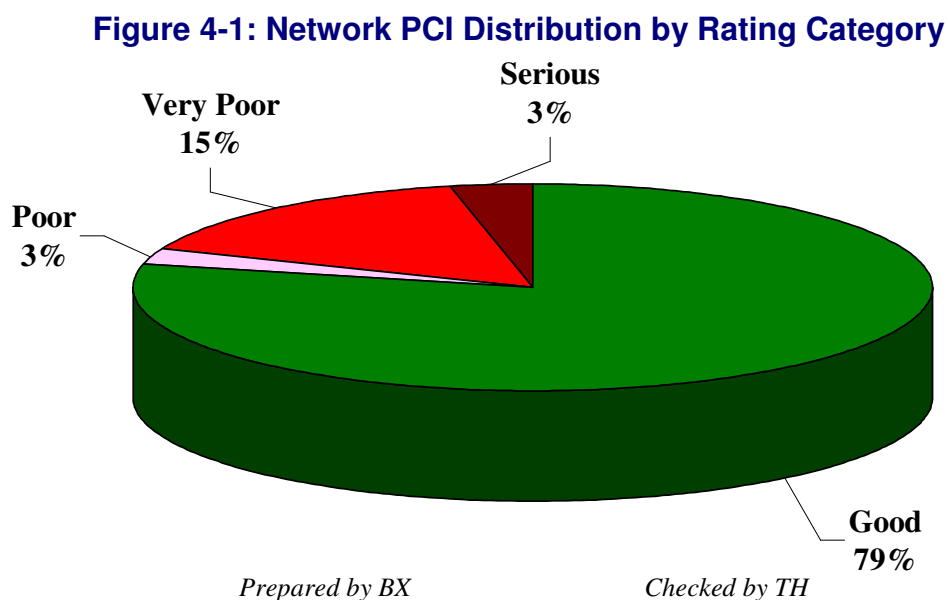
According to the 2007 survey, the overall area-weighted PCI at Sebastian Municipal Airport is 81, representing a Satisfactory overall network condition.

Figure 4-1 provides the PCI distribution by rating category for the network.

Approximately 79% of the network is in Good condition while 21% of the network is in Poor to Serious condition. Table 4-1 illustrates the area-weighted PCI computed individually for each pavement use.

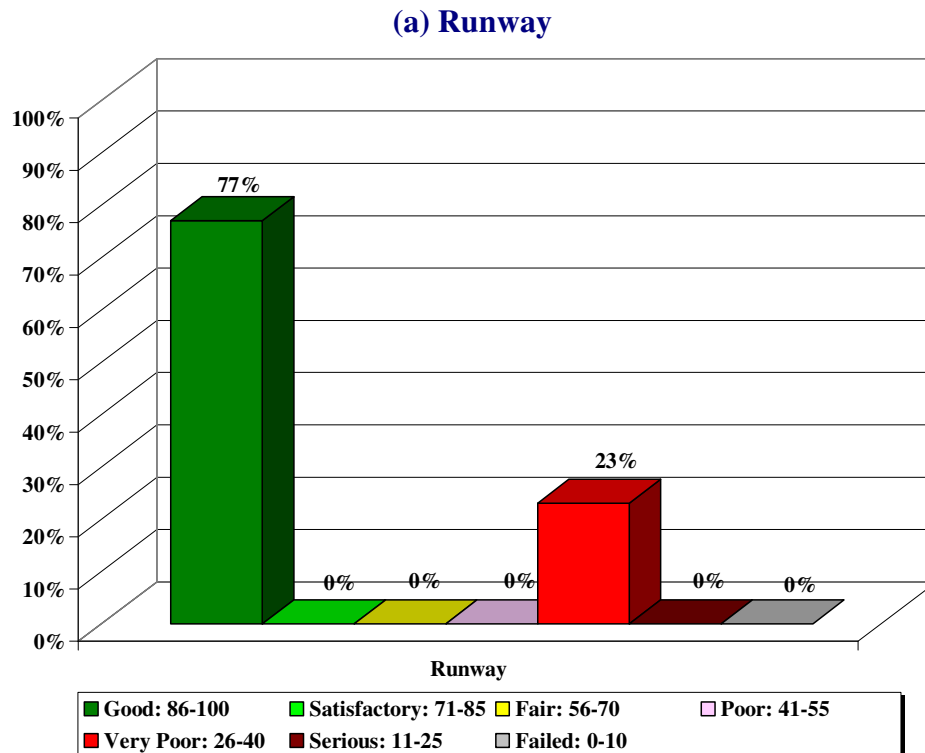
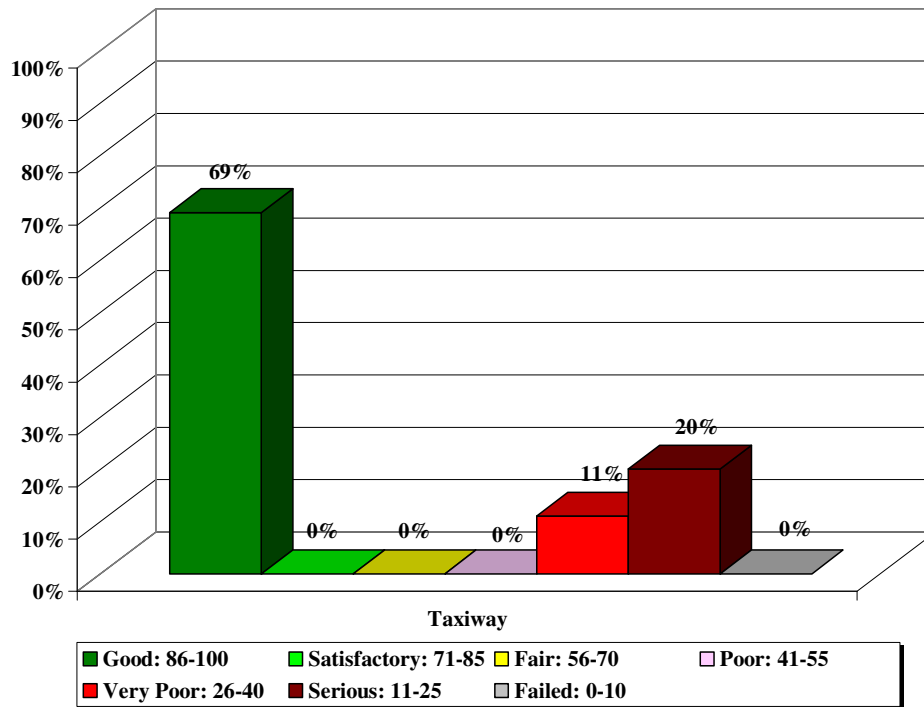
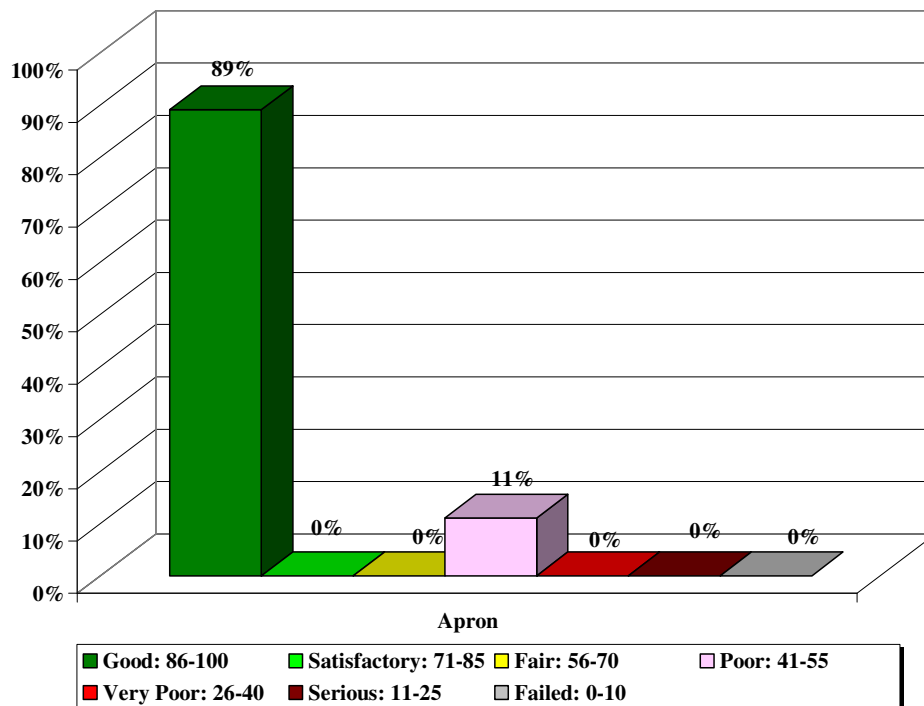
Figure 4-2: Percentage of Pavement Area within Each PCI Range by Pavement Use

Figure 4-2 presents the breakdown of PCI by range for each pavement use.

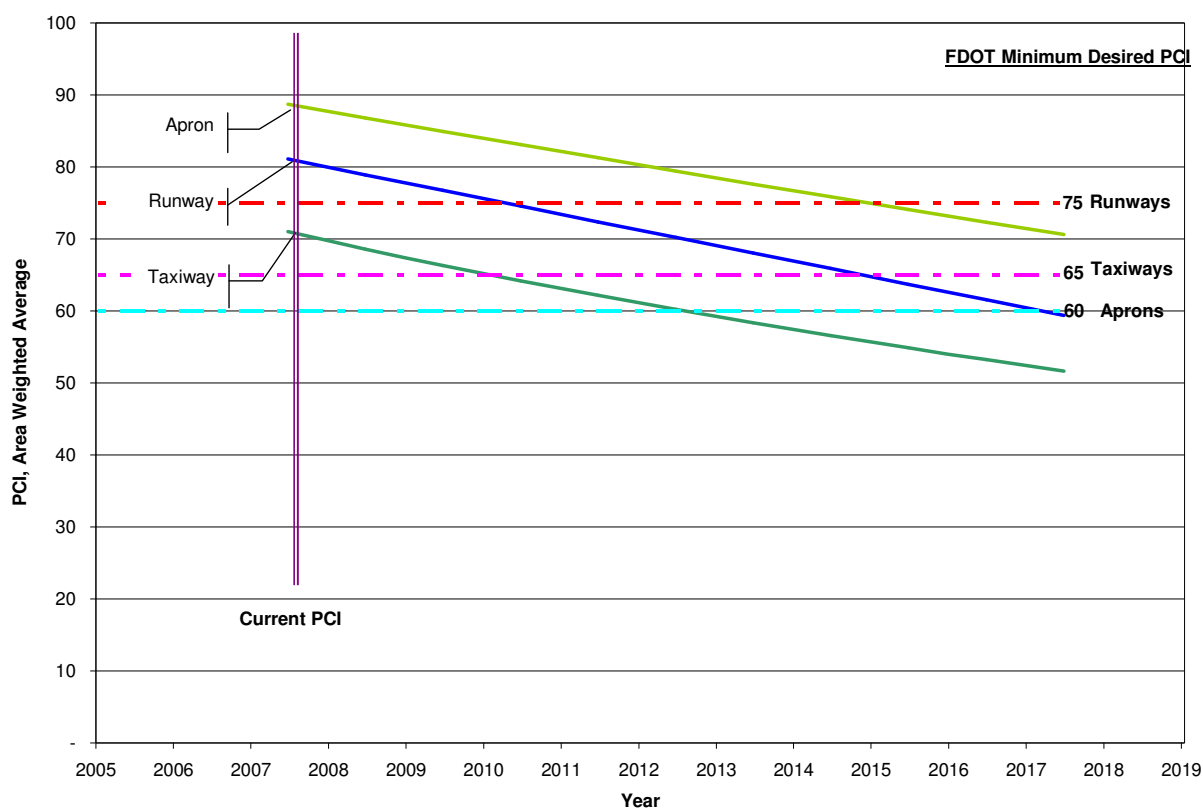
Figure 5-1: Predicted PCI by Pavement Use

Performance prediction models or deterioration curves for PCI were used to develop a condition forecast. The performance models were developed for combinations of variables such as pavement use (runway, taxiway or apron), surface type (AC or PCC) and airport category (GA, RL, or PR). Figure 5-1 illustrates the predicted performance of pavements at Sebastian Municipal Airport based on current condition, age since last construction and the deterioration model appropriate for the type of pavement. The figure presents the forecast for each pavement use and displays the FDOT minimum condition criteria for General Aviation (GA) airports.

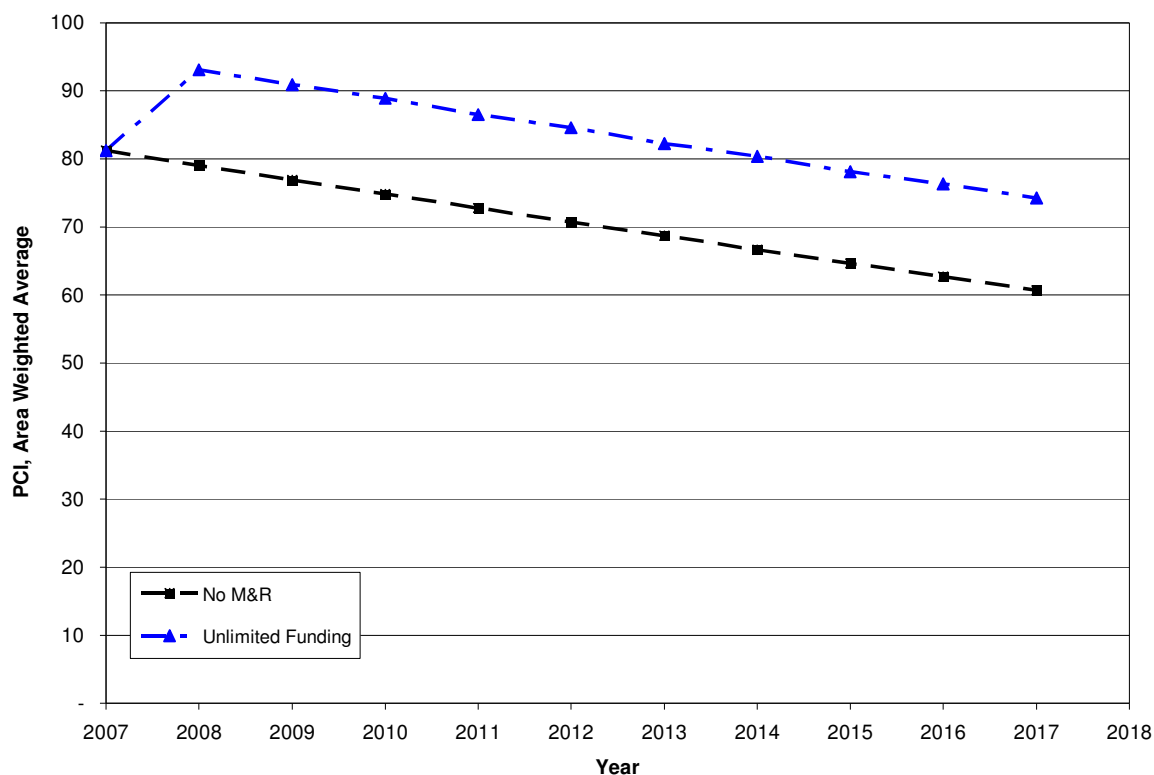
Figure 7-1: Budget Scenario Analysis

The 10 year forecast results are shown in Figure 7-1, illustrating the effect on pavement condition (PCI) of doing no maintenance versus having unlimited funds and performing all M&R actions based on the policies.

The 10 year analysis suggests an annual budget on the order of \$410,000 would be expected to provide an acceptable overall condition. The area-weighted PCI, however, would decrease from 81 in 2007 to 74 in 2017 (assuming the M&R was performed in 2008). This is because additional Major M&R would not be required until after 2017. Doing nothing would result in a 2017 PCI of 61 along with a significantly greater need for Major M&R.
