**STATE OF FLORIDA  
DEPARTMENT OF TRANSPORTATION  
AVIATION OFFICE**

**Statewide Airfield Pavement  
Management Program**

**AirGlades Airport– 2IS  
(General Aviation)  
Clewiston, Florida  
(District 1)**

**May 2011**

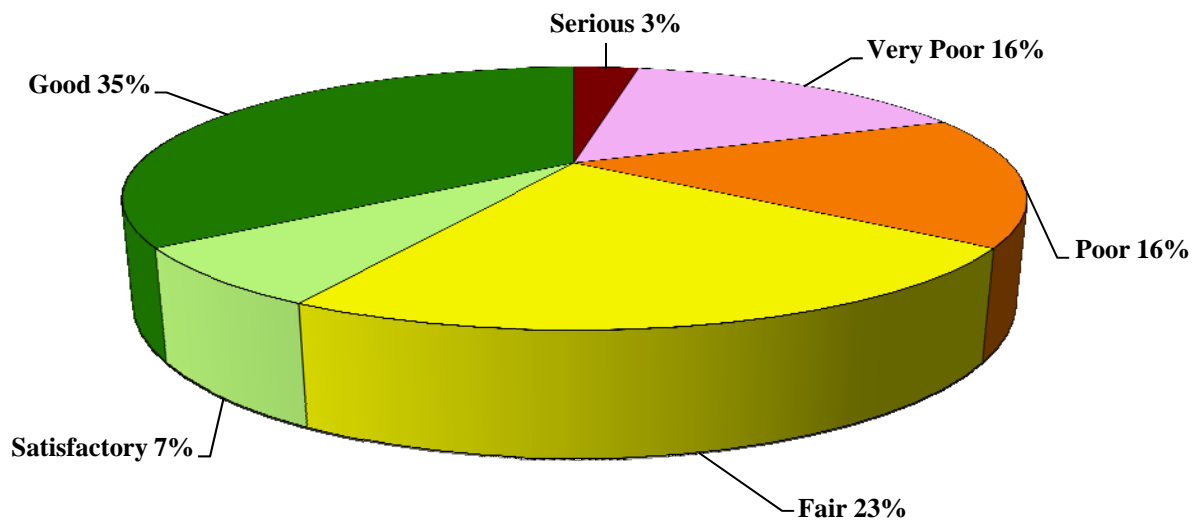
**Figure 3-1: Network PCI Distribution by Rating Category**

Figure 3-1 provides the PCI distribution by rating category for AirGlades Airport.

<b>Condition Rating</b>	<b>Total Area (ft<sup>2</sup>)</b>	<b>Percent</b>
Good	461,870	35%
Satisfactory	96,715	7%
Fair	308,095	23%
Poor	212,460	16%
Very Poor	206,720	16%
Serious	39,706	3%
Failed	0	0%

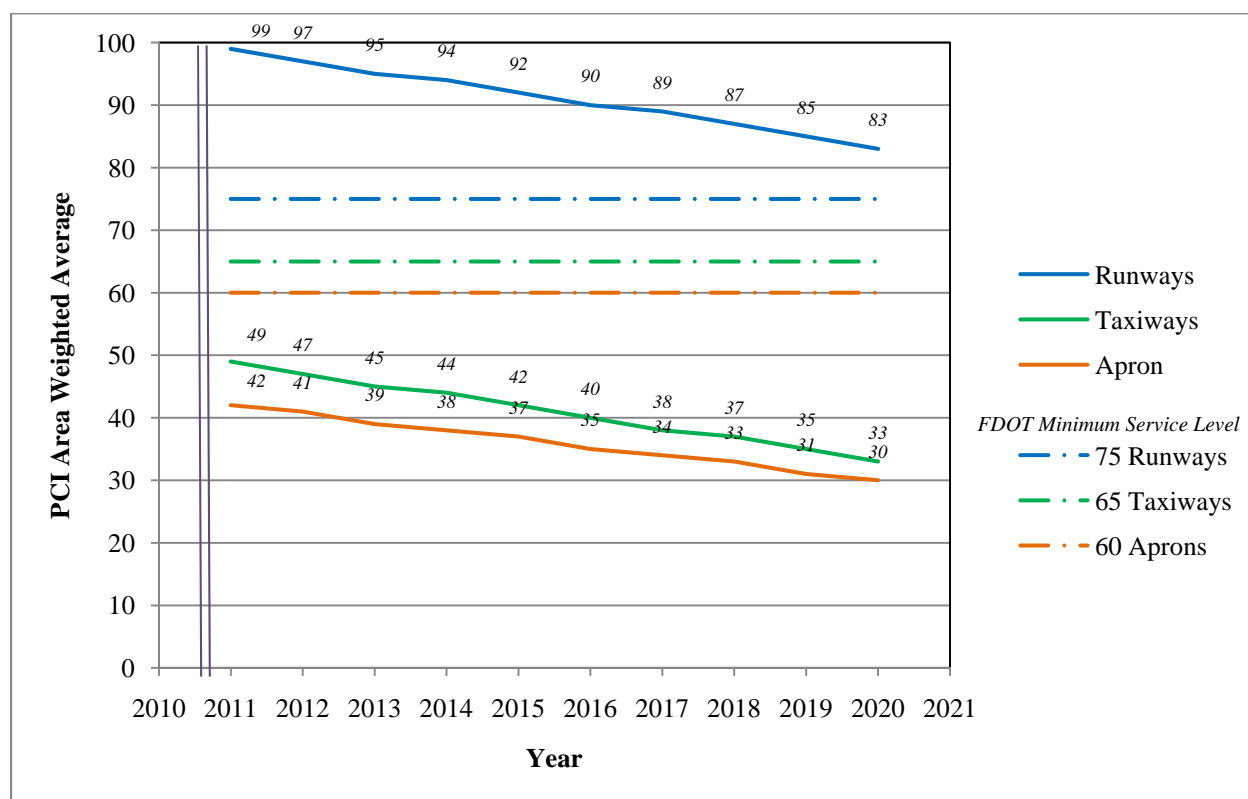
**Figure 4-1: Predicted PCI by Pavement Use**

Performance prediction models or deterioration curves for PCI were used to develop a condition forecast. The performance models were developed for combinations of variables such as pavement use (runway, taxiway or apron), surface type (AC or PCC) and airport category (GA, RL, or PR). Figure 4-1 illustrates the predicted performance of pavements at AirGlades Airport based on current condition, age since last construction and the deterioration model appropriate for the type of pavement. The figure presents the forecast for each pavement use and displays the FDOT minimum service level for General Aviation (GA) airports.

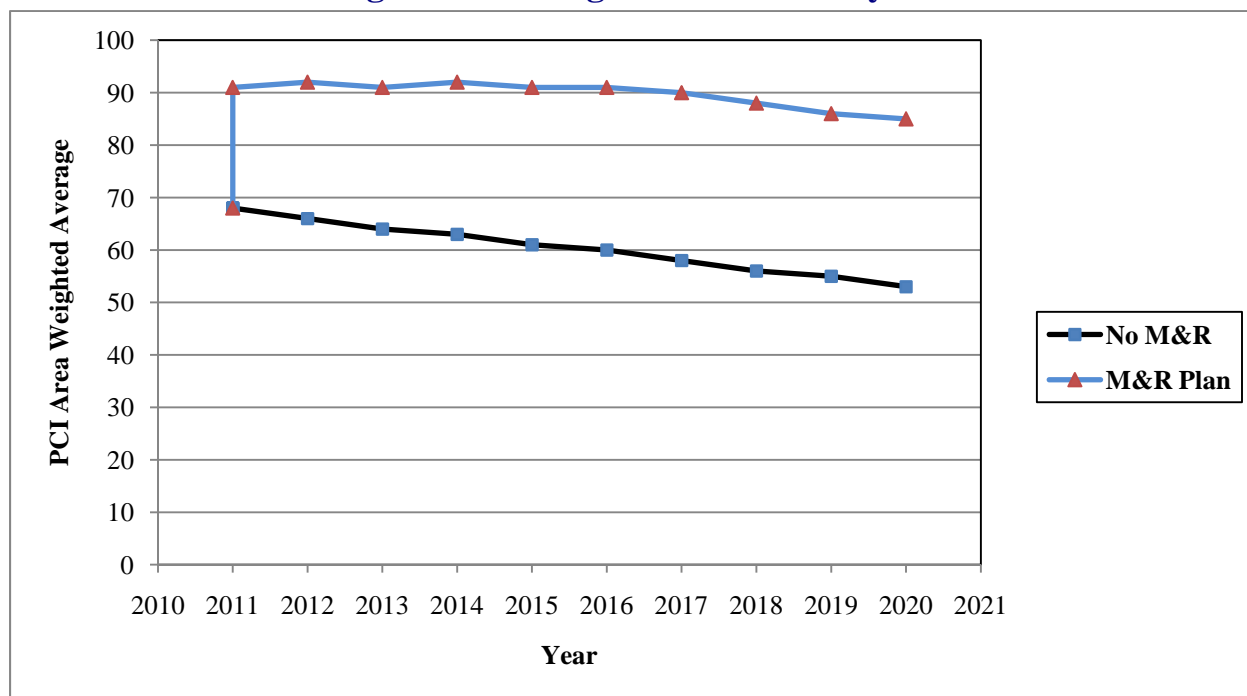
**Figure 6-1: Budget Scenario Analysis**

The following network level observations can be made from the figure above:

- The PCI will deteriorate from 68 in 2011 to 53 in ten years if no M&R activities are performed.
- The PCI will remain at or above 85 through the 10-year analysis period under the unlimited budget scenario. A 2020 PCI of 85 with this scenario is 32 PCI points higher than a “No M&R” scenario. The total cost for Major M&R over this 10-year period is about \$4.7 million.
