**STATE OF FLORIDA
DEPARTMENT OF TRANSPORTATION
AVIATION OFFICE**

**Statewide Airfield Pavement
Management Program**

**Apalachicola Regional Airport– AAF
(General Aviation)
Apalachicola, Florida
(District 3)**

May 2011

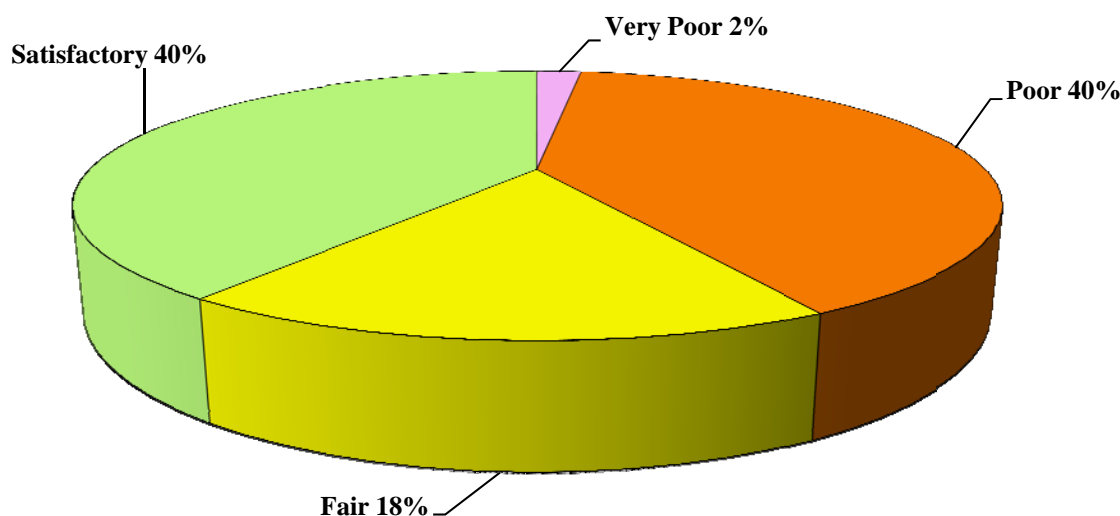
Figure 3-1: Network PCI Distribution by Rating Category

Figure 3-1 provides the PCI distribution by rating category for Apalachicola Regional Airport.

Condition Rating	Total Area (ft²)	Percent
Good	0	0%
Satisfactory	1,645,300	40%
Fair	746,196	18%
Poor	1,652,498	40%
Very Poor	69,400	2%
Serious	6,250	0%
Failed	10,500	0%

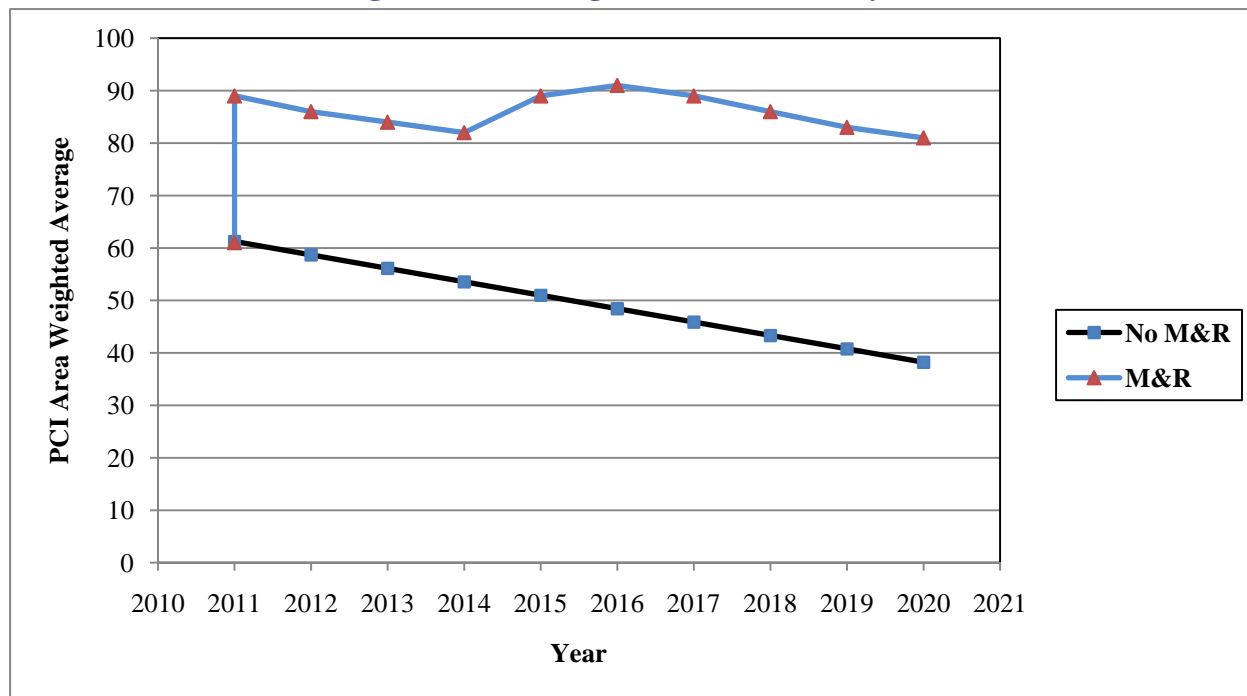
Figure 6-1: Budget Scenario Analysis

The following network level observations can be made from the figure above:

- The PCI will deteriorate from 62 in 2010 to 38 in ten years if no M&R activities are performed.
- The PCI will remain at or above 81 through the 10-year analysis period under the unlimited budget scenario. A 2020 PCI of 81 with this scenario is 43 PCI points higher than a “No M&R” scenario. The total cost for Major M&R over this 10-year period is about \$18 million.
