**STATE OF FLORIDA  
DEPARTMENT OF TRANSPORTATION  
AVIATION OFFICE**

**Statewide Airfield Pavement  
Management Program**

**Arcadia Municipal Airport– X06  
(General Aviation)  
Arcadia, Florida  
(District 1)**

**May 2011**

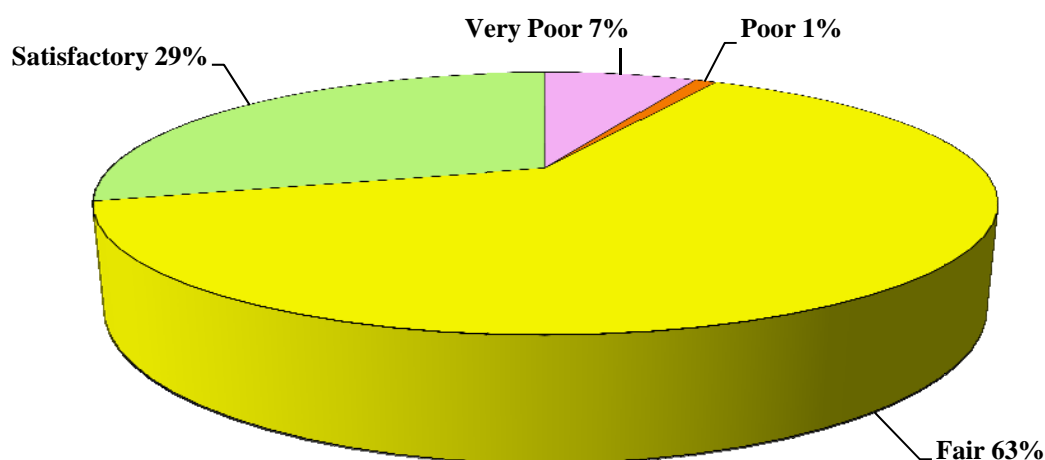
**Figure 3-1: Network PCI Distribution by Rating Category**

Condition Rating	Total Area (ft <sup>2</sup> )	Percent
Good	0	0%
Satisfactory	166,420	29%
Fair	362,935	63%
Poor	4,310	1%
Very Poor	38,300	7%
Serious	0	0%
Failed	0	0%

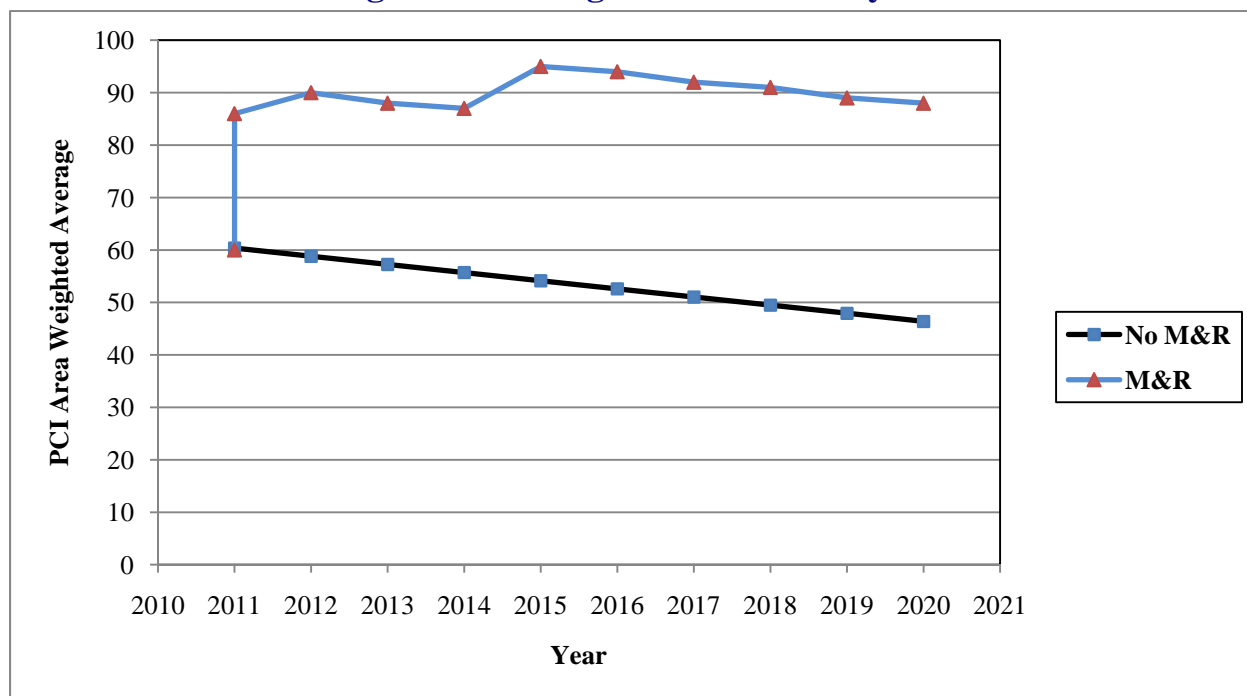
**Figure 6-1: Budget Scenario Analysis**

- The PCI will deteriorate from 61 in 2011 to 46 in ten years if no M&R activities are performed.
- The PCI will remain at or above 88 through the 10-year analysis period under the unlimited budget scenario. A 2020 PCI of 88 with this scenario is 42 PCI points higher than a “No M&R” scenario. The total cost for Major M&R over this 10-year period is about \$2.4 million.
