**STATE OF FLORIDA
DEPARTMENT OF TRANSPORTATION
AVIATION OFFICE**

**Statewide Airfield Pavement
Management Program**

**Bob Sikes Airport– CEW
(General Aviation)
Eglin AFB, Florida
(District 3)**

May 2011

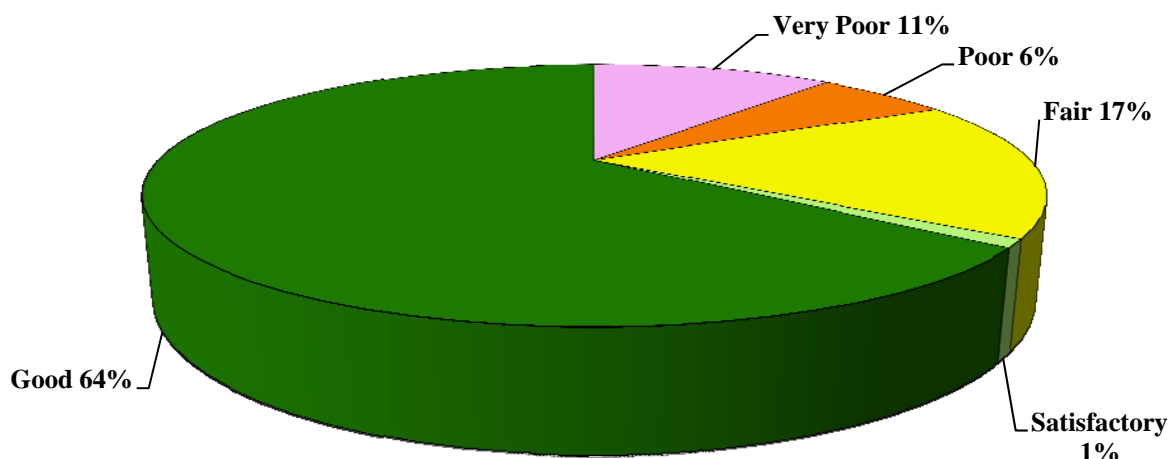
Figure 3-1: Network PCI Distribution by Rating Category

Figure 3-1 provides the PCI distribution by rating category for Bob Sikes Airport.

Condition Rating	Total Area (ft ²)	Percent
Good	1,587,770	64%
Satisfactory	13,250	1%
Fair	429,174	17%
Poor	158,135	6%
Very Poor	281,250	11%
Serious	9,550	0%
Failed	0	0%

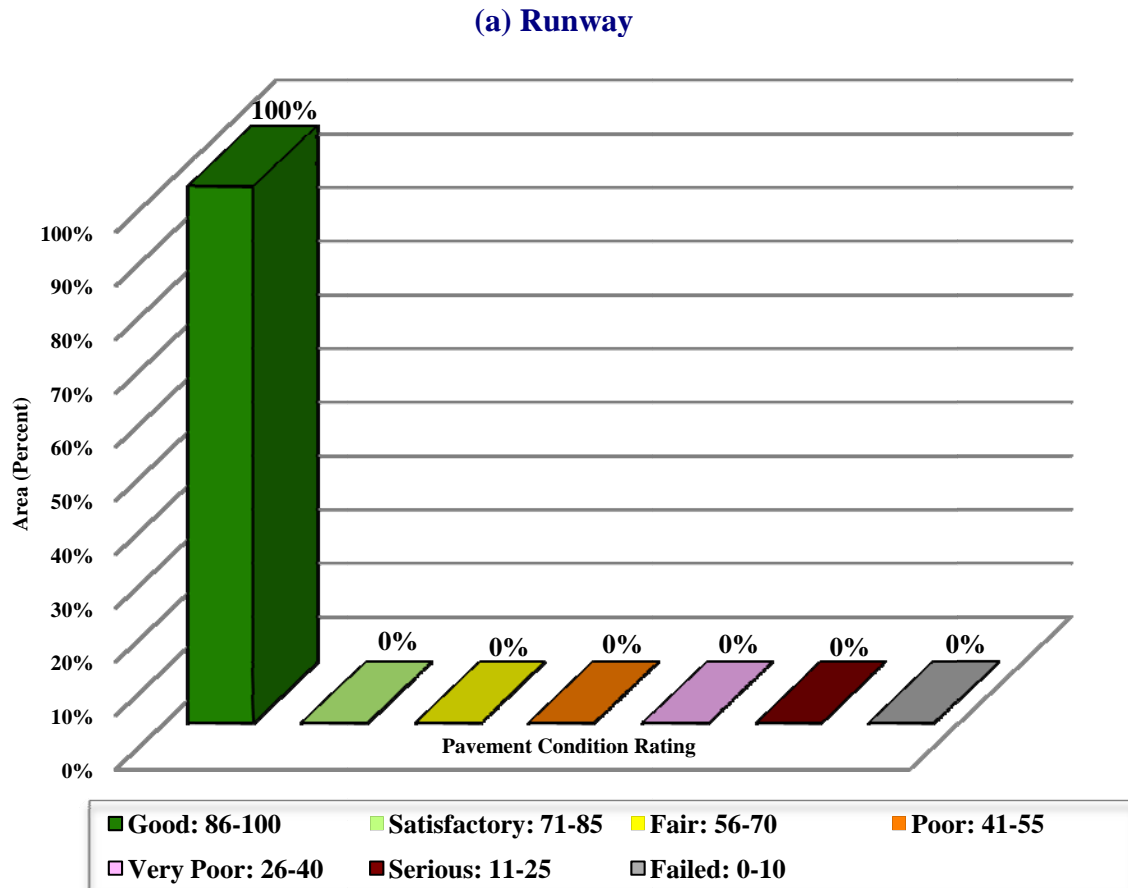
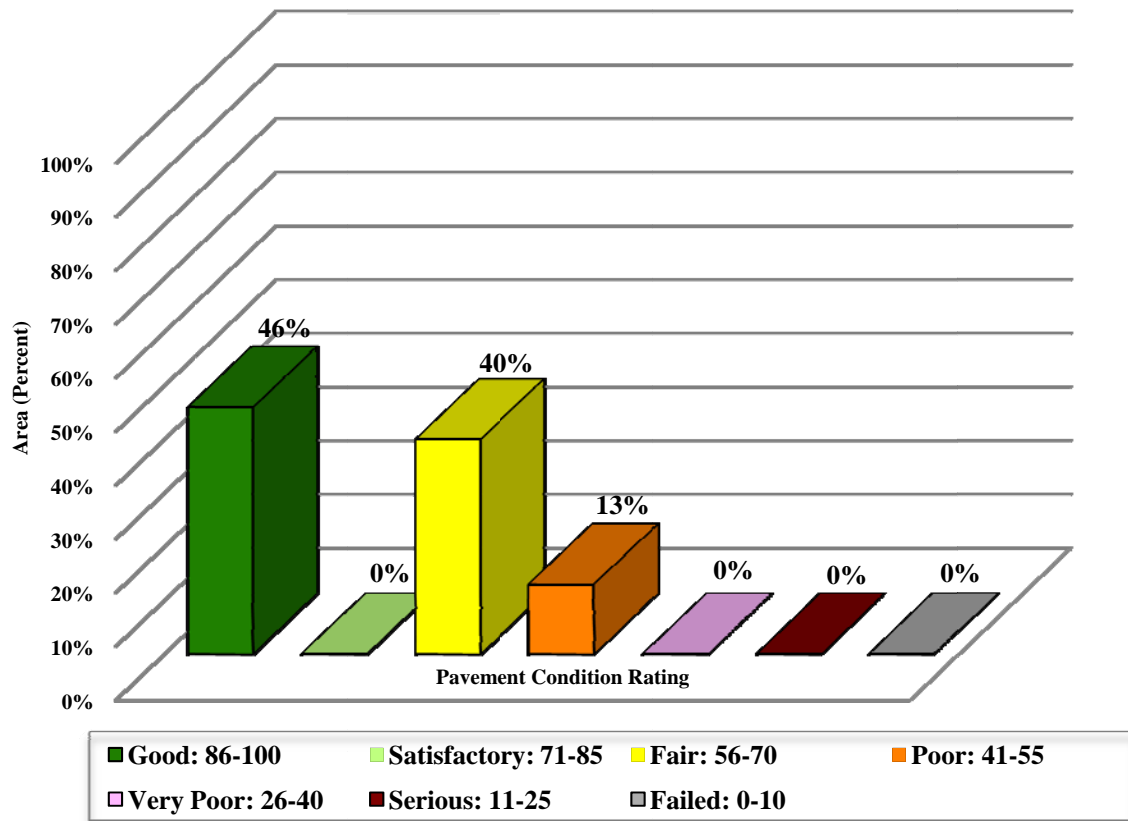
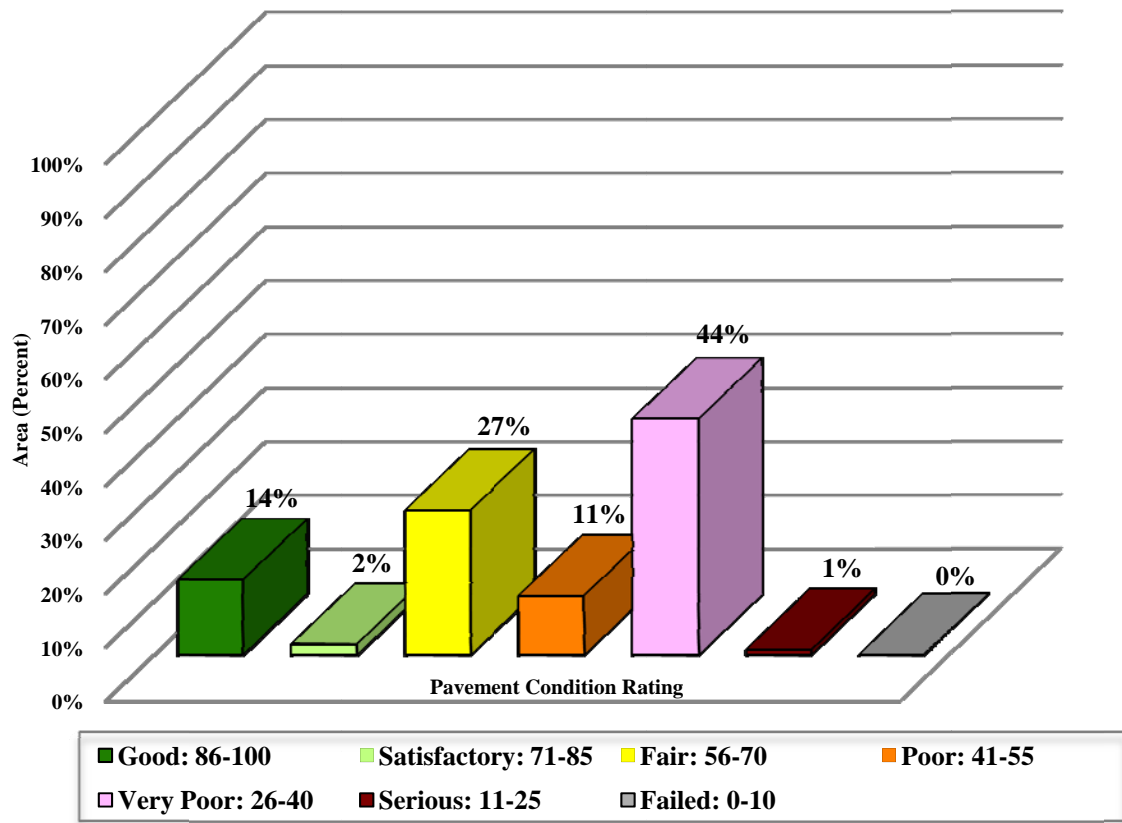
Figure 3-2: Percentage of Pavement Area within Each PCI Range by Pavement Use

Figure 3-2 presents the breakdown of PCI by range for each pavement use.

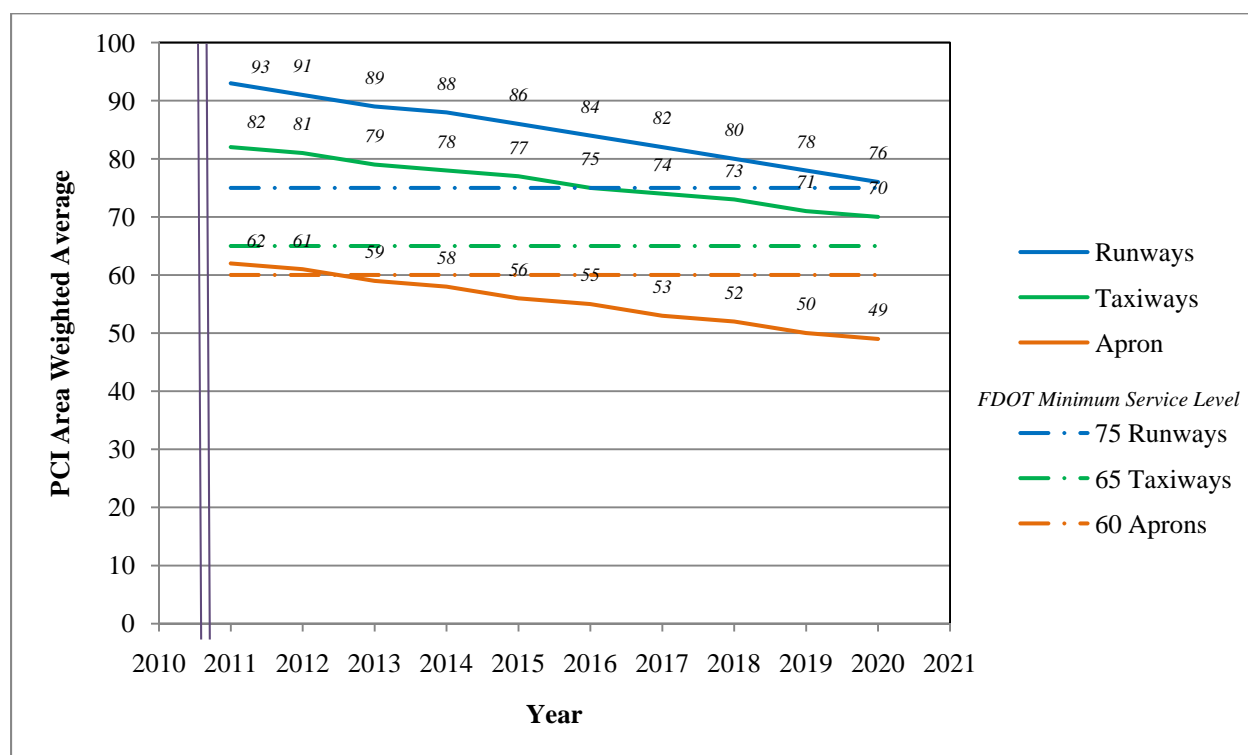
Figure 4-1: Predicted PCI by Pavement Use

Performance prediction models or deterioration curves for PCI were used to develop a condition forecast. The performance models were developed for combinations of variables such as pavement use (runway, taxiway or apron), surface type (AC or PCC) and airport category (GA, RL, or PR). Figure 4-1 illustrates the predicted performance of pavements at Bob Sikes Airport based on current condition, age since last construction and the deterioration model appropriate for the type of pavement. The figure presents the forecast for each pavement use and displays the FDOT minimum service level for General Aviation (GA) airports.

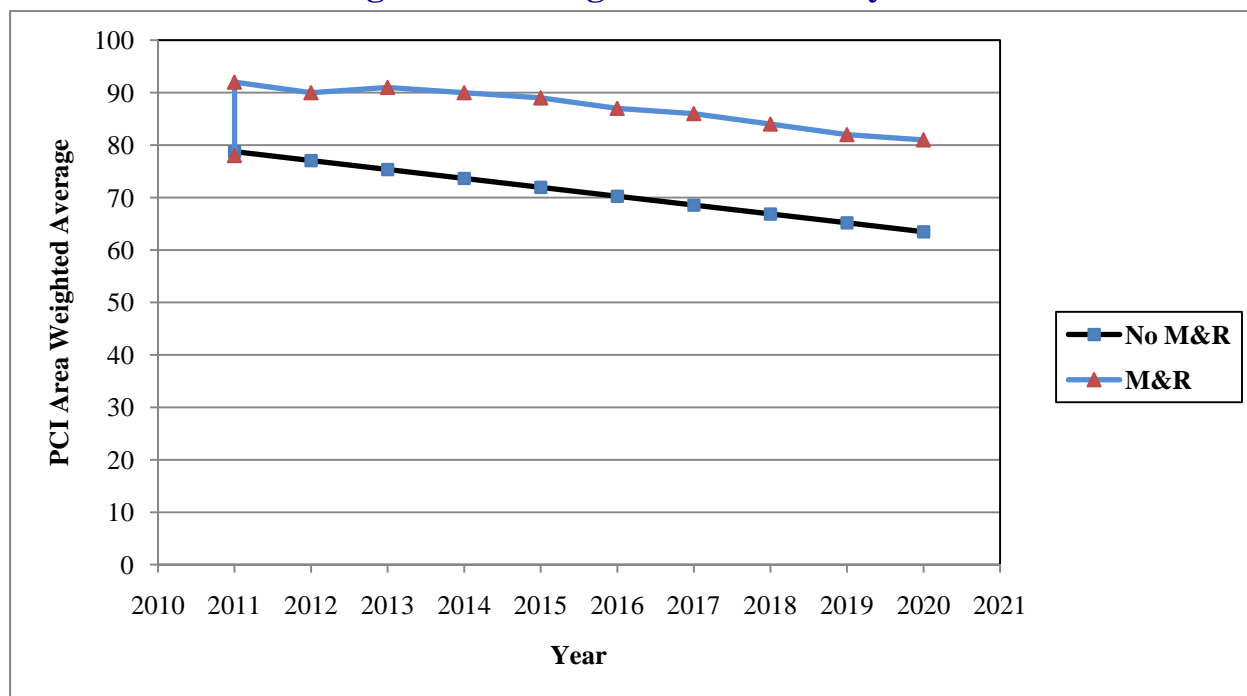
Figure 6-1: Budget Scenario Analysis

The following network level observations can be made from the figure above:

- The PCI will deteriorate from 79 in 2011 to 63 in ten years if no M&R activities are performed.
- The PCI will remain at or above 81 through the 10-year analysis period under the unlimited budget scenario. A 2020 PCI of 81 with this scenario is 18 PCI points higher than a “No M&R” scenario. The total cost for Major M&R over this 10-year period is about \$5.0 million.
