**STATE OF FLORIDA
DEPARTMENT OF TRANSPORTATION
AVIATION OFFICE**

**Statewide Airfield Pavement
Management Program**

**Clearwater Airpark– CLW
(Regional Reliever)
Clearwater, Florida
(District 7)**

January 2012

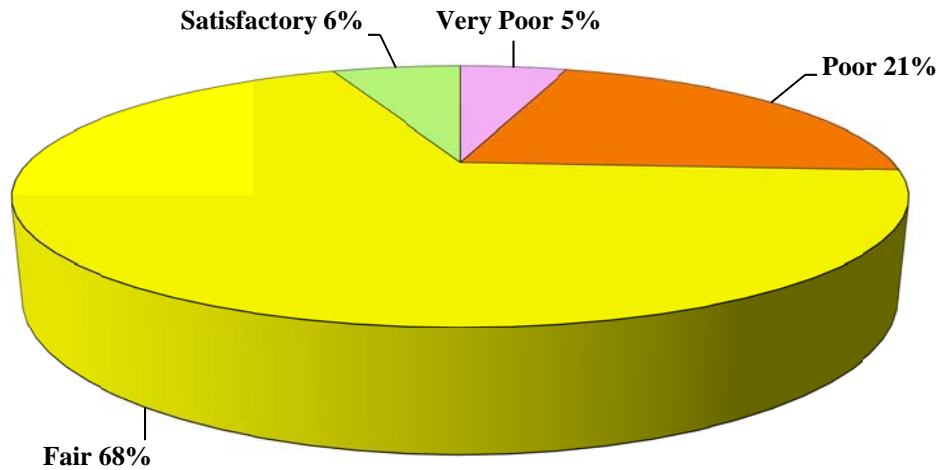
Figure 3-1: Network PCI Distribution by Rating Category

Figure 3-1 provides the PCI distribution by rating category for Clearwater Airpark.

Condition Rating	Total Area (ft ²)	Percent
Good	0	0%
Satisfactory	36,200	6%
Fair	412,479	68%
Poor	129,589	21%
Very Poor	30,031	5%
Serious	0	0%
Failed	0	0%

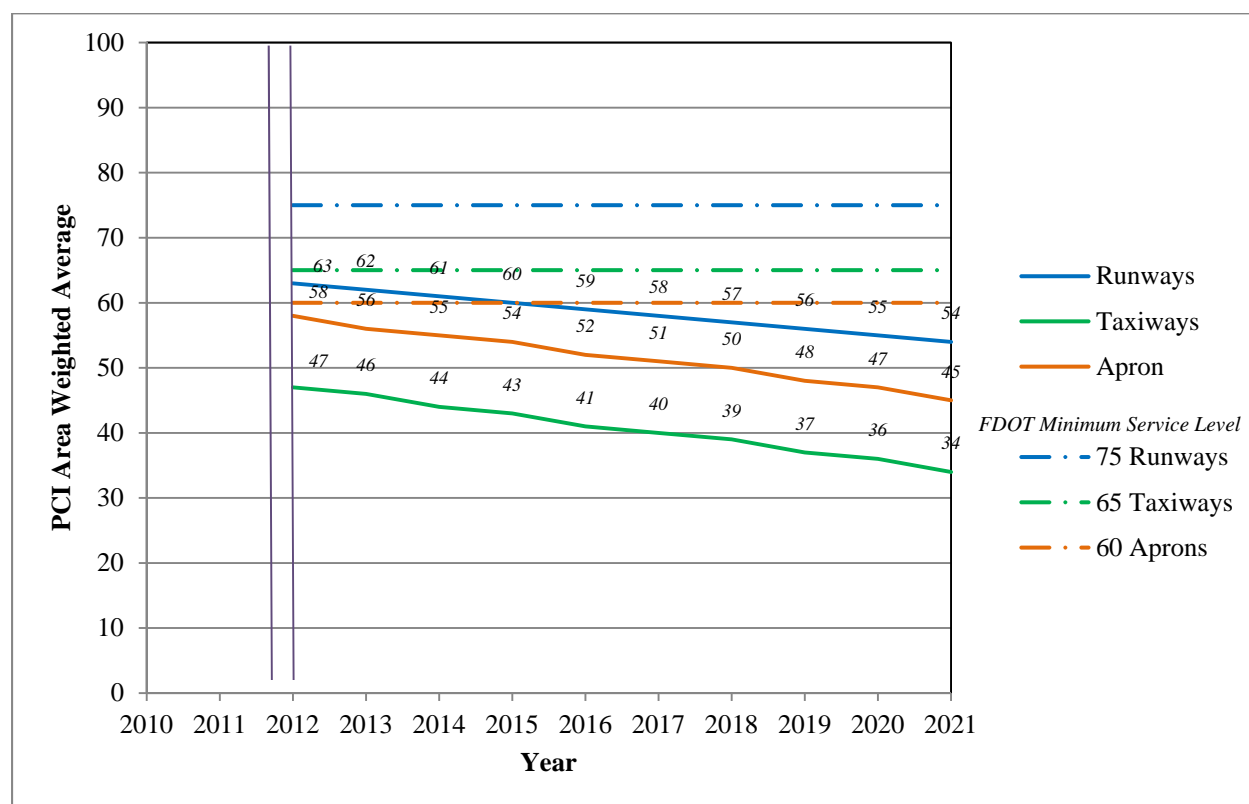
Figure 4-1: Predicted PCI by Pavement Use

Performance prediction models or deterioration curves for PCI were used to develop a condition forecast. The performance models were developed for combinations of variables such as pavement use (runway, taxiway or apron), surface type (AC or PCC) and airport category (GA, RL, or PR). Figure 4-1 illustrates the predicted performance of pavements at Clearwater Airpark based on current condition, age since last construction and the deterioration model appropriate for the type of pavement. The figure presents the forecast for each pavement use and displays the FDOT minimum service level for Regional Reliever (RL) airports.

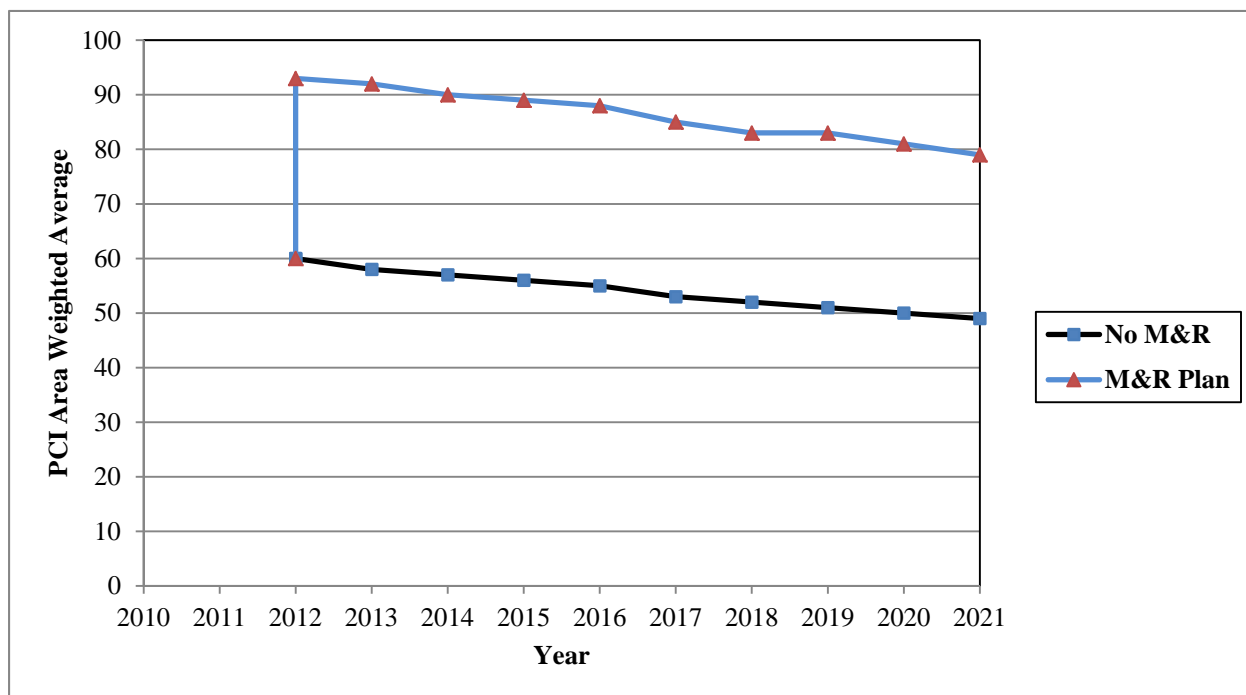
Figure 6-1: Budget Scenario Analysis

- The PCI will deteriorate from an average of 60 in 2012 to an average of 49 in ten years if no M&R activities are performed. Specific pavement sections may be closer to critical condition as identified by the immediate needs in Table IV. Estimated PCI ratings are presented in Appendix D.
- The PCI will remain at or above an average of 79 through the 10-year analysis period under the unlimited budget scenario. A 2021 PCI average of 79 with this scenario is 30 PCI points higher than a “No M&R” scenario. The total cost for Major M&R over this 10-year period is about \$2.8 million.
