**STATE OF FLORIDA
DEPARTMENT OF TRANSPORTATION
AVIATION OFFICE**

**Statewide Airfield Pavement
Management Program**

**Homestead General Aviation Airport– X51
(General Aviation)
Miami, Florida
(District 6)**

May 2012

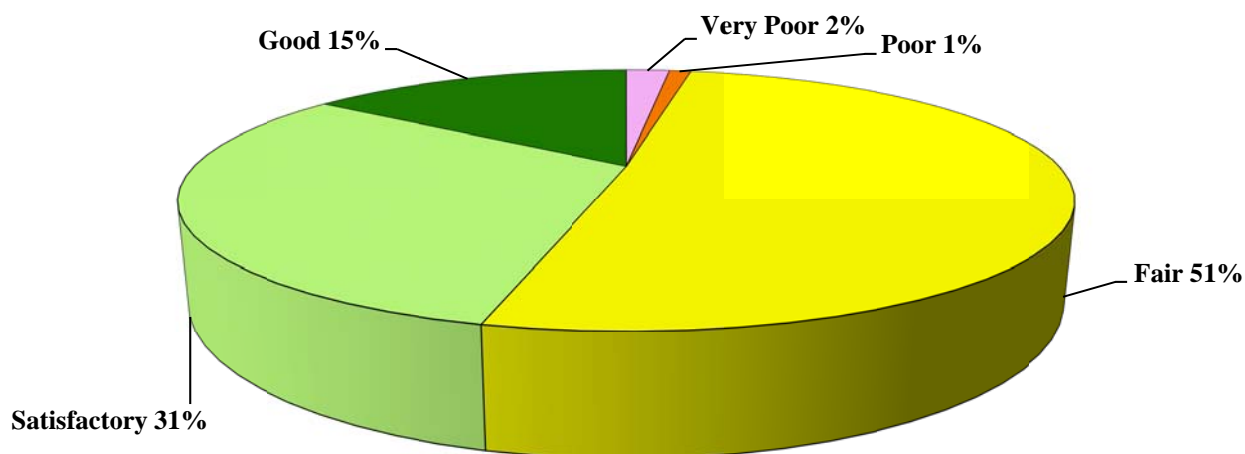
Figure 3-1: Network PCI Distribution by Rating Category

Figure 3-1 provides the PCI distribution by rating category for Homestead General Aviation Airport.

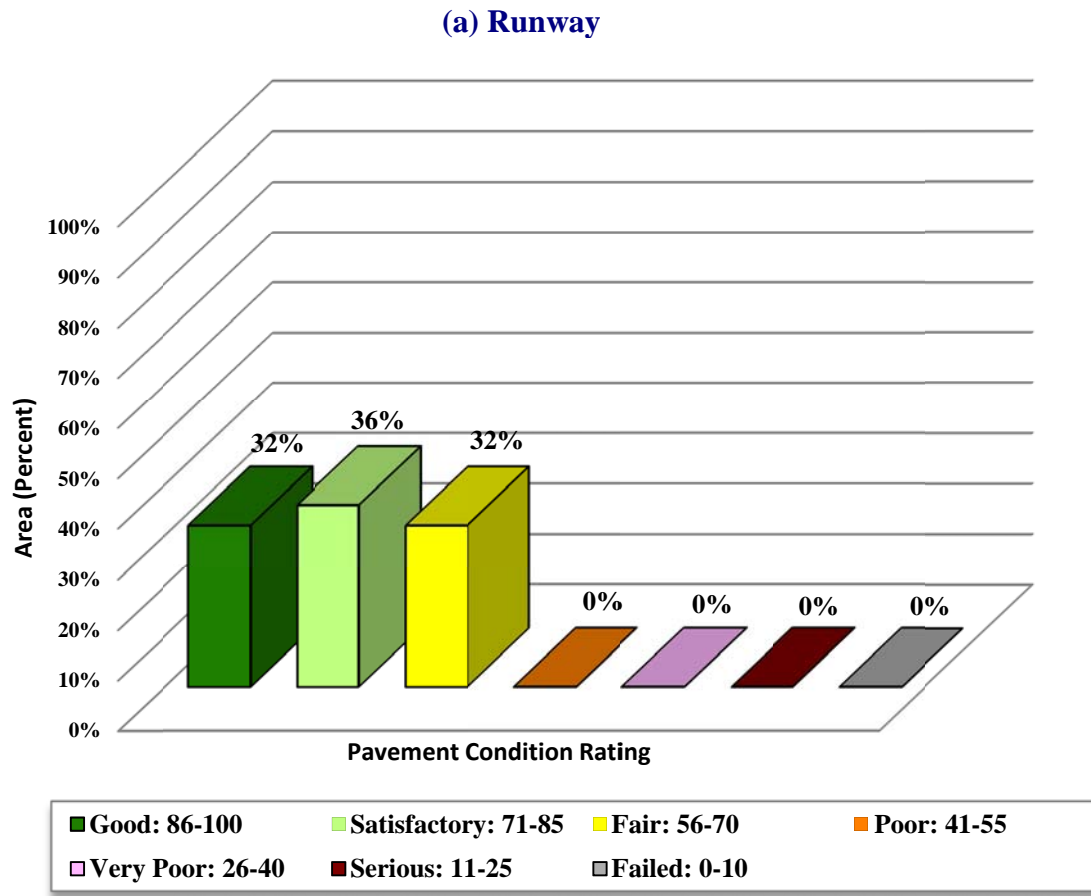
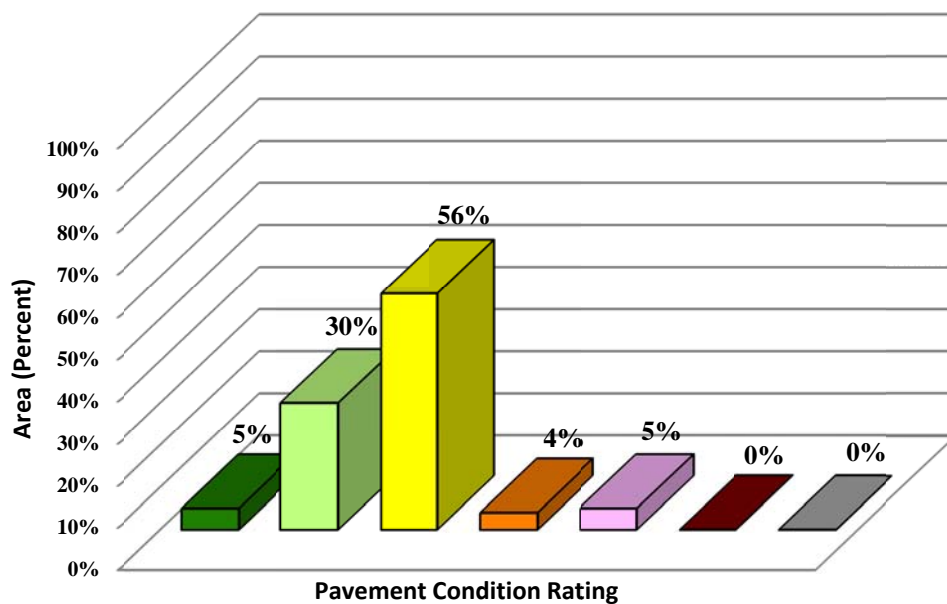
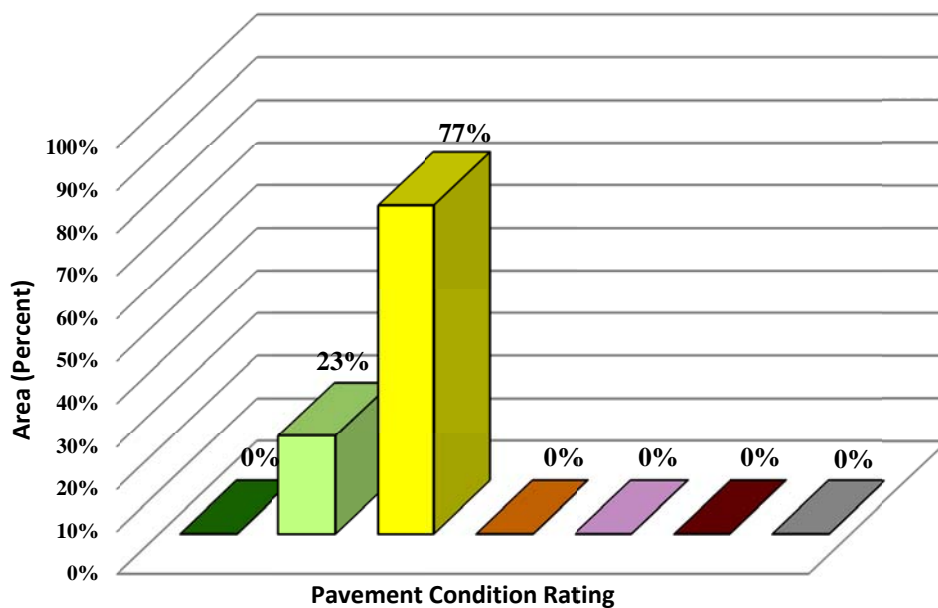
**Figure 3-2: Percentage of Pavement Area within Each
PCI Range by Pavement Use**

Figure 3-2 presents the breakdown of PCI by range for each pavement use.

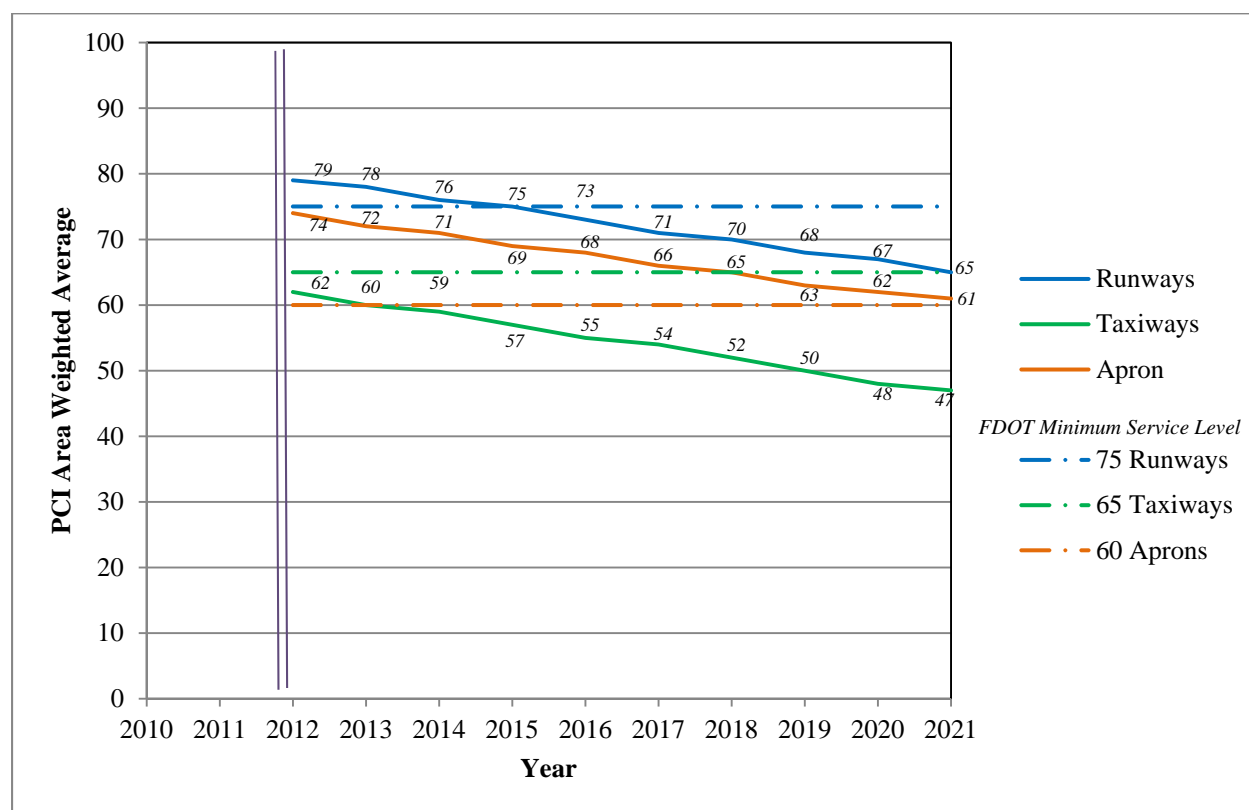
Figure 4-1: Predicted PCI by Pavement Use

Performance prediction models or deterioration curves for PCI were used to develop a condition forecast. The performance models were developed for combinations of variables such as pavement use (runway, taxiway or apron), surface type (AC or PCC) and airport category (GA, RL, or PR). Figure 4-1 illustrates the predicted performance of pavements at Homestead General Aviation Airport based on current condition, age since last construction and the deterioration model appropriate for the type of pavement. The figure presents the forecast for each pavement use and displays the FDOT minimum service level for General Aviation (GA) airports.

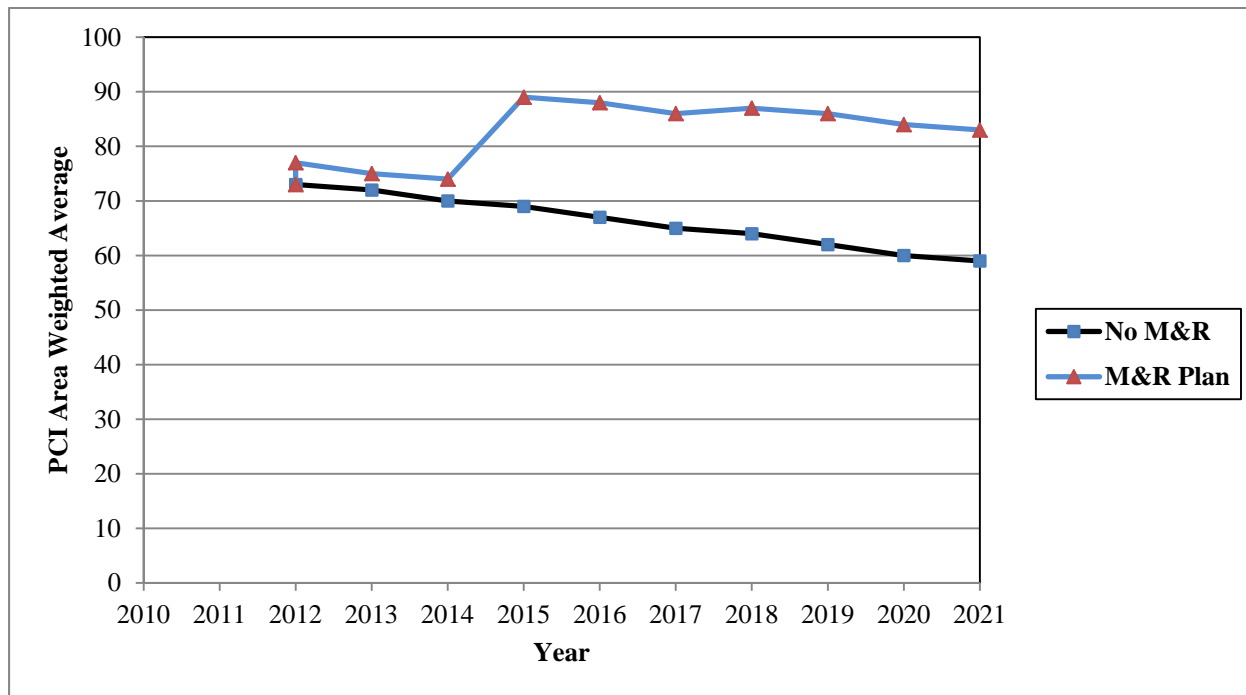
Figure 6-1: Budget Scenario Analysis

The 10 year forecast results are shown in Figure 6-1, illustrating the effect on pavement condition (PCI) of doing no maintenance versus having unlimited funds and performing all M&R actions based on the policies.

- The PCI will deteriorate from an average of 74 in 2012 to an average of 59 in ten years if no M&R activities are performed. Specific pavement sections may be closer to critical condition as identified by the immediate needs in Table IV. Estimated PCI ratings are presented in Appendix D.
- The PCI will remain at or above an average of 74 through the 10-year analysis period under the unlimited budget scenario. A 2021 PCI average of 83 with this scenario is 24 PCI points higher than a “No M&R” scenario. The total cost for Major M&R over this 10-year period is about \$2.8 million.
