**STATE OF FLORIDA
DEPARTMENT OF TRANSPORTATION
AVIATION OFFICE**

**Statewide Airfield Pavement
Management Program**

**Marianna Municipal Airport– MAI
(General Aviation)
Marianna, Florida
(District 3)**

May 2011

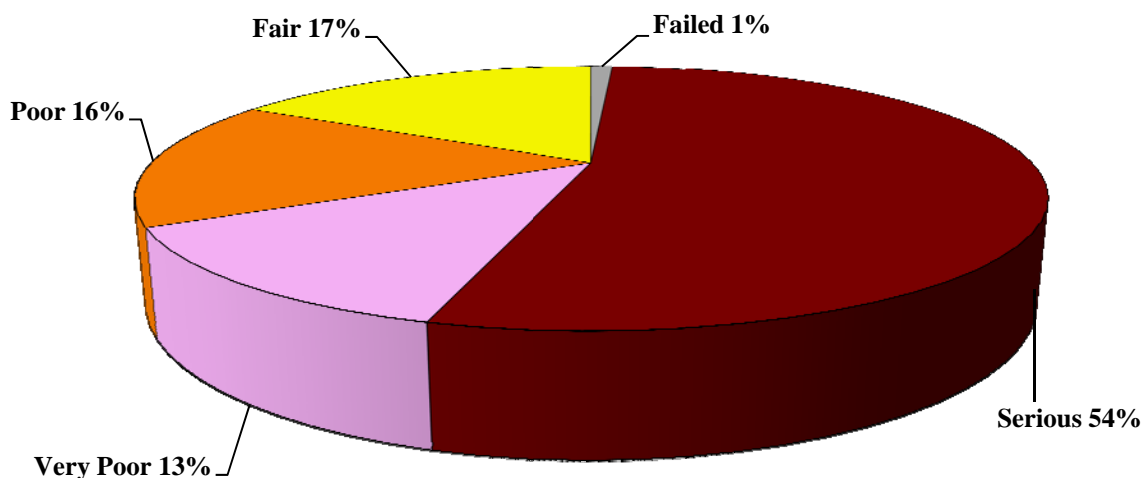
Figure 3-1: Network PCI Distribution by Rating Category

Condition Rating	Total Area (ft ²)	Percent
Good	0	0%
Satisfactory	0	0%
Fair	530,500	17%
Poor	490,000	16%
Very Poor	390,778	13%
Serious	1,647,444	54%
Failed	20,000	1%

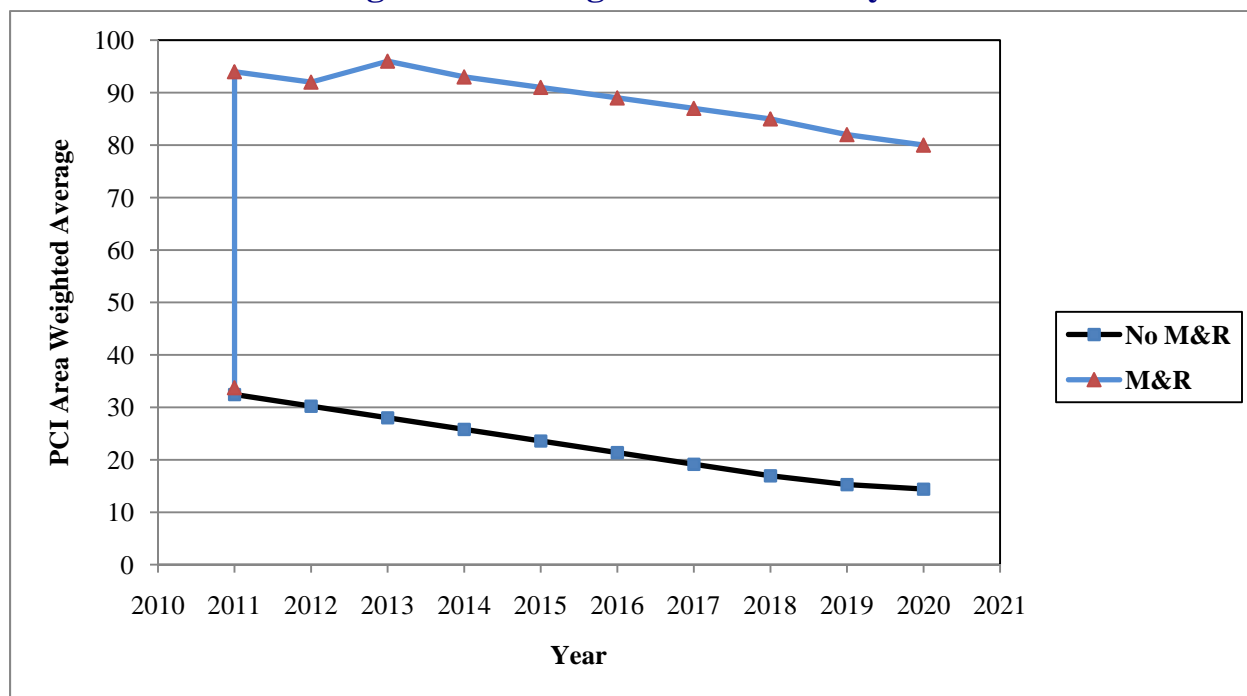
Figure 6-1: Budget Scenario Analysis

The following network level observations can be made from the figure above:

- The PCI will deteriorate from 33 in 2011 to 14 in ten years if no M&R activities are performed.
- The PCI will remain at or above 80 through the 10-year analysis period under the unlimited budget scenario. A 2020 PCI of 80 with this scenario is 66 PCI points higher than a “No M&R” scenario. The total cost for Major M&R over this 10-year period is about \$31.7 million.
