**STATE OF FLORIDA
DEPARTMENT OF TRANSPORTATION
AVIATION OFFICE**

**Statewide Airfield Pavement
Management Program**

**Marion County Airport – X35
(General Aviation)
Dunnellon, Florida
(District 5)**

May 2011

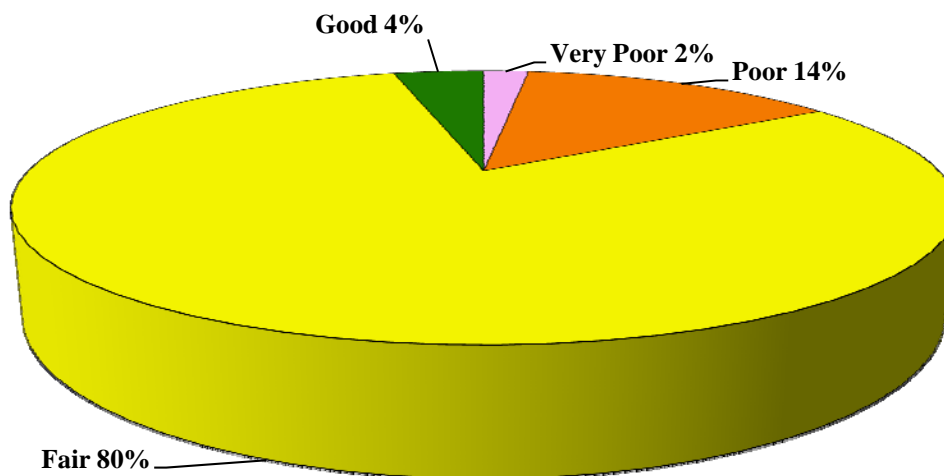
Figure 3-1: Network PCI Distribution by Rating Category

Figure 3-1 provides the PCI distribution by rating category for Marion County Airport.

Condition Rating	Total Area (ft ²)	Percent
Good	45,668	4%
Satisfactory	0	0%
Fair	956,680	80%
Poor	171,250	14%
Very Poor	16,910	2%
Serious	0	0%
Failed	0	0%

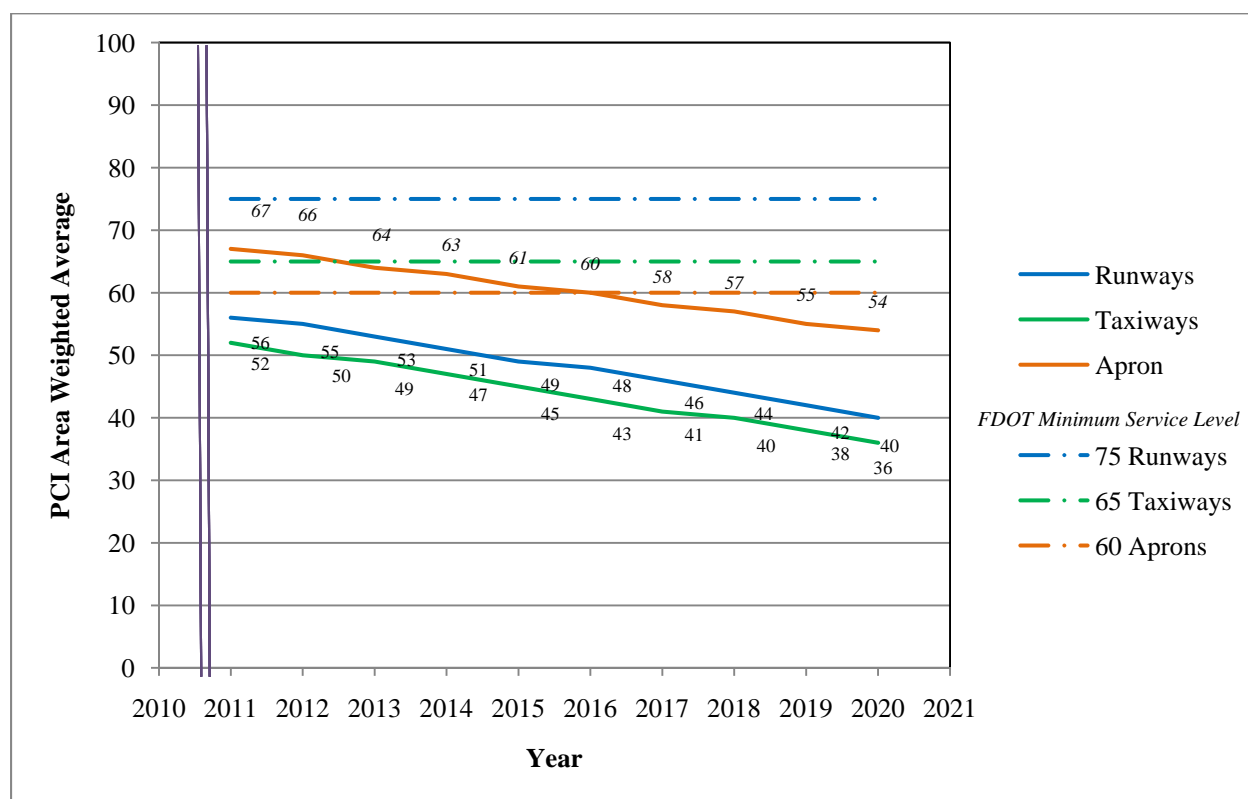
Figure 4-1: Predicted PCI by Pavement Use

Performance prediction models or deterioration curves for PCI were used to develop a condition forecast. The performance models were developed for combinations of variables such as pavement use (runway, taxiway or apron), surface type (AC or PCC) and airport category (GA, RL, or PR). Figure 4-1 illustrates the predicted performance of pavements at Marion County Airport based on current condition, age since last construction and the deterioration model appropriate for the type of pavement. The figure presents the forecast for each pavement use and displays the FDOT minimum service level for General Aviation (GA) airports.

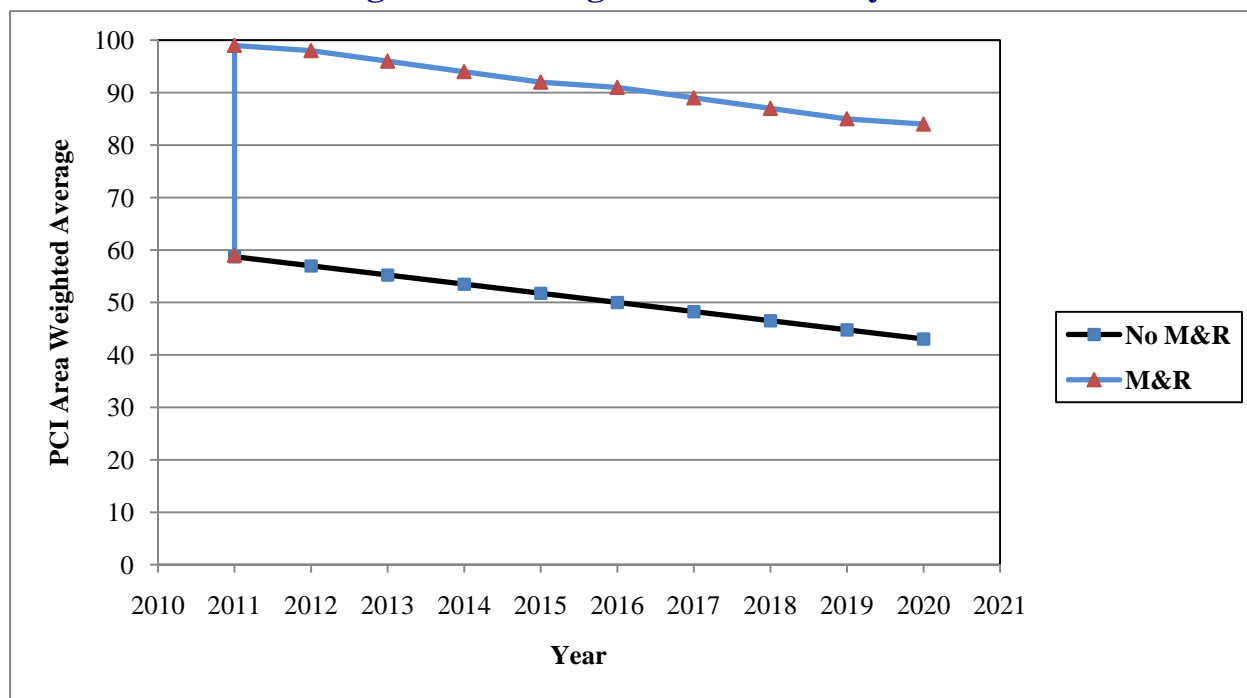
Figure 6-1: Budget Scenario Analysis

The following network level observations can be made from the figure above:

- The PCI will deteriorate from 63 in 2011 to 44 in ten years if no M&R activities are performed.
- The PCI will remain at or above 84 through the 10-year analysis period under the unlimited budget scenario. A 2020 PCI of 84 with this scenario is 40 PCI points higher than a “No M&R” scenario. The total cost for Major M&R over this 10-year period is about \$4.7 million.
