**STATE OF FLORIDA
DEPARTMENT OF TRANSPORTATION
AVIATION OFFICE**

**Statewide Airfield Pavement
Management Program**

**Merritt Island Airport– COI
(General Aviation)
Titusville, Florida
(District 5)**

May 2012

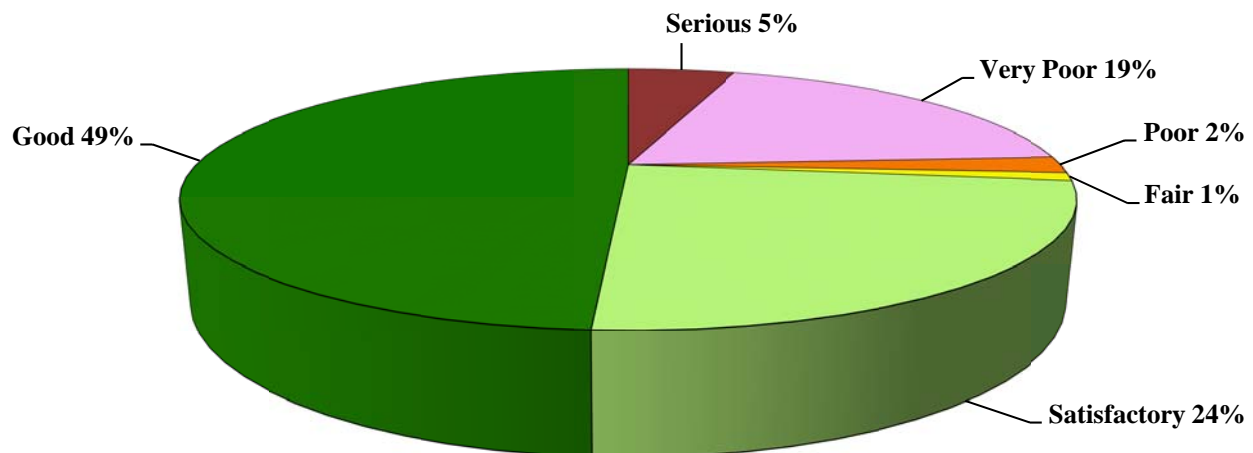
Figure 3-1: Network PCI Distribution by Rating Category

Figure 3-1 provides the PCI distribution by rating category for Merritt Island Airport.

Condition Rating	Total Area (ft²)	Percent
Good	597,253	49%
Satisfactory	280,964	24%
Fair	2,202	1%
Poor	21,455	2%
Very Poor	225,326	19%
Serious	63,200	5%
Failed	0	0%

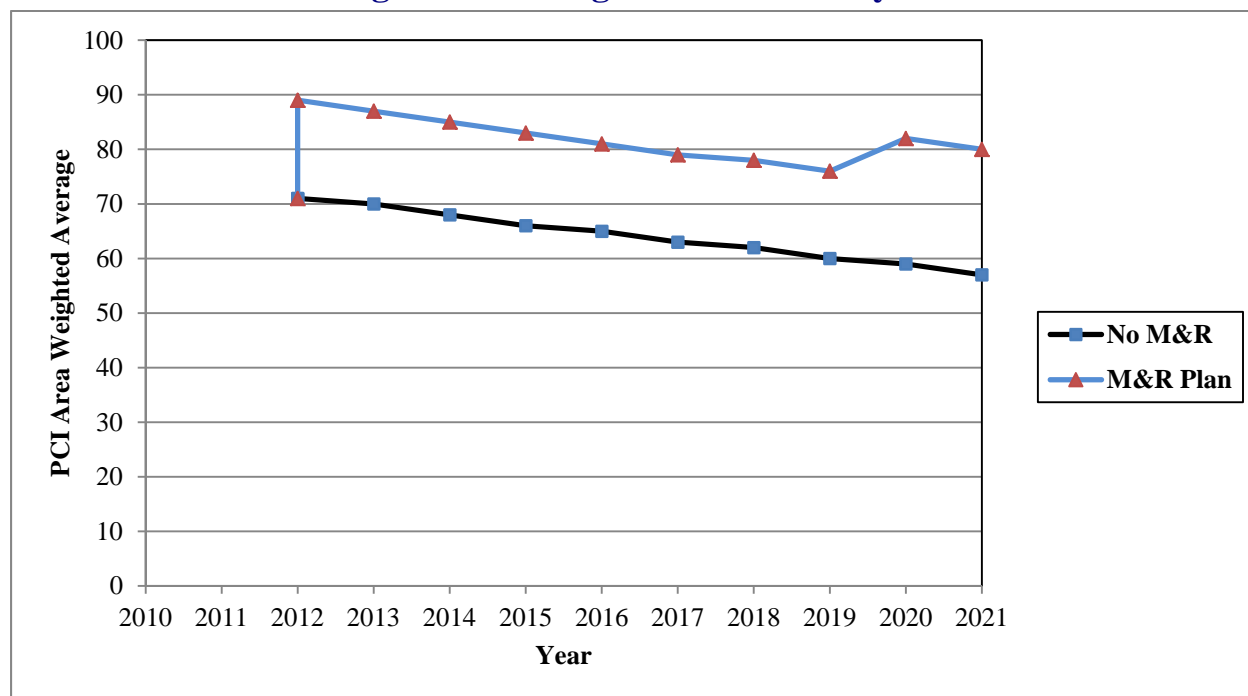
Figure 6-1: Budget Scenario Analysis

- The PCI will deteriorate from an average of 71 in 2012 to an average of 57 in ten years if no M&R activities are performed. Specific pavement sections may be closer to critical condition as identified by the immediate needs in Table IV. Estimated PCI ratings are presented in Appendix D.
- The PCI will remain at or above an average of 76 through the 10-year analysis period under the unlimited budget scenario. A 2021 PCI average of 80 with this scenario is 23 PCI points higher than a “No M&R” scenario. The total cost for Major M&R over this 10-year period is about \$4.5 million.
