STATE OF FLORIDA DEPARTMENT OF TRANSPORTATION AVIATION OFFICE

Statewide Airfield Pavement Management Program

Ormond Beach Municipal Airport- OMN
(Regional Reliever)
Ormond Beach, Florida
(District 5)

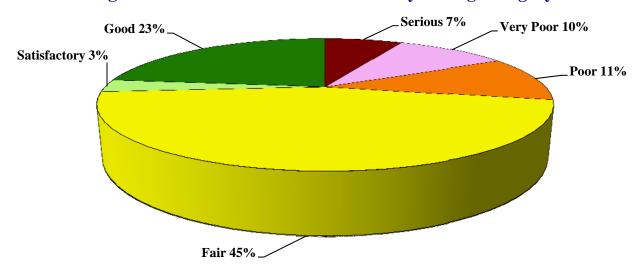
Figure 3-1: Network PCI Distribution by Rating Category

Figure 3-1 provides the PCI distribution by rating category for Ormond Beach Municipal Airport.

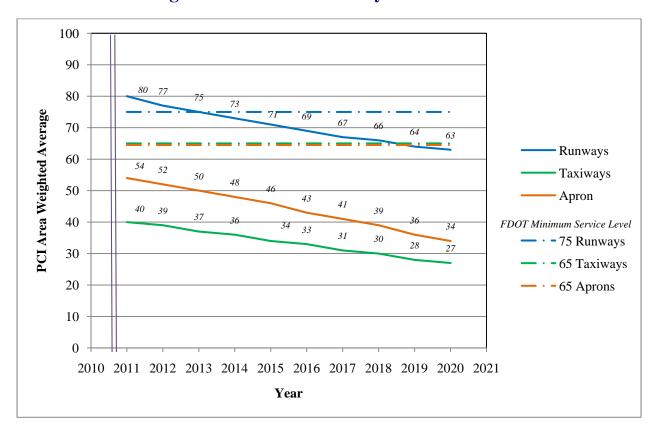
Figure 4-1: Predicted PCI by Pavement Use

Performance prediction models or deterioration curves for PCI were used to develop a condition forecast. The performance models were developed for combinations of variables such as pavement use (runway, taxiway or apron), surface type (AC or PCC) and airport category (GA, RL, or PR). Figure 4-1 illustrates the predicted performance of pavements at Ormond Beach Municipal Airport based on current condition, age since last construction and the deterioration model appropriate for the type of pavement. The figure presents the forecast for each pavement use and displays the FDOT minimum service level for Regional Reliever (RL) airports.

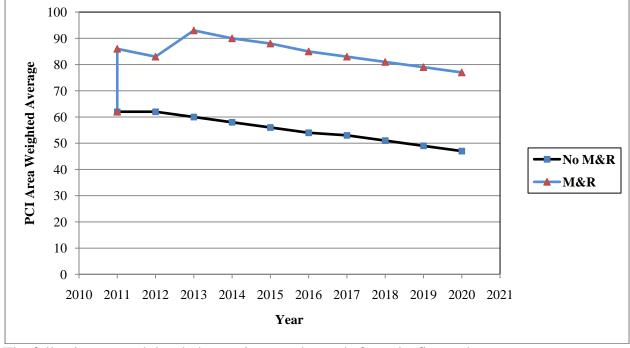
Figure 6-1: Budget Scenario Analysis

The 10 year forecast results are shown in Figure 6-1, illustrating the effect on pavement condition (PCI) of doing no maintenance versus having unlimited funds and performing all M&R actions based on the policies.
