**STATE OF FLORIDA  
DEPARTMENT OF TRANSPORTATION  
AVIATION OFFICE**

**Statewide Airfield Pavement  
Management Program**

**Perry-Foley Airport – 40J  
(General Aviation)  
Perry, Florida  
(District 2)**

**May 2011**

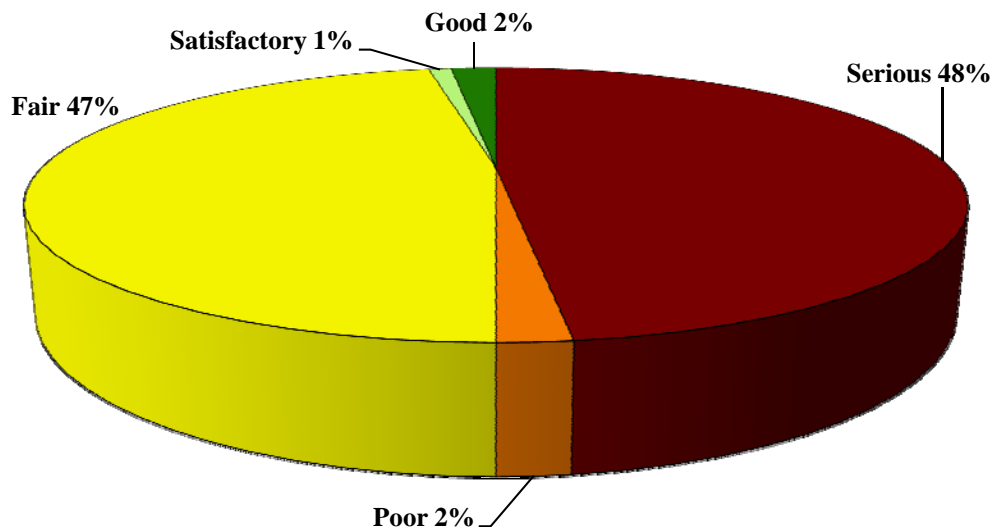
**Figure 3-1: Network PCI Distribution by Rating Category**

Figure 3-1 provides the PCI distribution by rating category for Perry-Foley Airport.

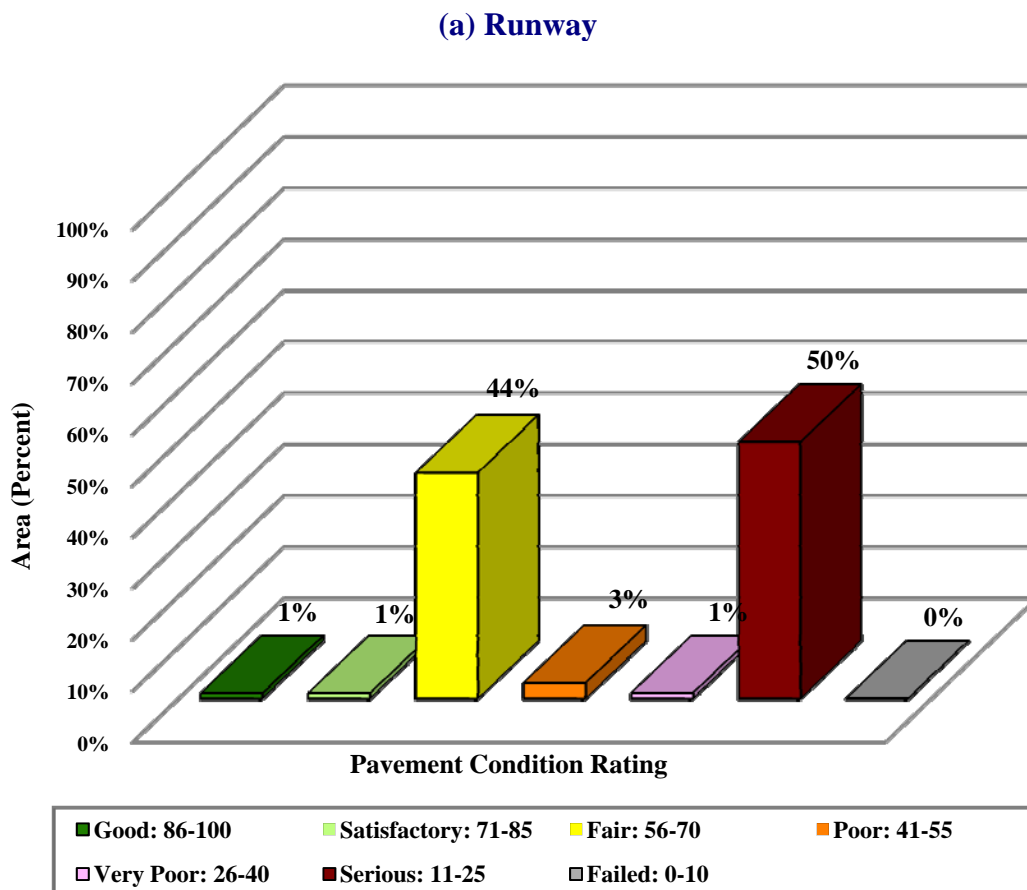
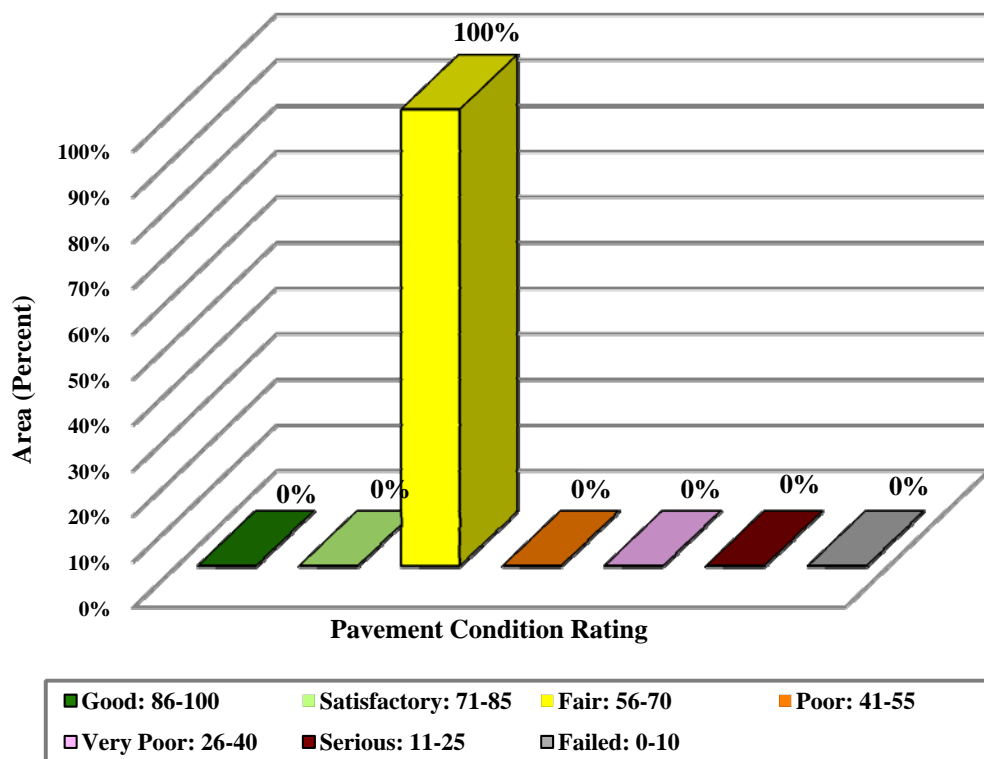
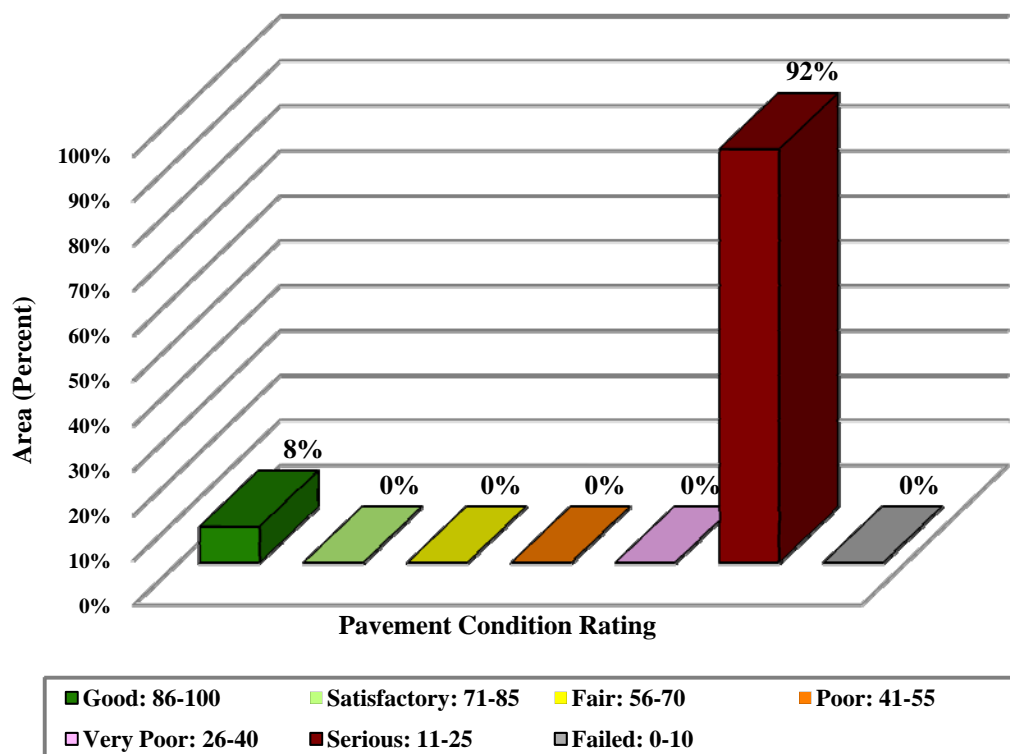
**Figure 3-2: Percentage of Pavement Area within Each PCI Range by Pavement Use**

Figure 3-2 presents the breakdown of PCI by range for each pavement use.

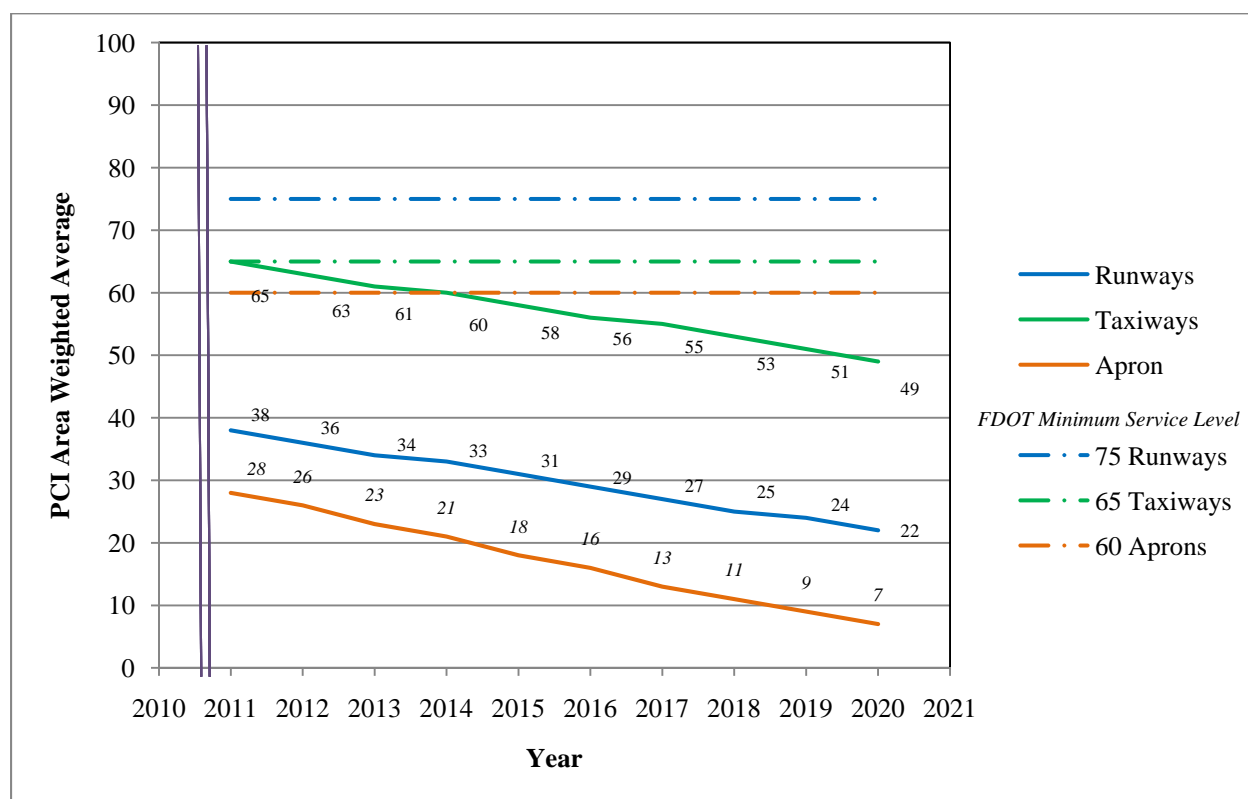
**Figure 4-1: Predicted PCI by Pavement Use**

Performance prediction models or deterioration curves for PCI were used to develop a condition forecast. The performance models were developed for combinations of variables such as pavement use (runway, taxiway or apron), surface type (AC or PCC) and airport category (GA, RL, or PR). Figure 4-1 illustrates the predicted performance of pavements at Perry-Foley Airport based on current condition, age since last construction and the deterioration model appropriate for the type of pavement. The figure presents the forecast for each pavement use and displays the FDOT minimum service level for General Aviation (GA) airports.

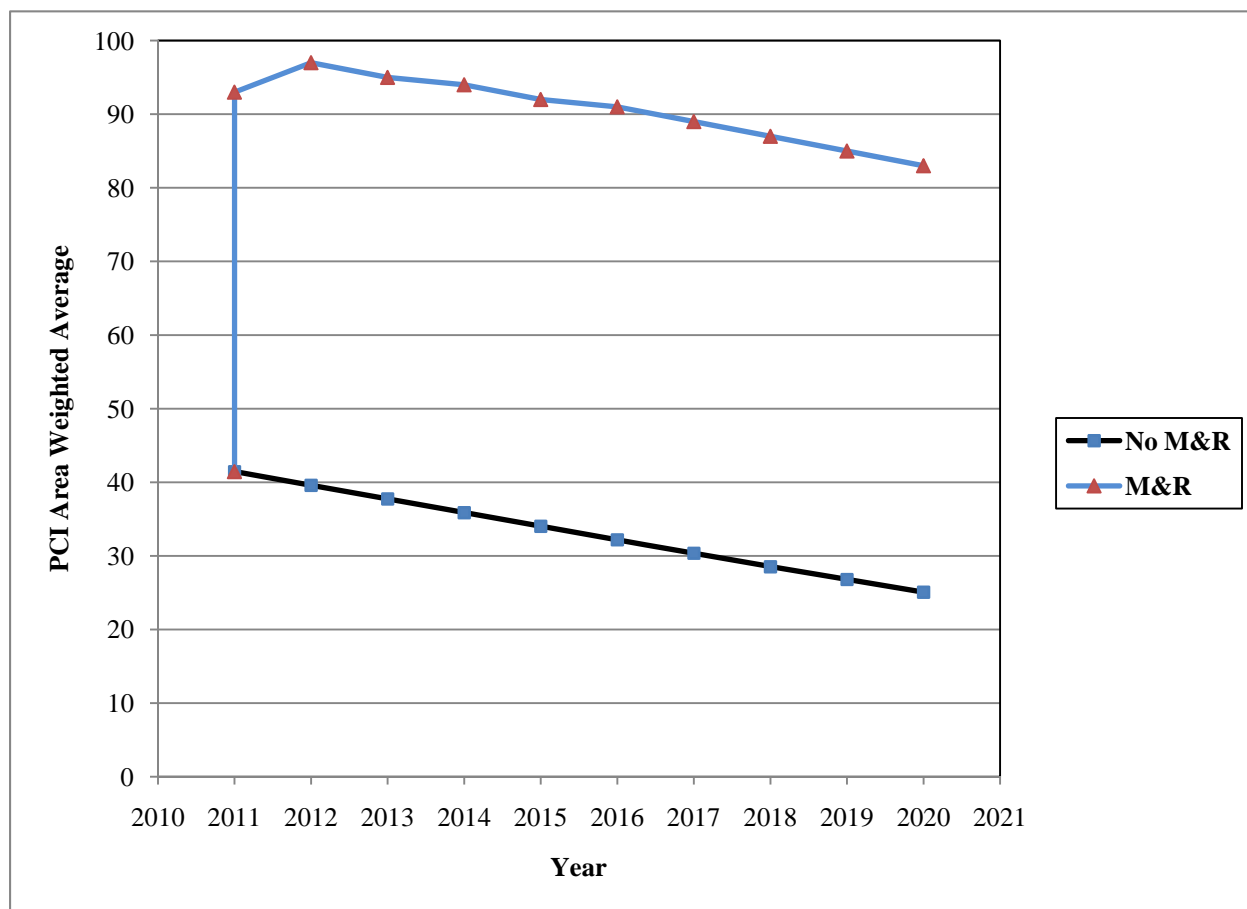
**Figure 6-1: Budget Scenario Analysis**

The following network level observations can be made from the figure above:

- The PCI will deteriorate from 44 in 2010 to 25 in ten years if no M&R activities are performed.
- The PCI will remain at or above 83 through the 10-year analysis period under the unlimited budget scenario. A 2020 PCI of 83 with this scenario is 58 PCI points higher than a “No M&R” scenario. The total cost for Major M&R over this 10-year period is about \$24.3 million.
