**STATE OF FLORIDA
DEPARTMENT OF TRANSPORTATION
AVIATION OFFICE**

**Statewide Airfield Pavement
Management Program**

**Peter Prince Field– 2R4
(General Aviation)
Milton, Florida
(District 3)**

May 2011

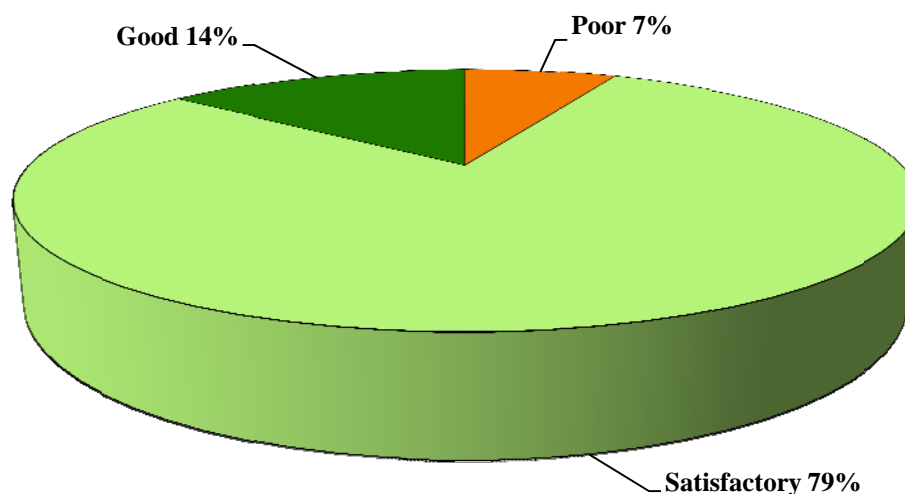
Figure 3-1: Network PCI Distribution by Rating Category

Figure 3-1 provides the PCI distribution by rating category for Peter Prince Field.

Condition Rating	Total Area (ft ²)	Percent
Good	145,560	14%
Satisfactory	824,870	79%
Fair	0	0%
Poor	73,950	7%
Very Poor	0	0%
Serious	0	0%
Failed	0	0%

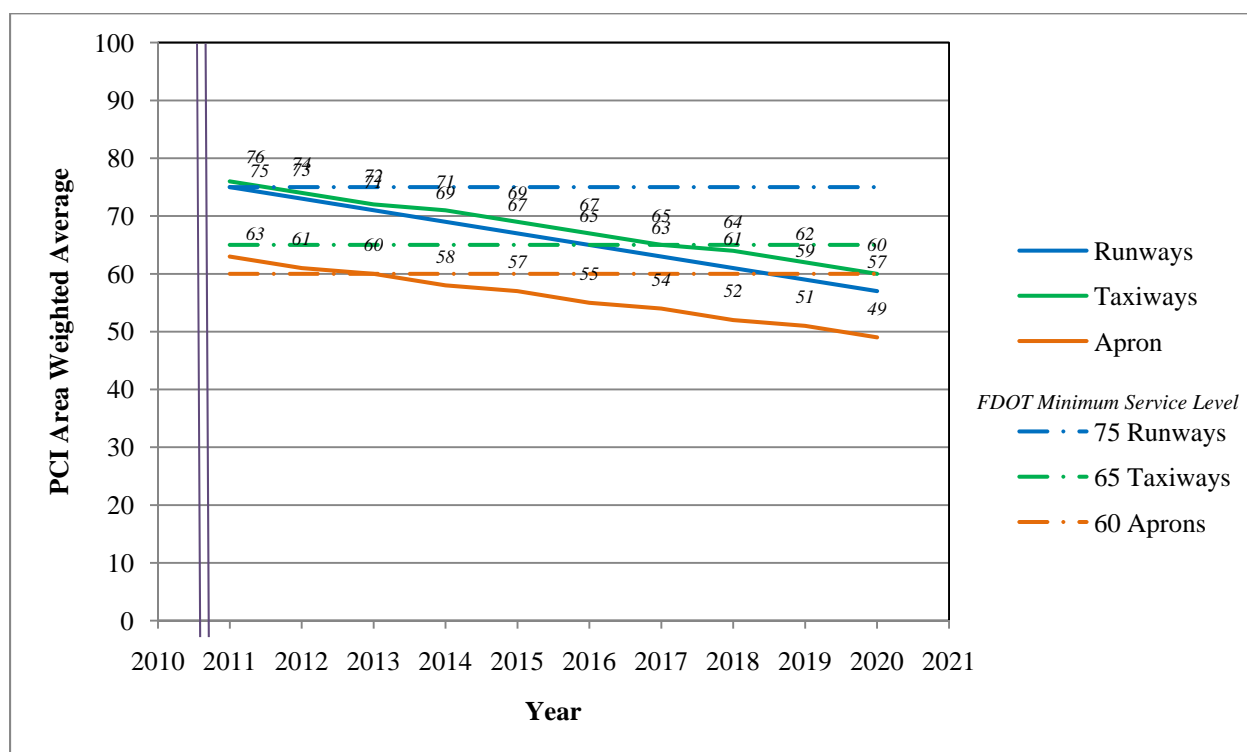
Figure 4-1: Predicted PCI by Pavement Use

Performance prediction models or deterioration curves for PCI were used to develop a condition forecast. The performance models were developed for combinations of variables such as pavement use (runway, taxiway or apron), surface type (AC or PCC) and airport category (GA, RL, or PR). Figure 4-1 illustrates the predicted performance of pavements at Peter Prince Field based on current condition, age since last construction and the deterioration model appropriate for the type of pavement. The figure presents the forecast for each pavement use and displays the FDOT minimum service level for General Aviation (GA) airports.

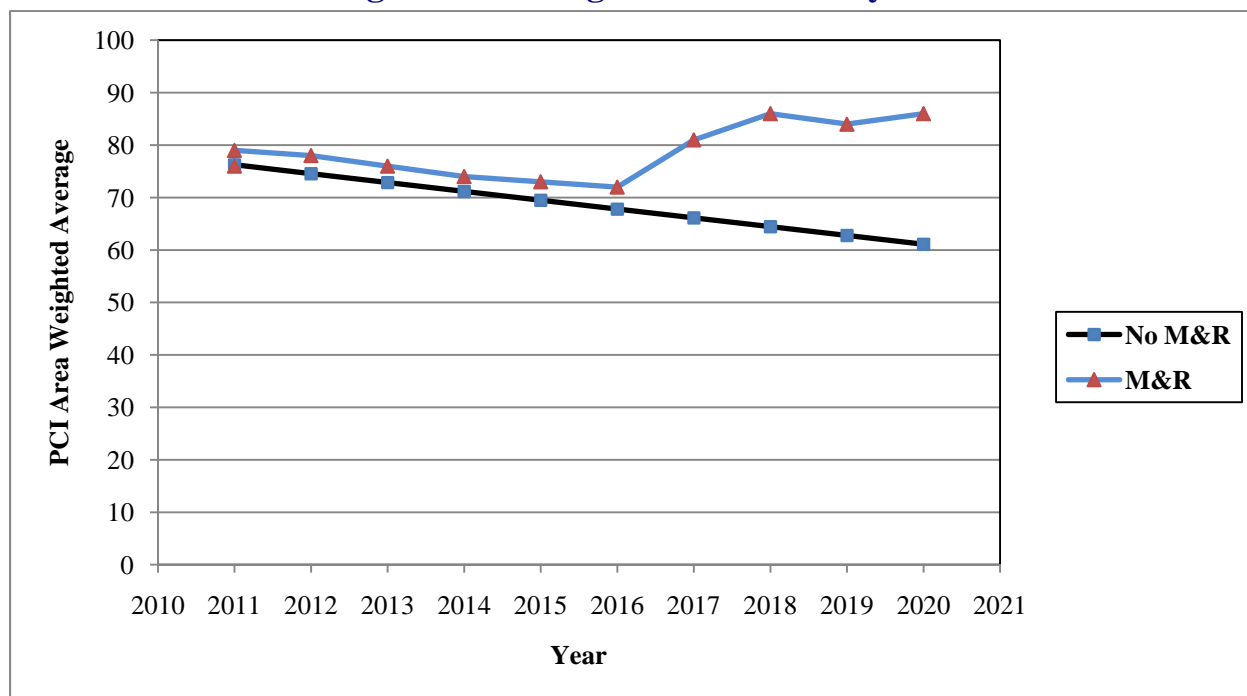
Figure 6-1: Budget Scenario Analysis

The following network level observations can be made from the figure above:

- The PCI will deteriorate from 76 in 2011 to 61 in ten years if no M&R activities are performed.
- The PCI will remain at or above 86 through the 10-year analysis period under the unlimited budget scenario. A 2020 PCI of 86 with this scenario is 25 PCI points higher than a “No M&R” scenario. The total cost for Major M&R over this 10-year period is about \$2.2 million.
