**STATE OF FLORIDA
DEPARTMENT OF TRANSPORTATION
AVIATION OFFICE**

**Statewide Airfield Pavement
Management Program**

**Sebring Regional Airport– SEF
(General Aviation)
Sebring, Florida
(District 1)**

May 2012

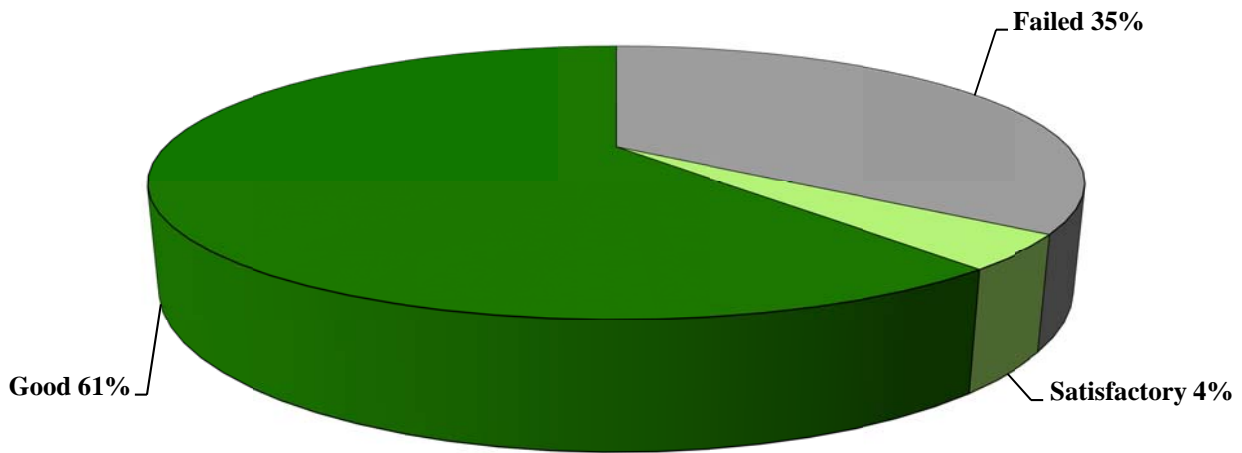
Figure 3-1: Network PCI Distribution by Rating Category

Figure 3-1 provides the PCI distribution by rating category for Sebring Regional Airport.

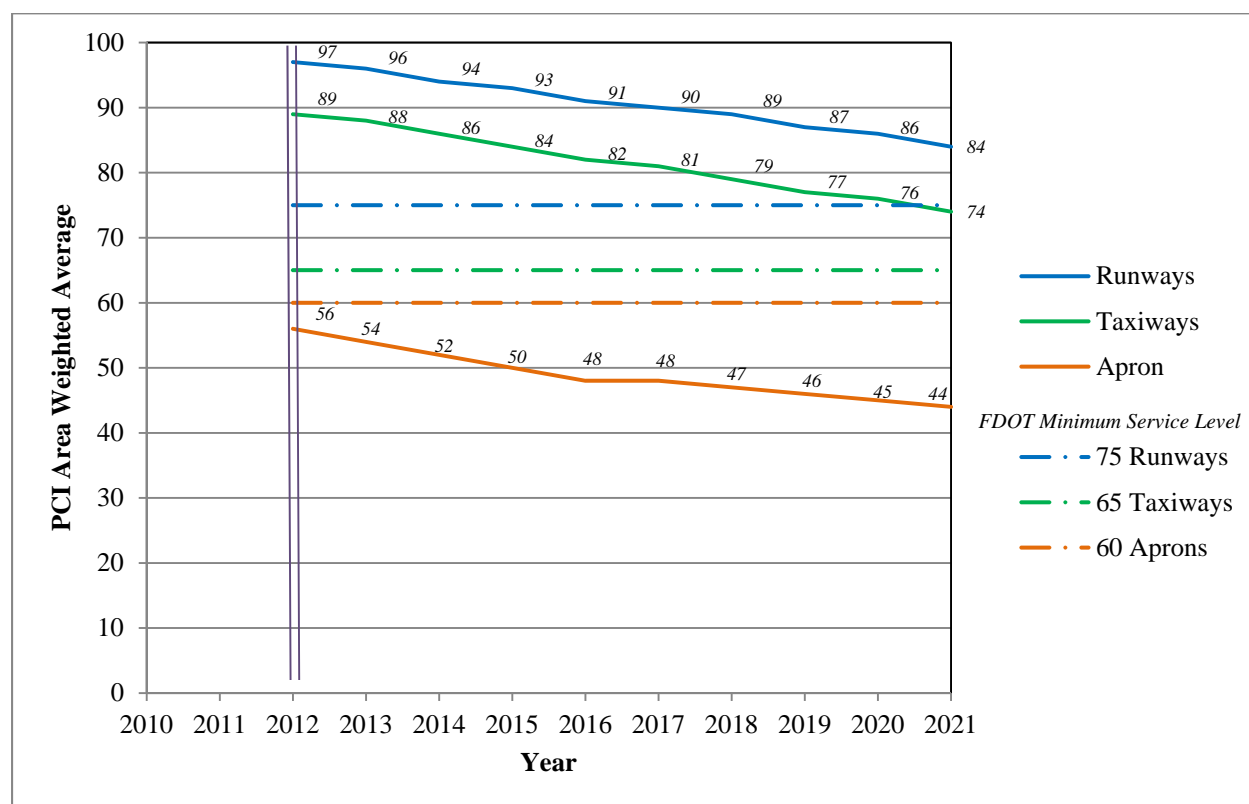
Figure 4-1: Predicted PCI by Pavement Use

Performance prediction models or deterioration curves for PCI were used to develop a condition forecast. The performance models were developed for combinations of variables such as pavement use (runway, taxiway or apron), surface type (AC or PCC) and airport category (GA, RL, or PR). Figure 4-1 illustrates the predicted performance of pavements at Sebring Regional Airport based on current condition, age since last construction and the deterioration model appropriate for the type of pavement. The figure presents the forecast for each pavement use and displays the FDOT minimum service level for General Aviation (GA) airports.

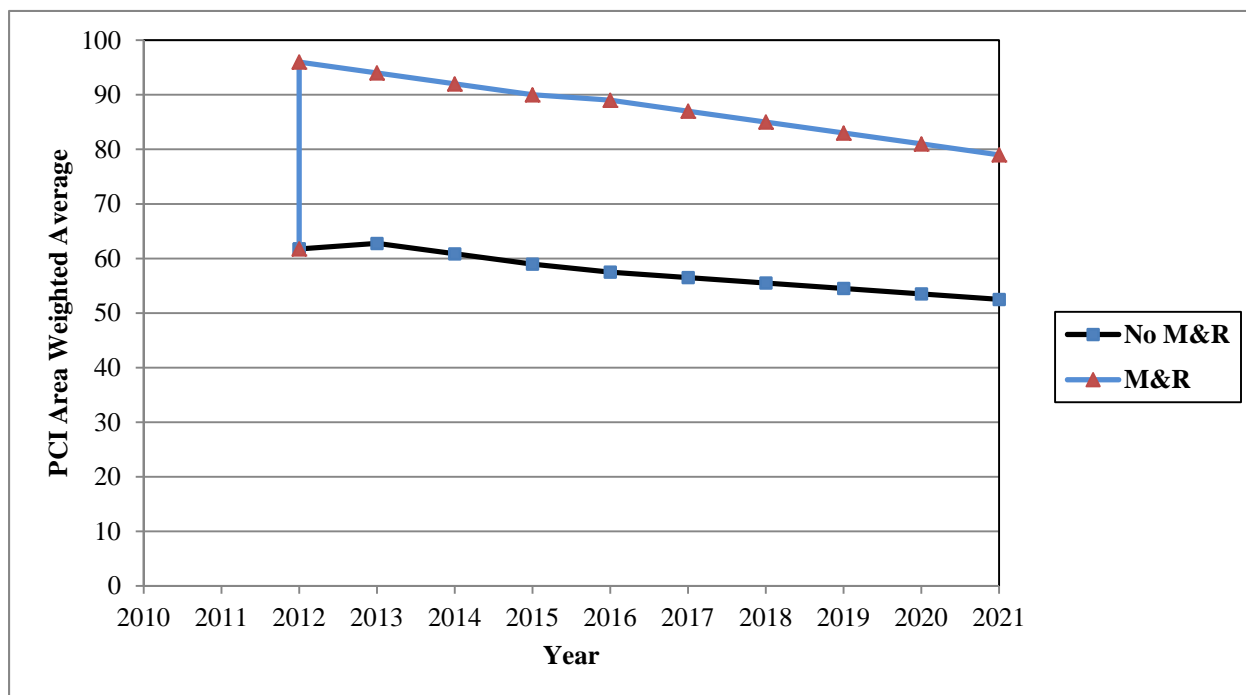
Figure 6-1: Budget Scenario Analysis

The following network level observations can be made from the figure above:

- The PCI will deteriorate from an average of 65 in 2012 to an average of 53 in ten years if no M&R activities are performed. Specific pavement sections may be closer to critical condition as identified by the immediate needs in Table IV. Estimated PCI ratings are presented in Appendix D.
- The PCI will remain at or above an average of 79 through the 10-year analysis period under the unlimited budget scenario. A 2021 PCI average of 79 with this scenario is 26 PCI points higher than a “No M&R” scenario. The total cost for Major M&R over this 10-year period is about \$13.1 million.

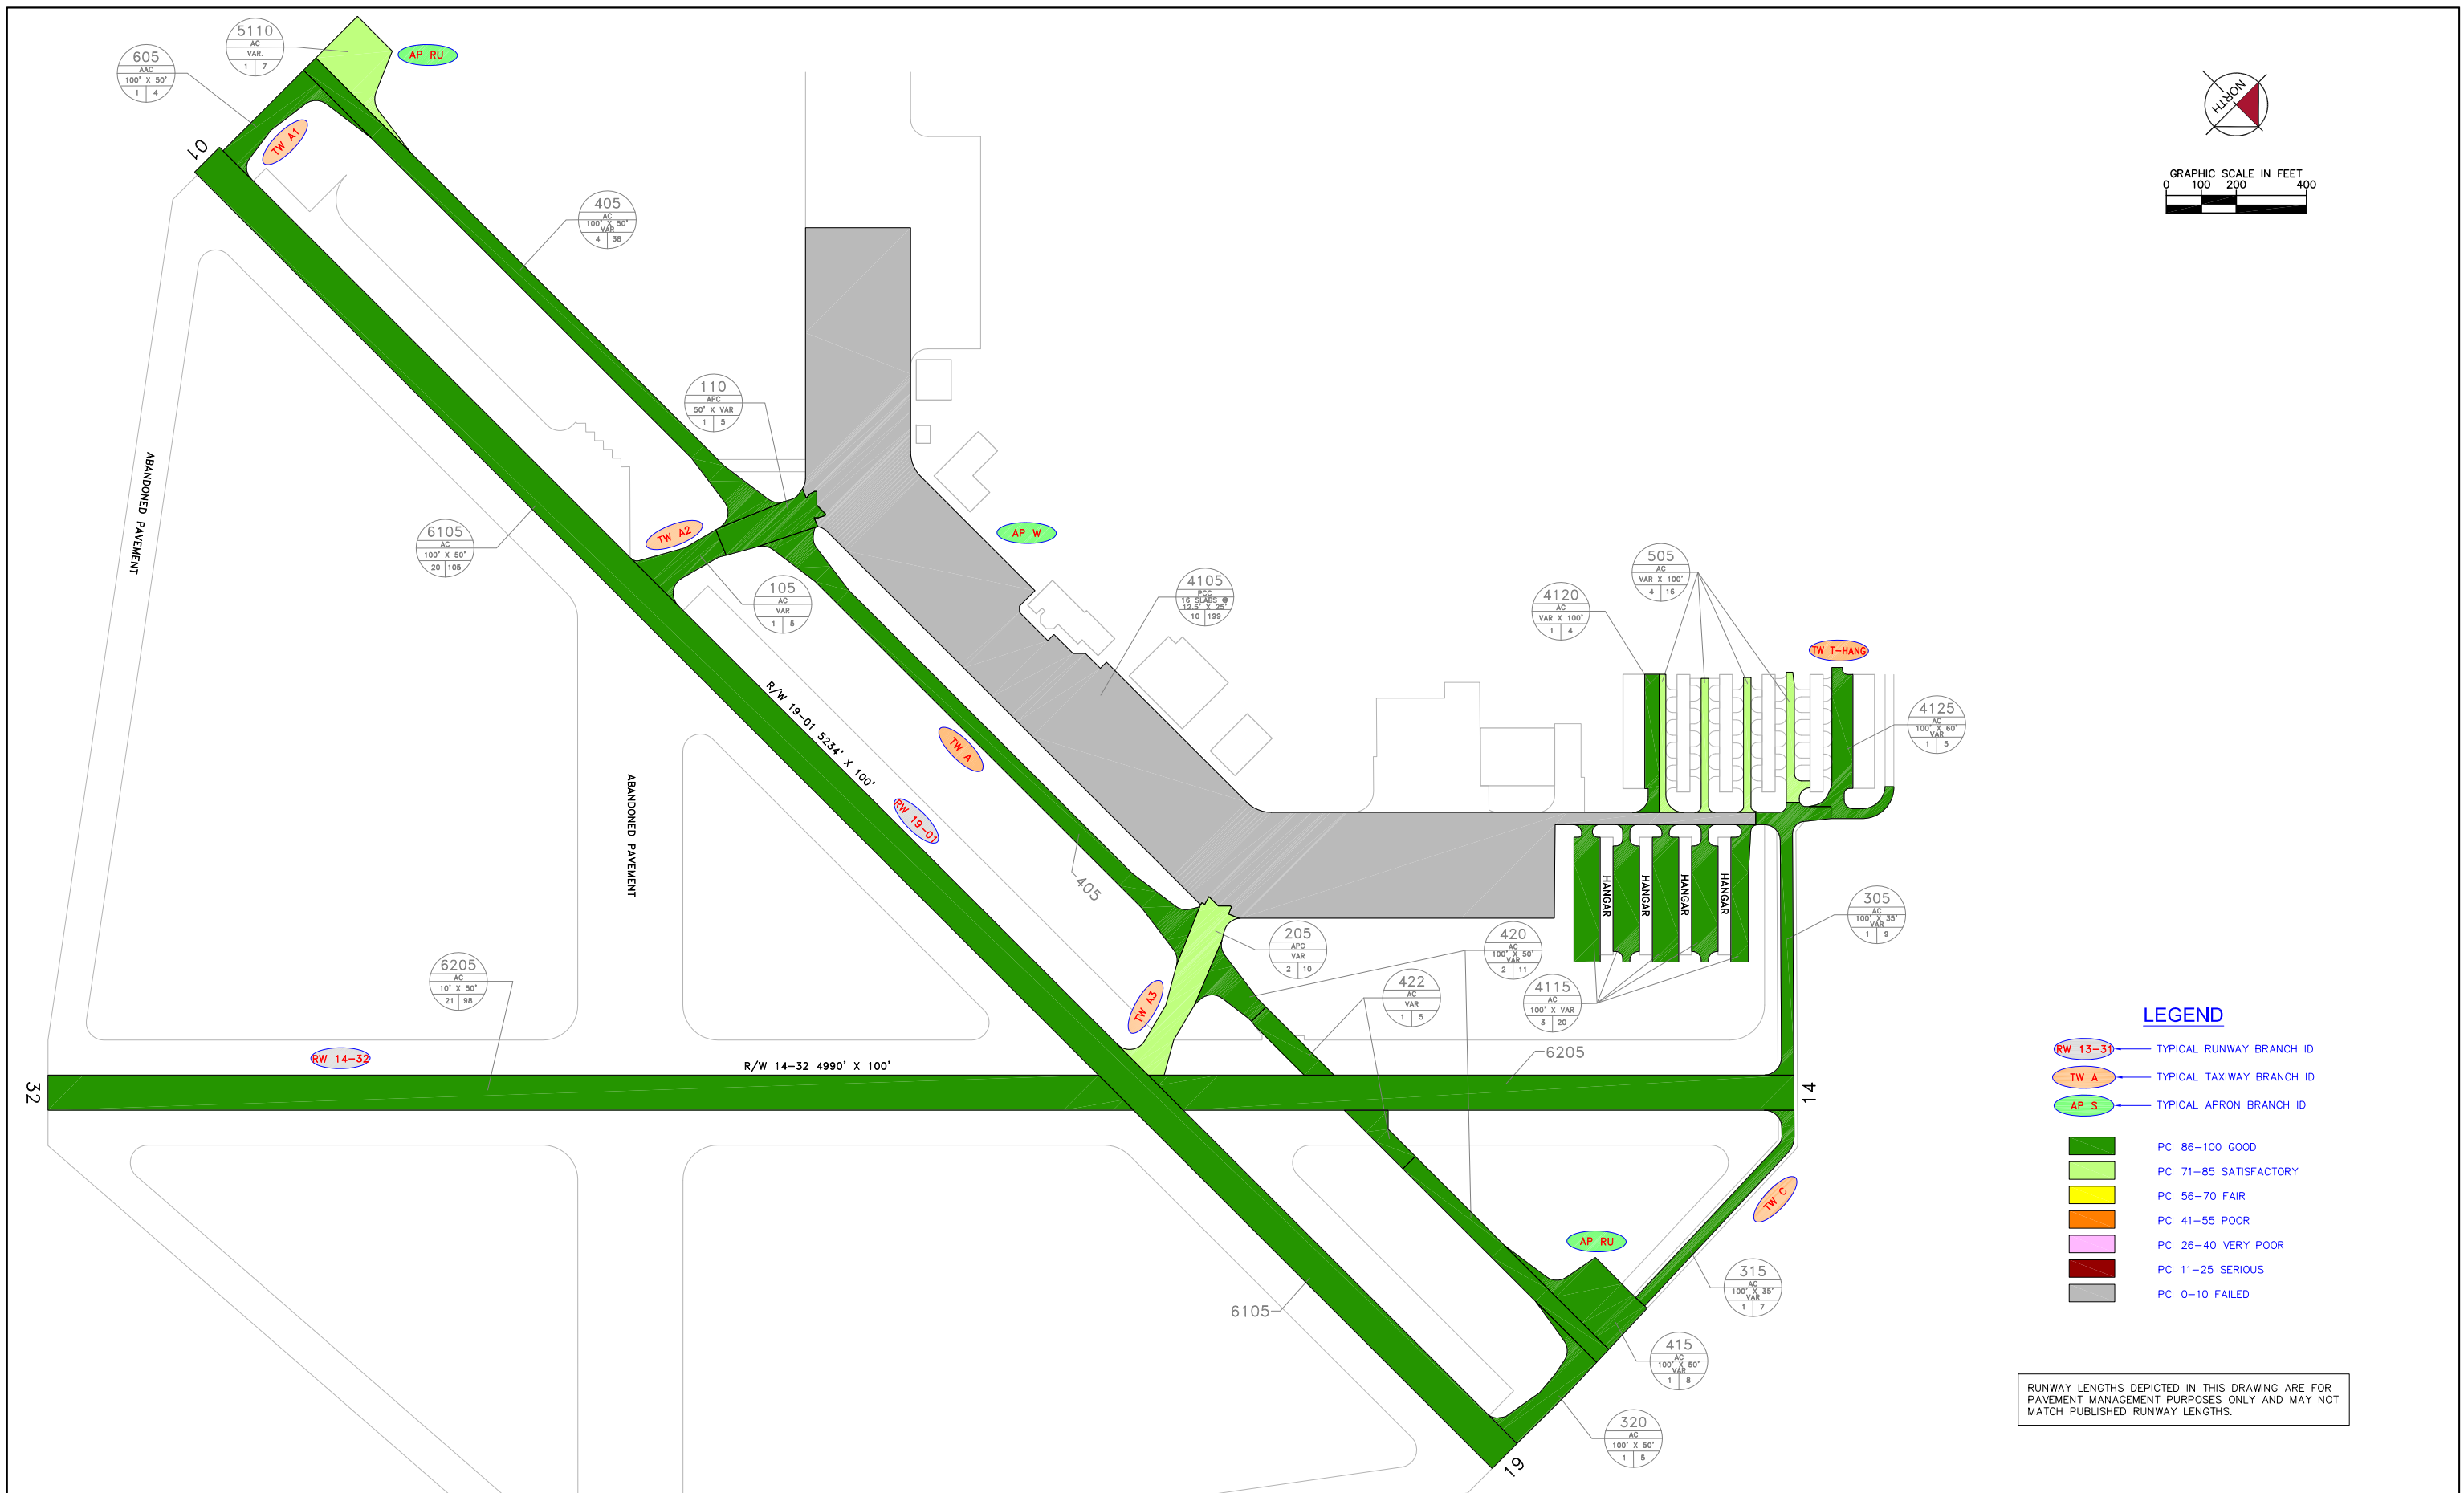
2012 CONDITION MAP PAVEMENT CONDITION INDEX TABLE

During February 2012, the PCI survey was performed at Sebring Regional Airport. The results of the survey indicate that, based on a numerical scale of 0 to 100, the overall area-weighted average PCI of the airfield pavements in 2012 is 65, representing a Fair overall network condition.
