STATE OF FLORIDA DEPARTMENT OF TRANSPORTATION AVIATION OFFICE

Statewide Airfield Pavement Management Program

Suwannee County Airport – 24J (General Aviation) Live Oak, Florida (District 2)

May 2011

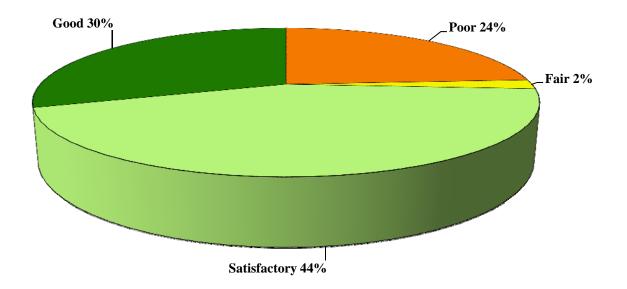
Figure 3-1: Network PCI Distribution by Rating Category

Figure 3-1 provides the PCI distribution by rating category for Suwannee County Airport.

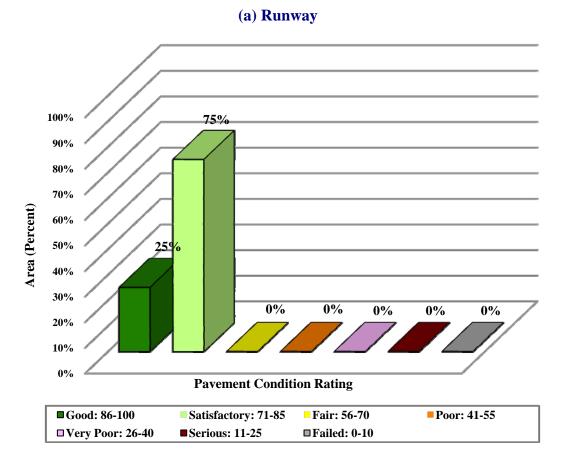
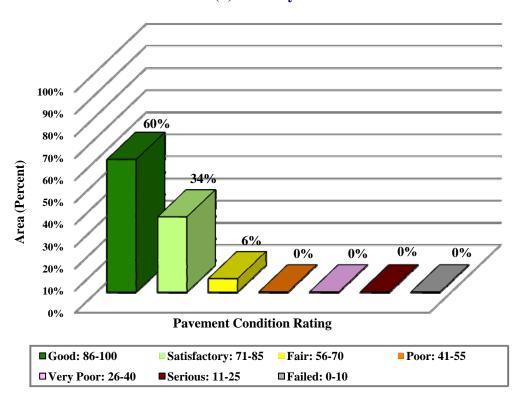
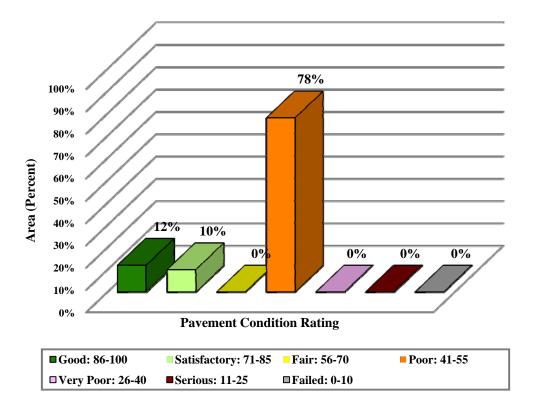
Figure 3-2: Percentage of Pavement Area within Each PCI Range by Pavement Use

Figure 3-2 presents the breakdown of PCI by range for each pavement use.

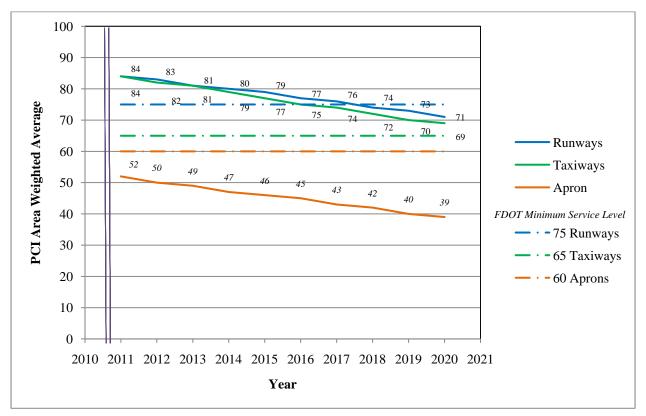
Figure 4-1: Predicted PCI by Pavement Use

Performance prediction models or deterioration curves for PCI were used to develop a condition forecast. The performance models were developed for combinations of variables such as pavement use (runway, taxiway or apron), surface type (AC or PCC) and airport category (GA, RL, or PR). Figure 4-1 illustrates the predicted performance of pavements at Suwannee County Airport based on current condition, age since last construction and the deterioration model appropriate for the type of pavement. The figure presents the forecast for each pavement use and displays the FDOT minimum service level for General Aviation (GA) airports.

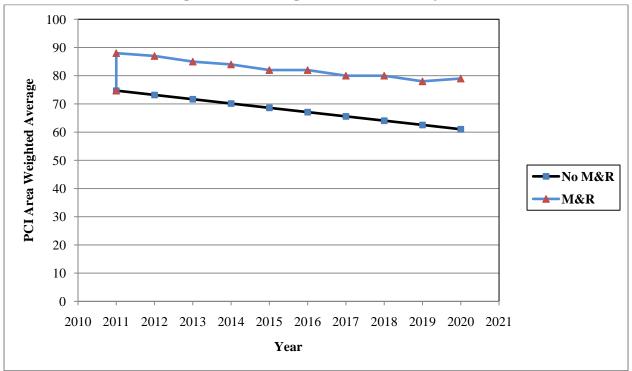
Figure 6-1: Budget Scenario Analysis

The 10 year forecast results are shown in Figure 6-1, illustrating the effect on pavement condition (PCI) of doing no maintenance versus having unlimited funds and performing all M&R actions based on the policies.
