**STATE OF FLORIDA
DEPARTMENT OF TRANSPORTATION
AVIATION OFFICE**

**Statewide Airfield Pavement
Management Program**

**Valkaria Municipal Airport– X59
(General Aviation)
Malabar, Florida
(District 5)**

May 2011

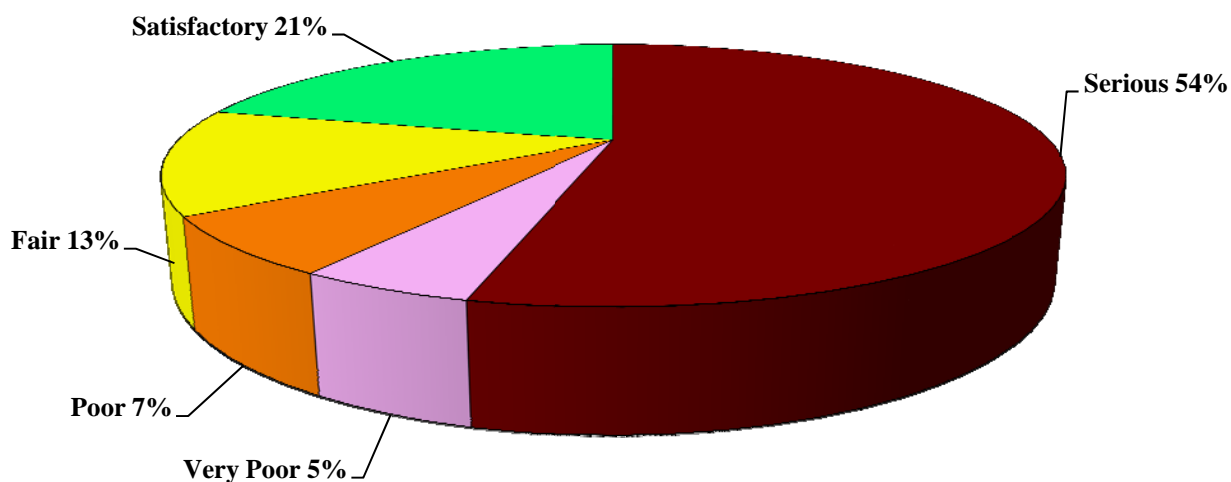
Figure 3-1: Network PCI Distribution by Rating Category

Condition Rating	Total Area (ft ²)	Percent
Good	0	0%
Satisfactory	217,500	21%
Fair	133,725	13%
Poor	69,770	7%
Very Poor	53,810	5%
Serious	564,780	54%
Failed	0	0%

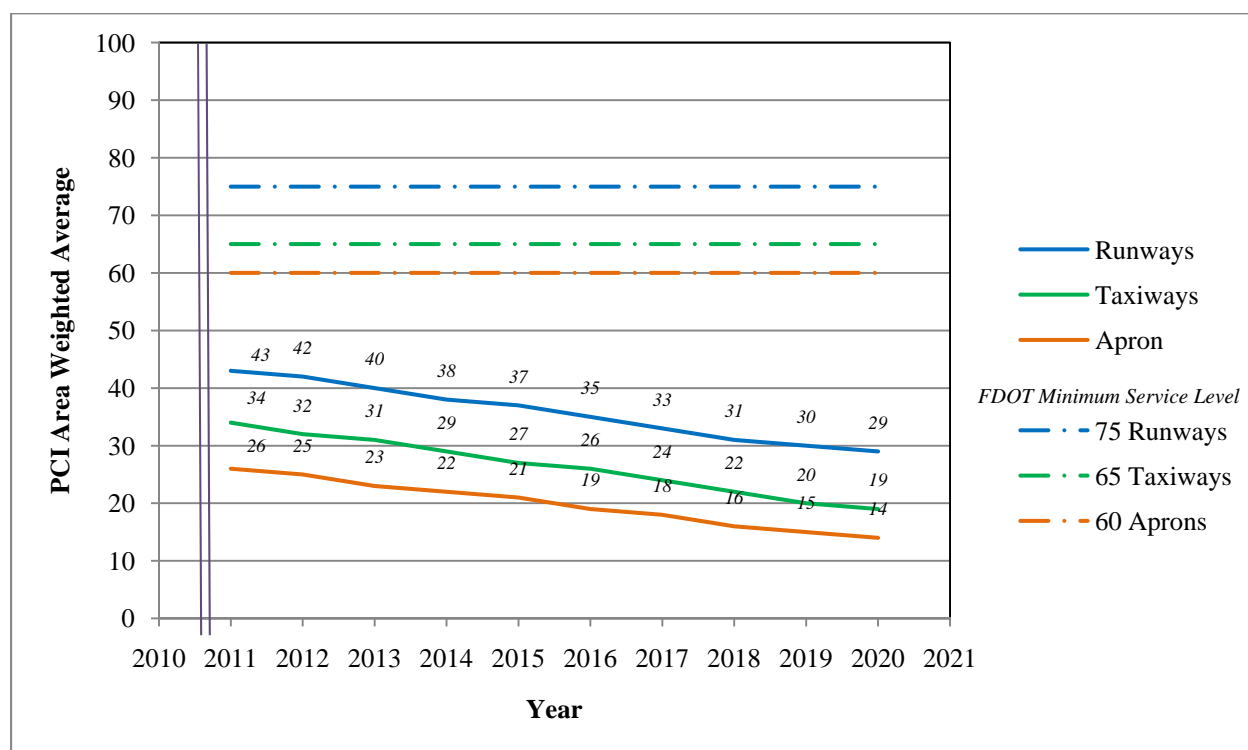
Figure 4-1: Predicted PCI by Pavement Use

Performance prediction models or deterioration curves for PCI were used to develop a condition forecast. The performance models were developed for combinations of variables such as pavement use (runway, taxiway or apron), surface type (AC or PCC) and airport category (GA, RL, or PR). Figure 4-1 illustrates the predicted performance of pavements at Valkaria Municipal Airport based on current condition, age since last construction and the deterioration model appropriate for the type of pavement. The figure presents the forecast for each pavement use and displays the FDOT minimum service level for General Aviation (GA) airports.

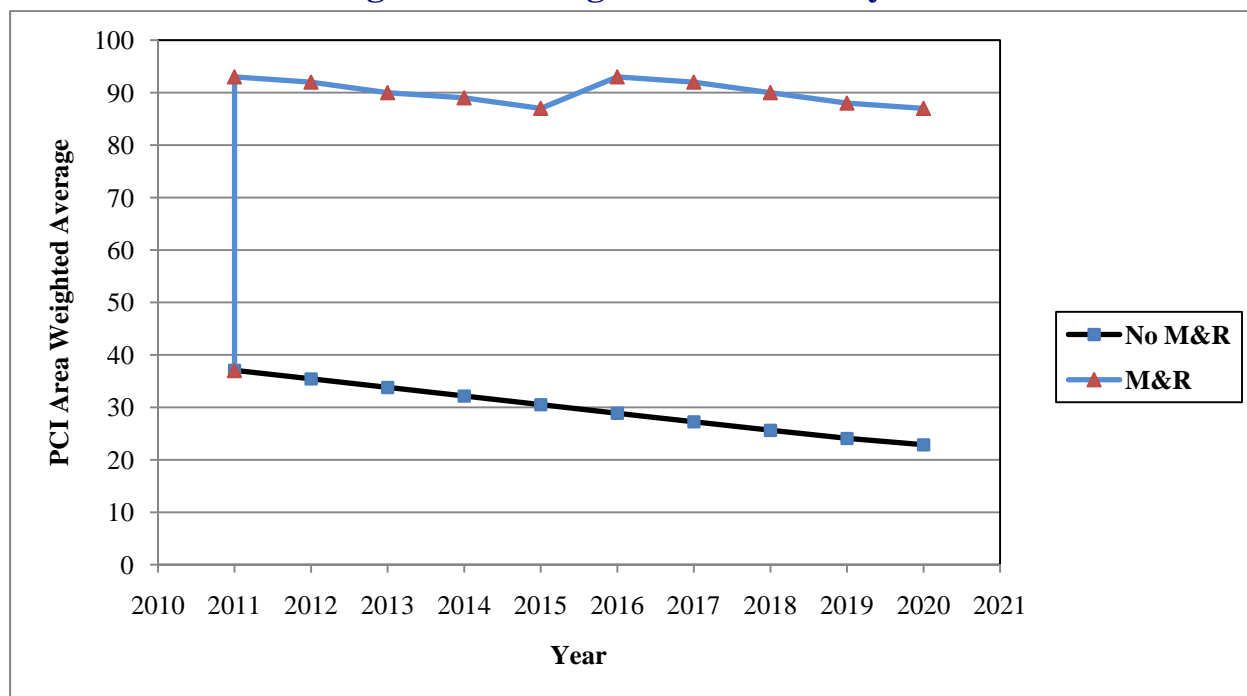
Figure 6-1: Budget Scenario Analysis

The following network level observations can be made from the figure above:

- The PCI will deteriorate from 37 in 2011 to 22 in ten years if no M&R activities are performed.
- The PCI will remain at or above 87 through the 10-year analysis period under the unlimited budget scenario. A 2020 PCI of 87 with this scenario is 65 PCI points higher than a “No M&R” scenario. The total cost for Major M&R over this 10-year period is about \$9.9 million.

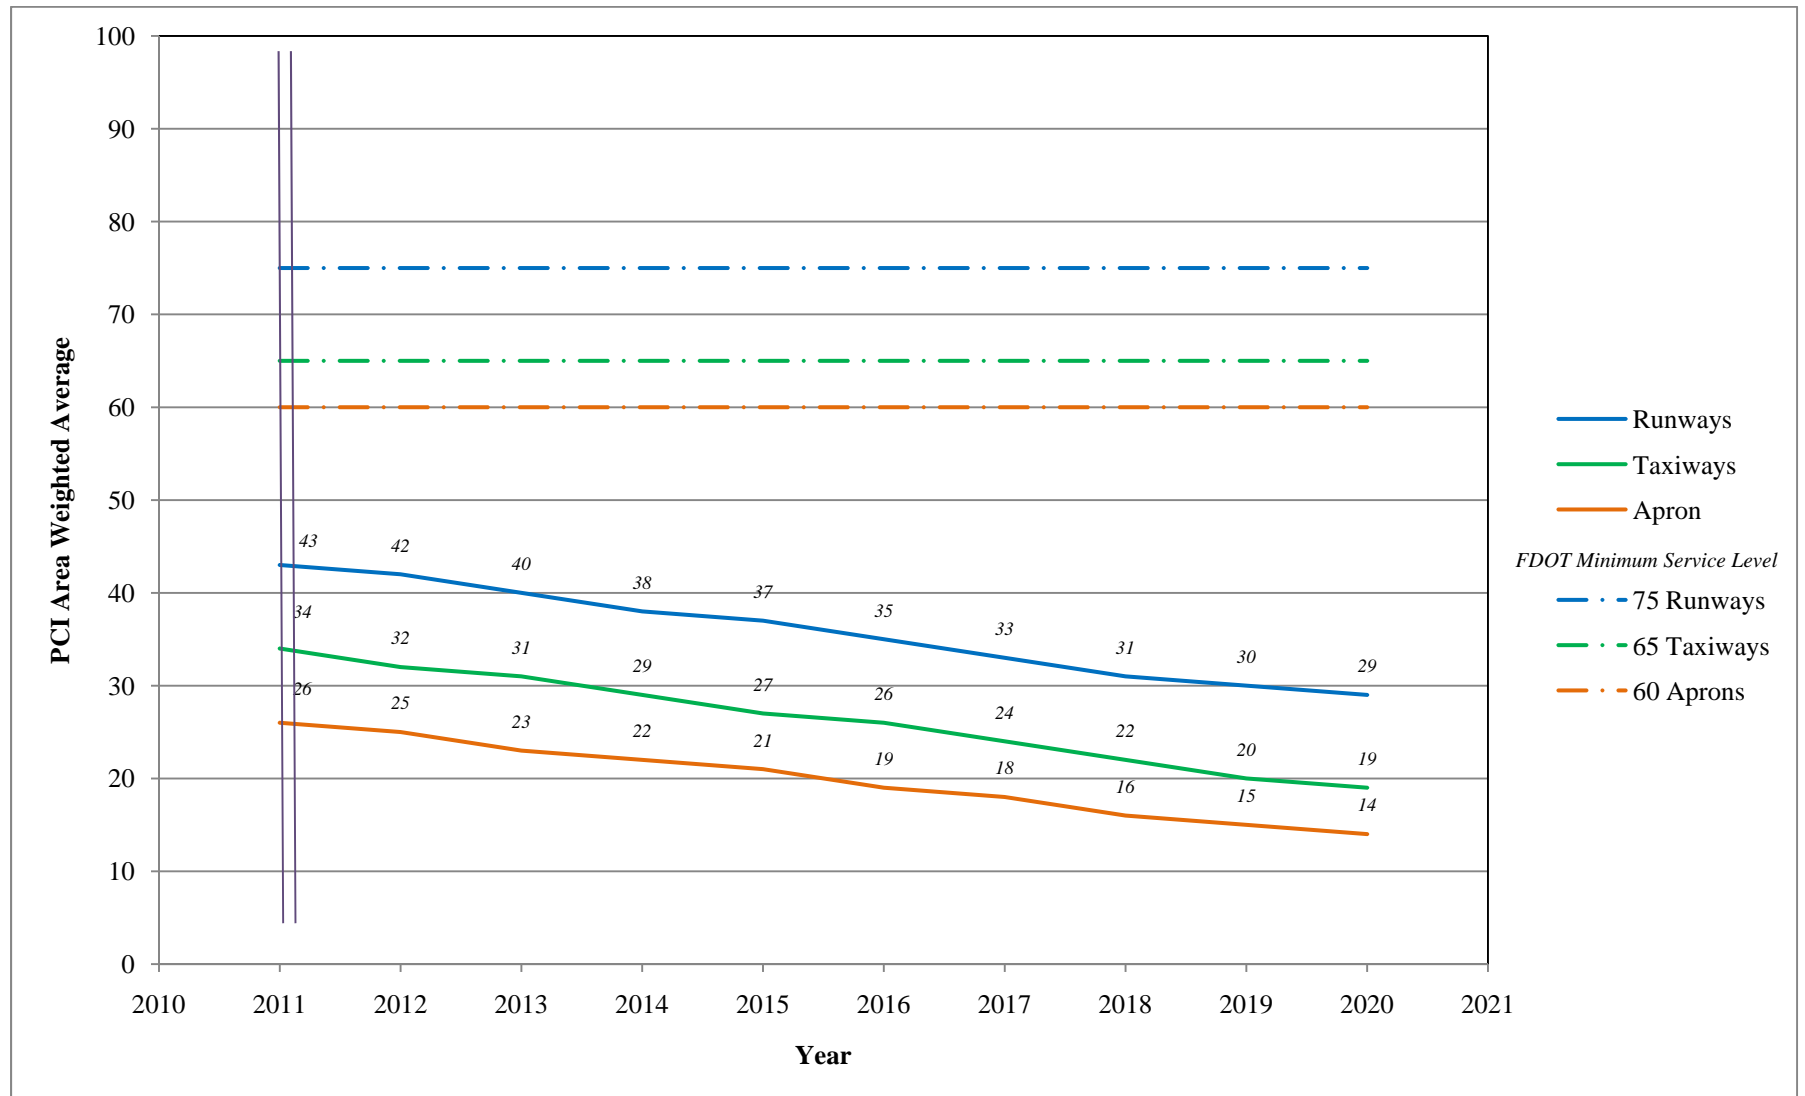
Figure D-1: Predicted PCI by Pavement Use

Branch Name	Branch ID	Section ID	Current PCI	PCI Forecast									
				2011	2012	2013	2014	2015	2016	2017	2018	2019	2020
Apron	AP	4105	25	24	23	22	20	19	17	16	14	13	11
Apron	AP	4110	33	33	32	31	30	29	29	28	27	27	26
Apron	AP	4115	69	68	67	66	64	63	61	60	58	57	55
Runway 10-28	RW 10-28	6205	12	11	10	8	7	6	4	3	1	0	0
Runway 10-28	RW 10-28	6210	65	64	62	60	58	56	54	52	51	49	47
Runway 14-32	RW 14-32	6105	74	73	71	69	67	65	63	61	60	58	56
Runway 14-32	RW 14-32	6110	74	73	71	69	67	65	63	61	60	58	56
Runway 14-32	RW 14-32	6115	60	59	57	55	53	51	49	47	46	44	42
Taxiway Between Rws	TW BETW RW	105	42	41	40	38	36	34	33	31	29	28	26
Connector Taxiways to Ramp	TW CONN	205	29	28	27	25	23	21	20	18	16	15	13
Connector Taxiways to Ramp	TW CONN	206	28	27	26	24	22	20	19	17	15	14	12
