FLORIDA DEPARTMENT OF TRANSPORTATION  
AVIATION AND SPACEPORT OFFICE

AVON PARK  
EXECUTIVE  
AIRPORT (AVO)

DECEMBER 2013

# STATEWIDE Airfield Pavement Management PROGRAM

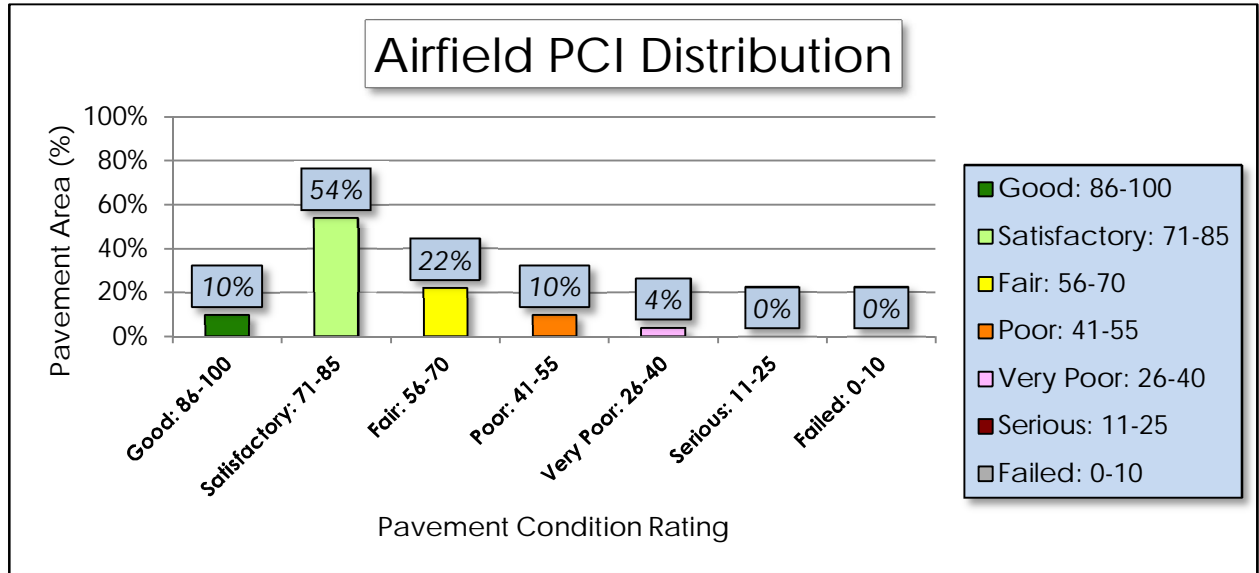
Figure 3-1: Airfield Pavement Condition Index Rating Summary

The pavement condition at Avon Park Executive Airport is represented in Figure 3-1 in accordance with the condition categories and PCI scale referenced in ASTM D 5340. Further detail is provided in Table 3-3 which describes the breakdown of the airport's airfield conditions according to area and use.

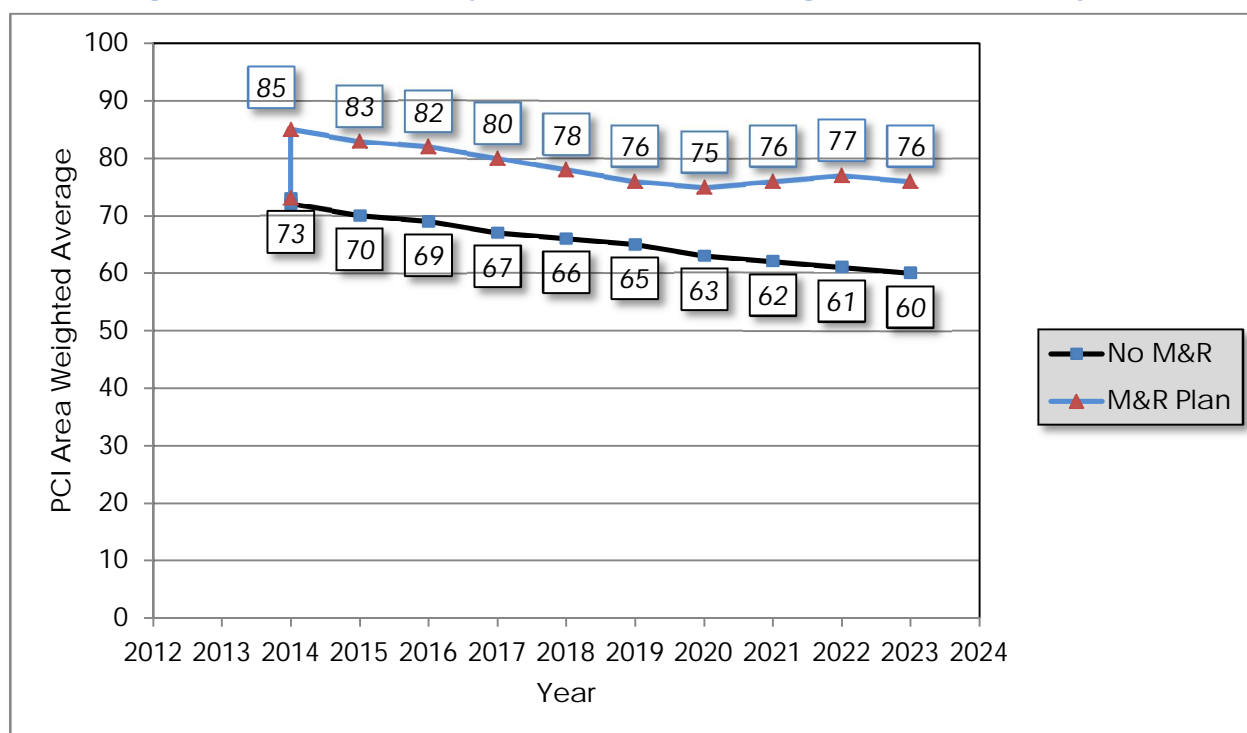
Figure 6-1: 10-Year Major Rehabilitation Budget Scenario Analysis

The 10-year major rehabilitation program addresses those pavement sections that have a current or project PCI that is below the Critical PCI of 65 during the 10-year analysis period. The unconstrained or “unlimited budget” Major Rehabilitation Program is compared to a “No Major Rehabilitation Program” scenario in Figure 6-1. As shown, if no major rehabilitation work is completed in the next 10 years at your airport, the average PCI may be 16 points less than a plan that provides timely repairs to the airfield pavements.

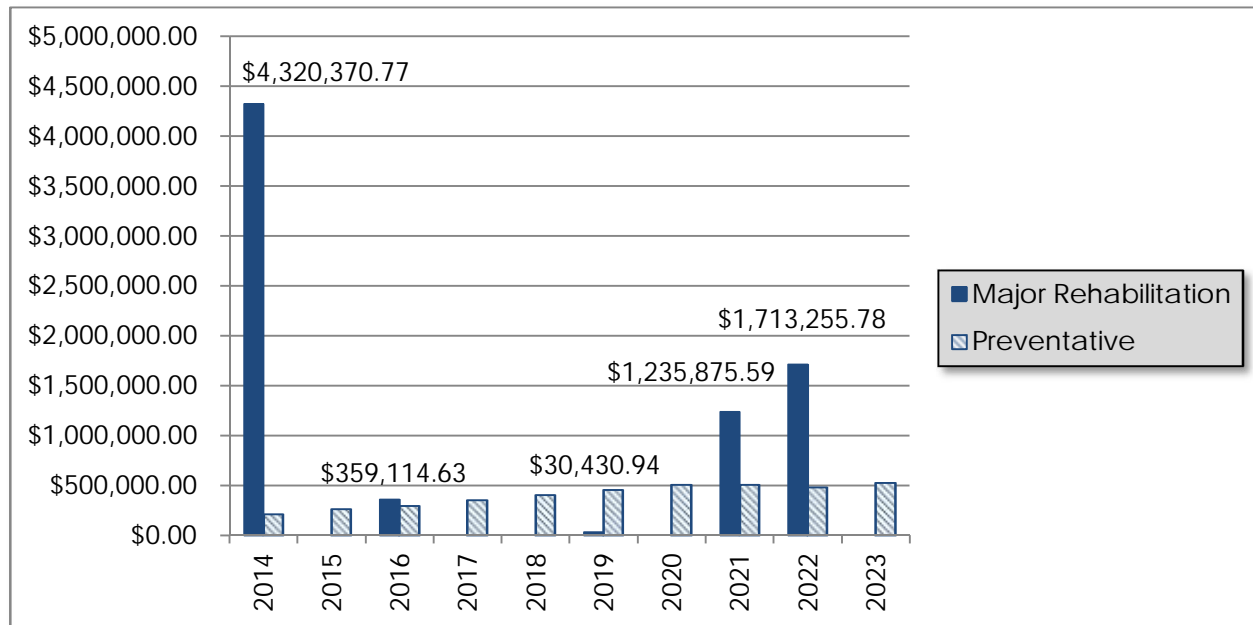
Figure 7-1: 10-Year Preventative and Major Rehabilitation Summary

In an effort to identify appropriate budget levels, the 10-year Preventative and Major Rehabilitation analysis evaluated projected budget needs based on predicted PCI of each pavement section. Table 7-1 and Figure 7-1 provides a summary of the expected preventative and major rehabilitation for each program year.

- Runway 5-23 – Section 6102
  - Mill and overlay attributed to distresses related to climate, age, and subgrade quality of pavement.
- East Apron – Section 4505
  - Mill and overlay attributed to distresses related to climate, age, and subgrade quality of pavement.
- Southeast Apron – Section 4405
  - Mill and overlay attributed to distresses related to climate, age, and subgrade quality of pavement.
- South Apron – Section 4305
  - Reconstruction attributed to distresses related to climate, age, and subgrade quality of pavement.
- Northeast Apron – Sections 4205, 4210
  - Reconstruction or mill and overlay attributed to distresses related to climate, age, and subgrade quality of pavement.
- Northwest Apron – Section 4105
  - Mill and overlay attributed to distresses related to climate and age of pavement.
