# FLORIDA DEPARTMENT OF TRANSPORTATION AVIATION AND SPACEPORT OFFICE

Pavement Evaluation Report - Bob Sikes Airport

In AUGUST 2013, a PCI survey inspection was performed at Bob Sikes Airport. The results of the inspection indicate that, based on ASTM D 5340-11, the airport's airfield pavement facilities had an overall area-weighted average PCI of 87, representing a GOOD overall network condition. Table I summarizes the overall condition summary by network level branch in comparison to the FDOT recommended minimum service level.

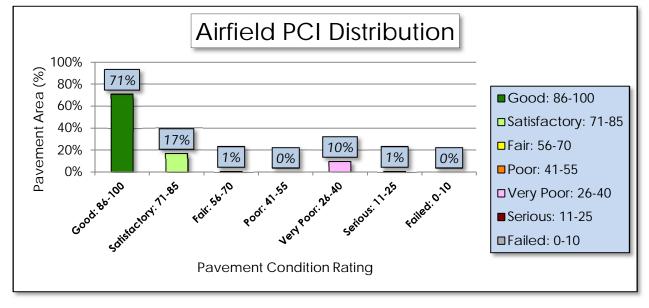
Figure 3-1: Airfield Pavement Condition Index Rating Summary

Approximately 88% of the airfield network is in Good and Satisfactory condition; while 11% of the network is in a Poor to Serious condition. Table 3-3 provides a breakdown of total area for each pavement by condition rating. Figures 3.2 a, b, c depict the condition rating of the airfield pavement by Branch Use. Photographs taken during the condition survey inspection are included in Appendix G. The photographs included are intended to be representative of the distress observed.

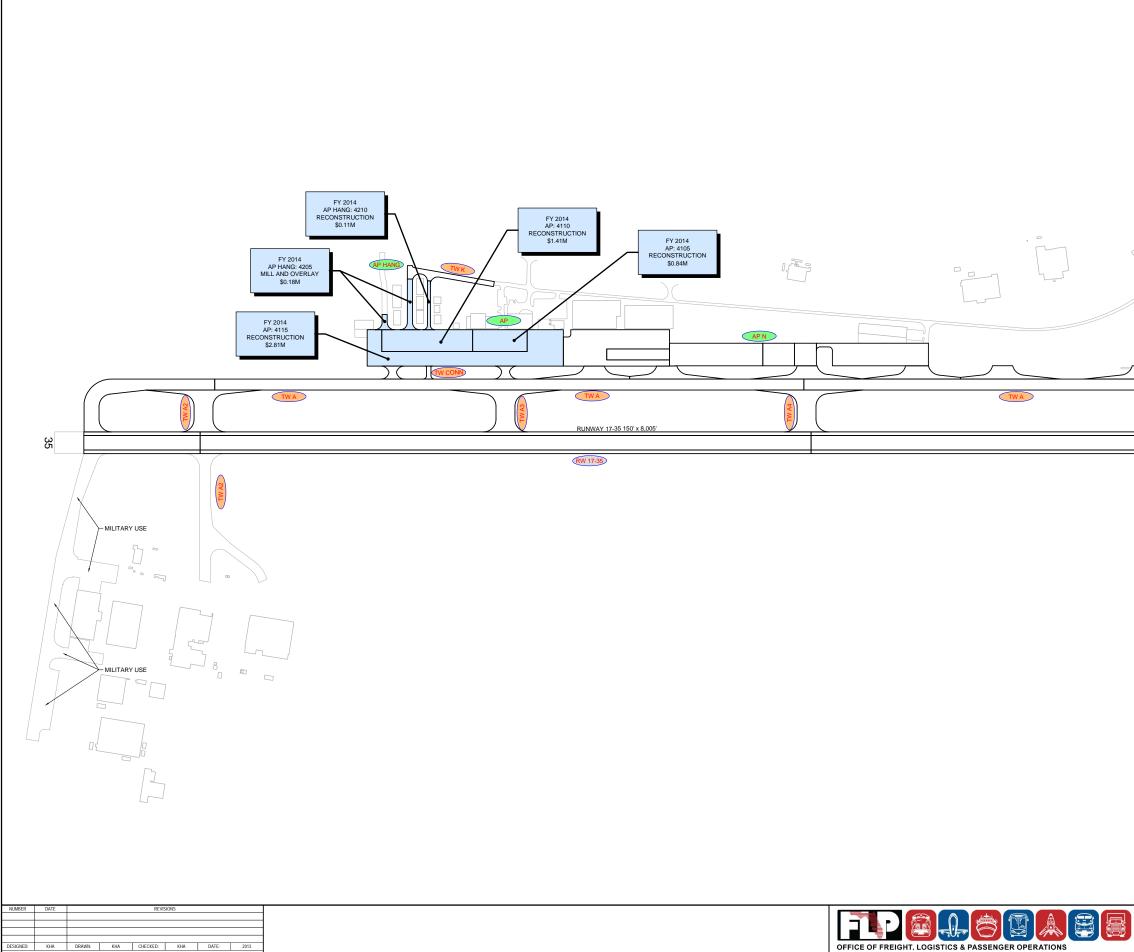
Year	Branch ID	Section ID	Major M&R Costs*	PCI Before M&R	M&R Activity	PCI After M&R
2014	AP HANG	4210	\$106,552.98	18	Reconstruction	100
2014	AP HANG	4205	\$180,101.89	62	Mill and Overlay	100
2014	AP	4115	\$2,808,460.86	32	Reconstruction	100
2014	AP	4110	\$1,406,250.33	30	Reconstruction	100
2014	AP	4105	\$843,750.20	37	Reconstruction	100
		Total =	\$5,345,116.26
