FLORIDA DEPARTMENT OF TRANSPORTATION
AVIATION AND SPACEPORT OFFICE

WAUCHULA
MUNICIPAL
AIRPORT (CHN)

DECEMBER 2013

STATEWIDE Airfield Pavement Management PROGRAM

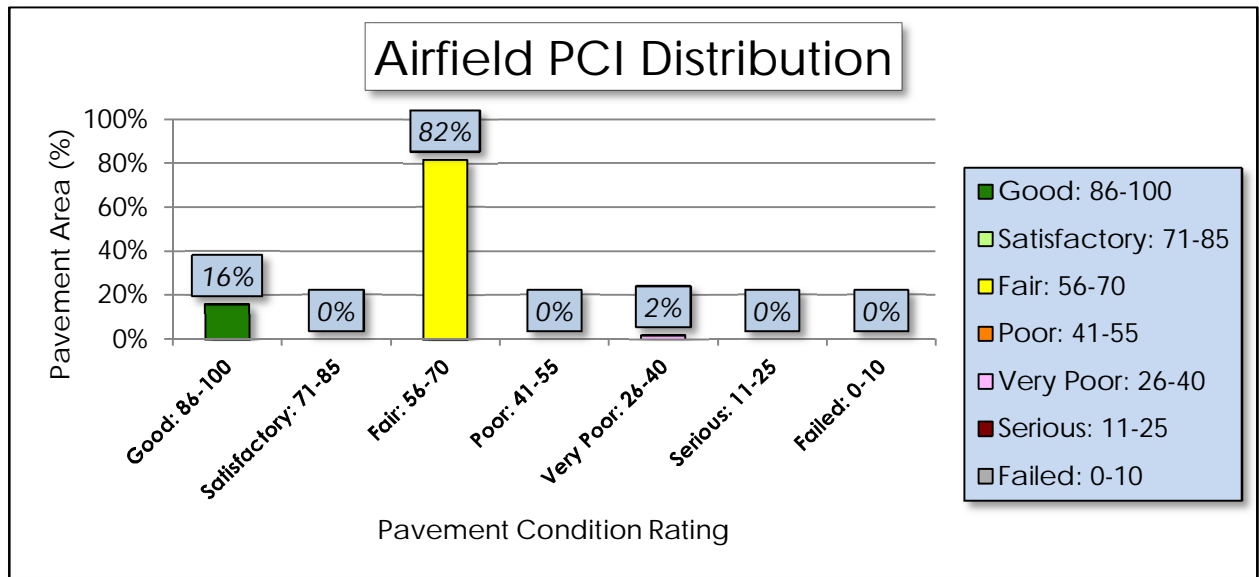
Figure 3-1: Airfield Pavement Condition Index Rating Summary

The pavement condition at Wauchula Municipal Airport is represented in Figure 3-1 in accordance with the condition categories and PCI scale referenced in ASTM D 5340. Further detail is provided in Table 3-3 which describes the breakdown of the airport's airfield conditions according to area and use.

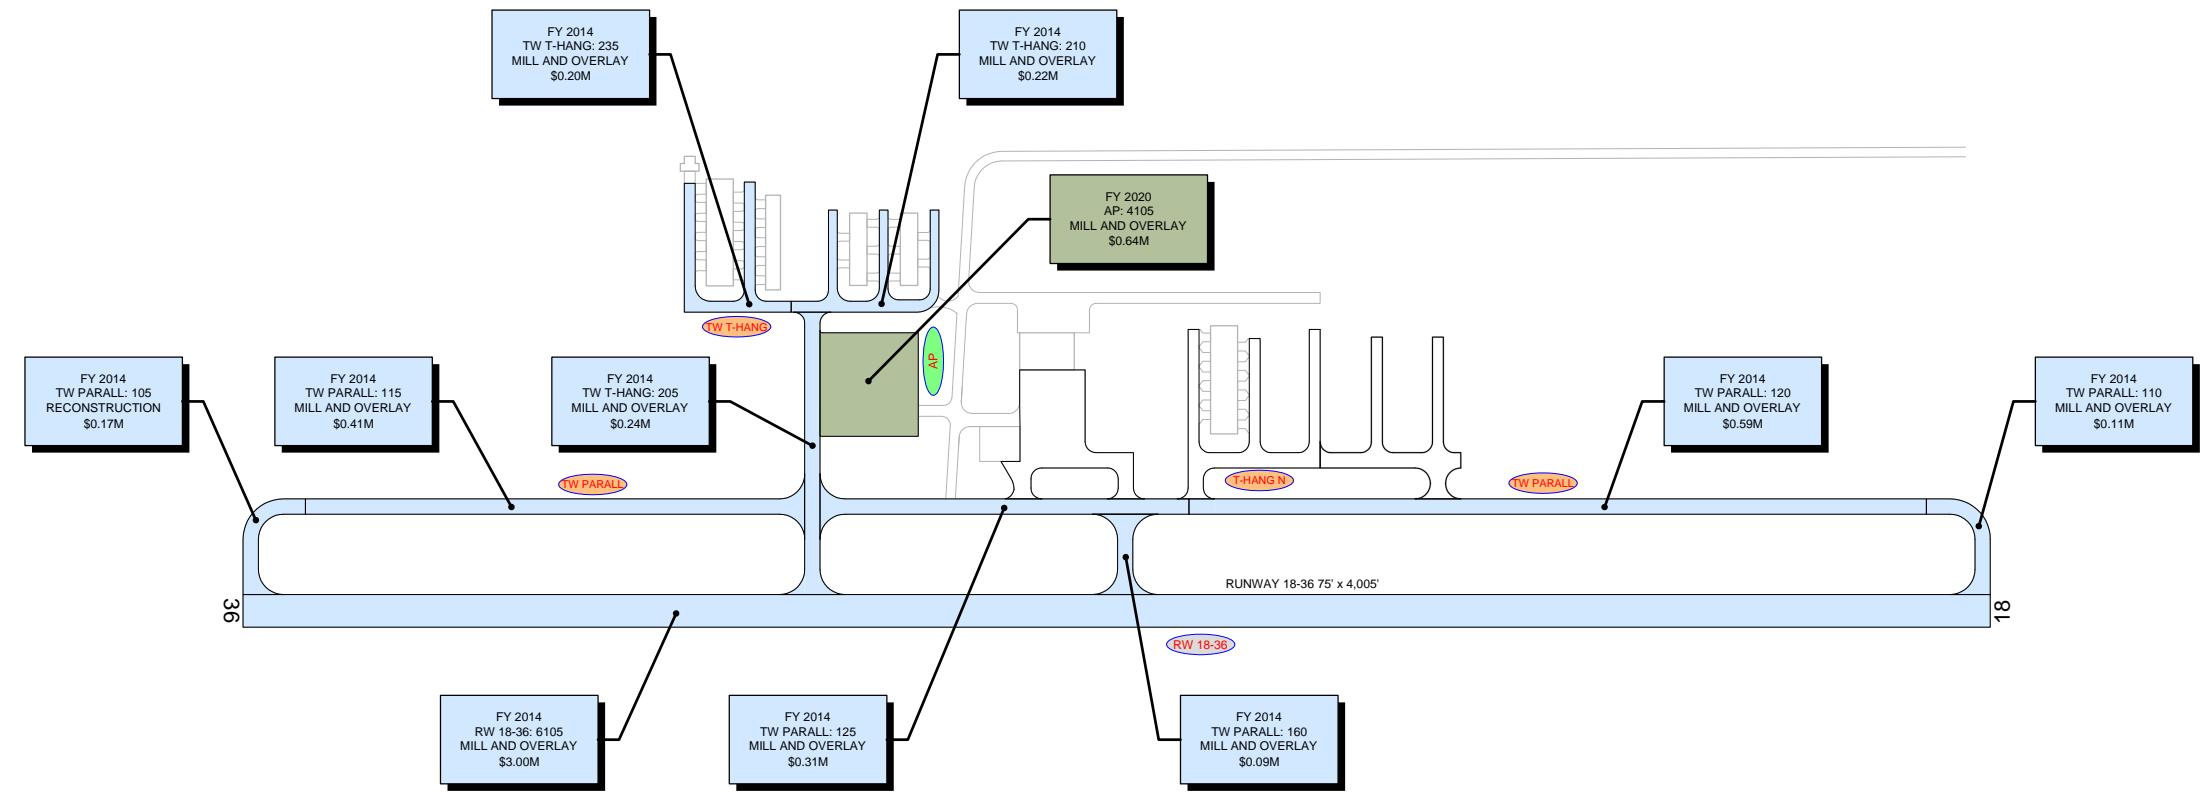
- AIRFIELD PAVEMENT 10-YEAR MAJOR REHABILITATION
EXHIBIT

- Runway 18-36 – Section 6105
 - Mill and Overlay attributed to distresses related to climate and age of pavement.
- Taxiway to Hangars – Sections 235, 210, and 205
 - Mill and Overlay attributed to distresses related to subgrade quality, PCC pavement movement, climate, and age of pavement.
- Parallel Taxiway – Sections 160, 125, 120, 115, and 110
 - Mill and Overlay attributed to distresses related to climate and age of pavement.
- Parallel Taxiway – Section 105
 - Reconstruction attributed to distresses related to subgrade quality, climate, and age of pavement.
