FLORIDA DEPARTMENT OF TRANSPORTATION
AVIATION AND SPACEPORT OFFICE

MERRITT ISLAND
AIRPORT (COI)

DECEMBER 2013

STATEWIDE Airfield Pavement Management PROGRAM

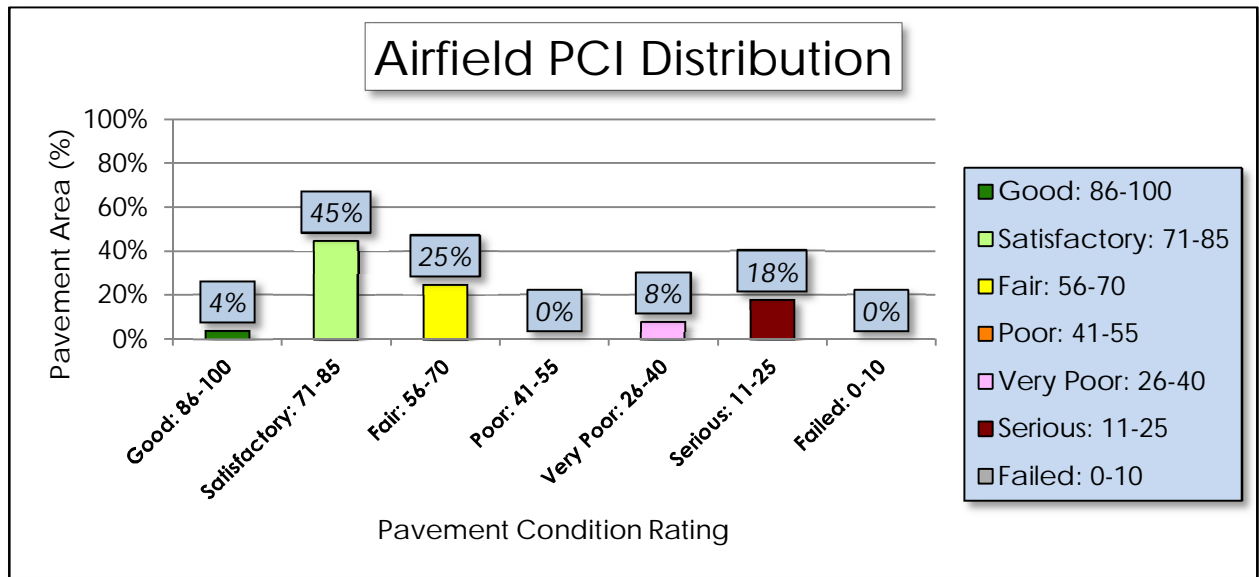
Figure 3-1: Airfield Pavement Condition Index Rating Summary

The pavement condition at Merritt Island Airport is represented in Figure 3-1 in accordance with the condition categories and PCI scale referenced in ASTM D 5340. Further detail is provided in Table 3-3 which describes the breakdown of the airport's airfield conditions according to area and use.
