FLORIDA DEPARTMENT OF TRANSPORTATION  
AVIATION AND SPACEPORT OFFICE

LAKE CITY  
GATEWAY  
AIRPORT (LCQ)

DECEMBER 2013

# STATEWIDE Airfield Pavement Management PROGRAM

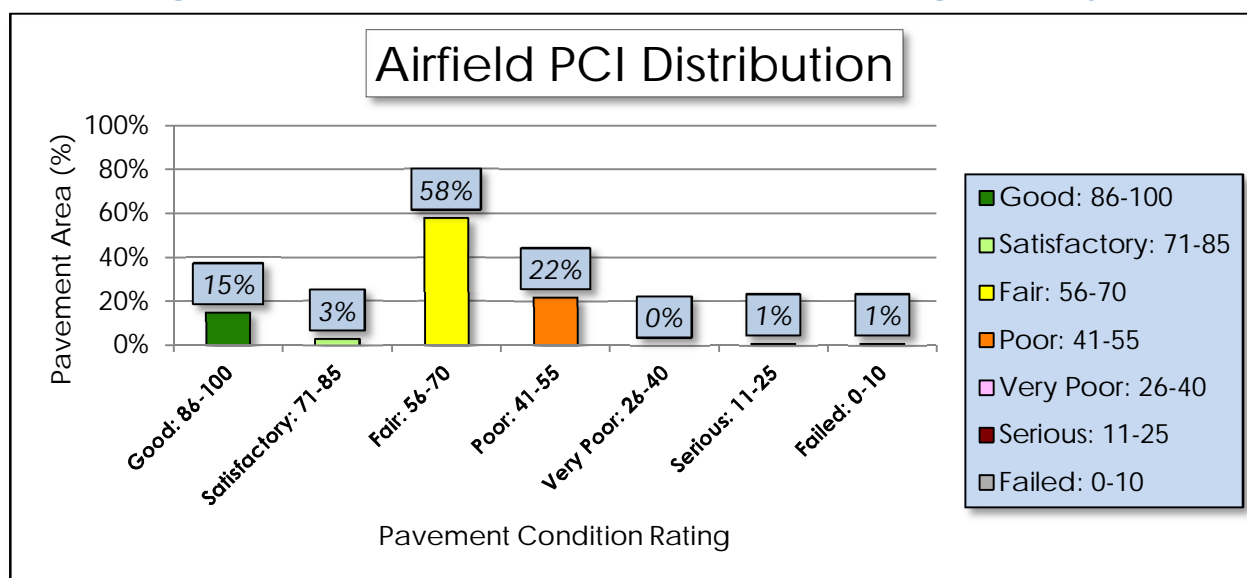
Figure 3-1: Airfield Pavement Condition Index Rating Summary

The pavement condition at Lake City Gateway Airport is represented in Figure 3-1 in accordance with the condition categories and PCI scale referenced in ASTM D 5340. Further detail is provided in Table 3-3 which describes the breakdown of the airport's airfield conditions according to area and use.

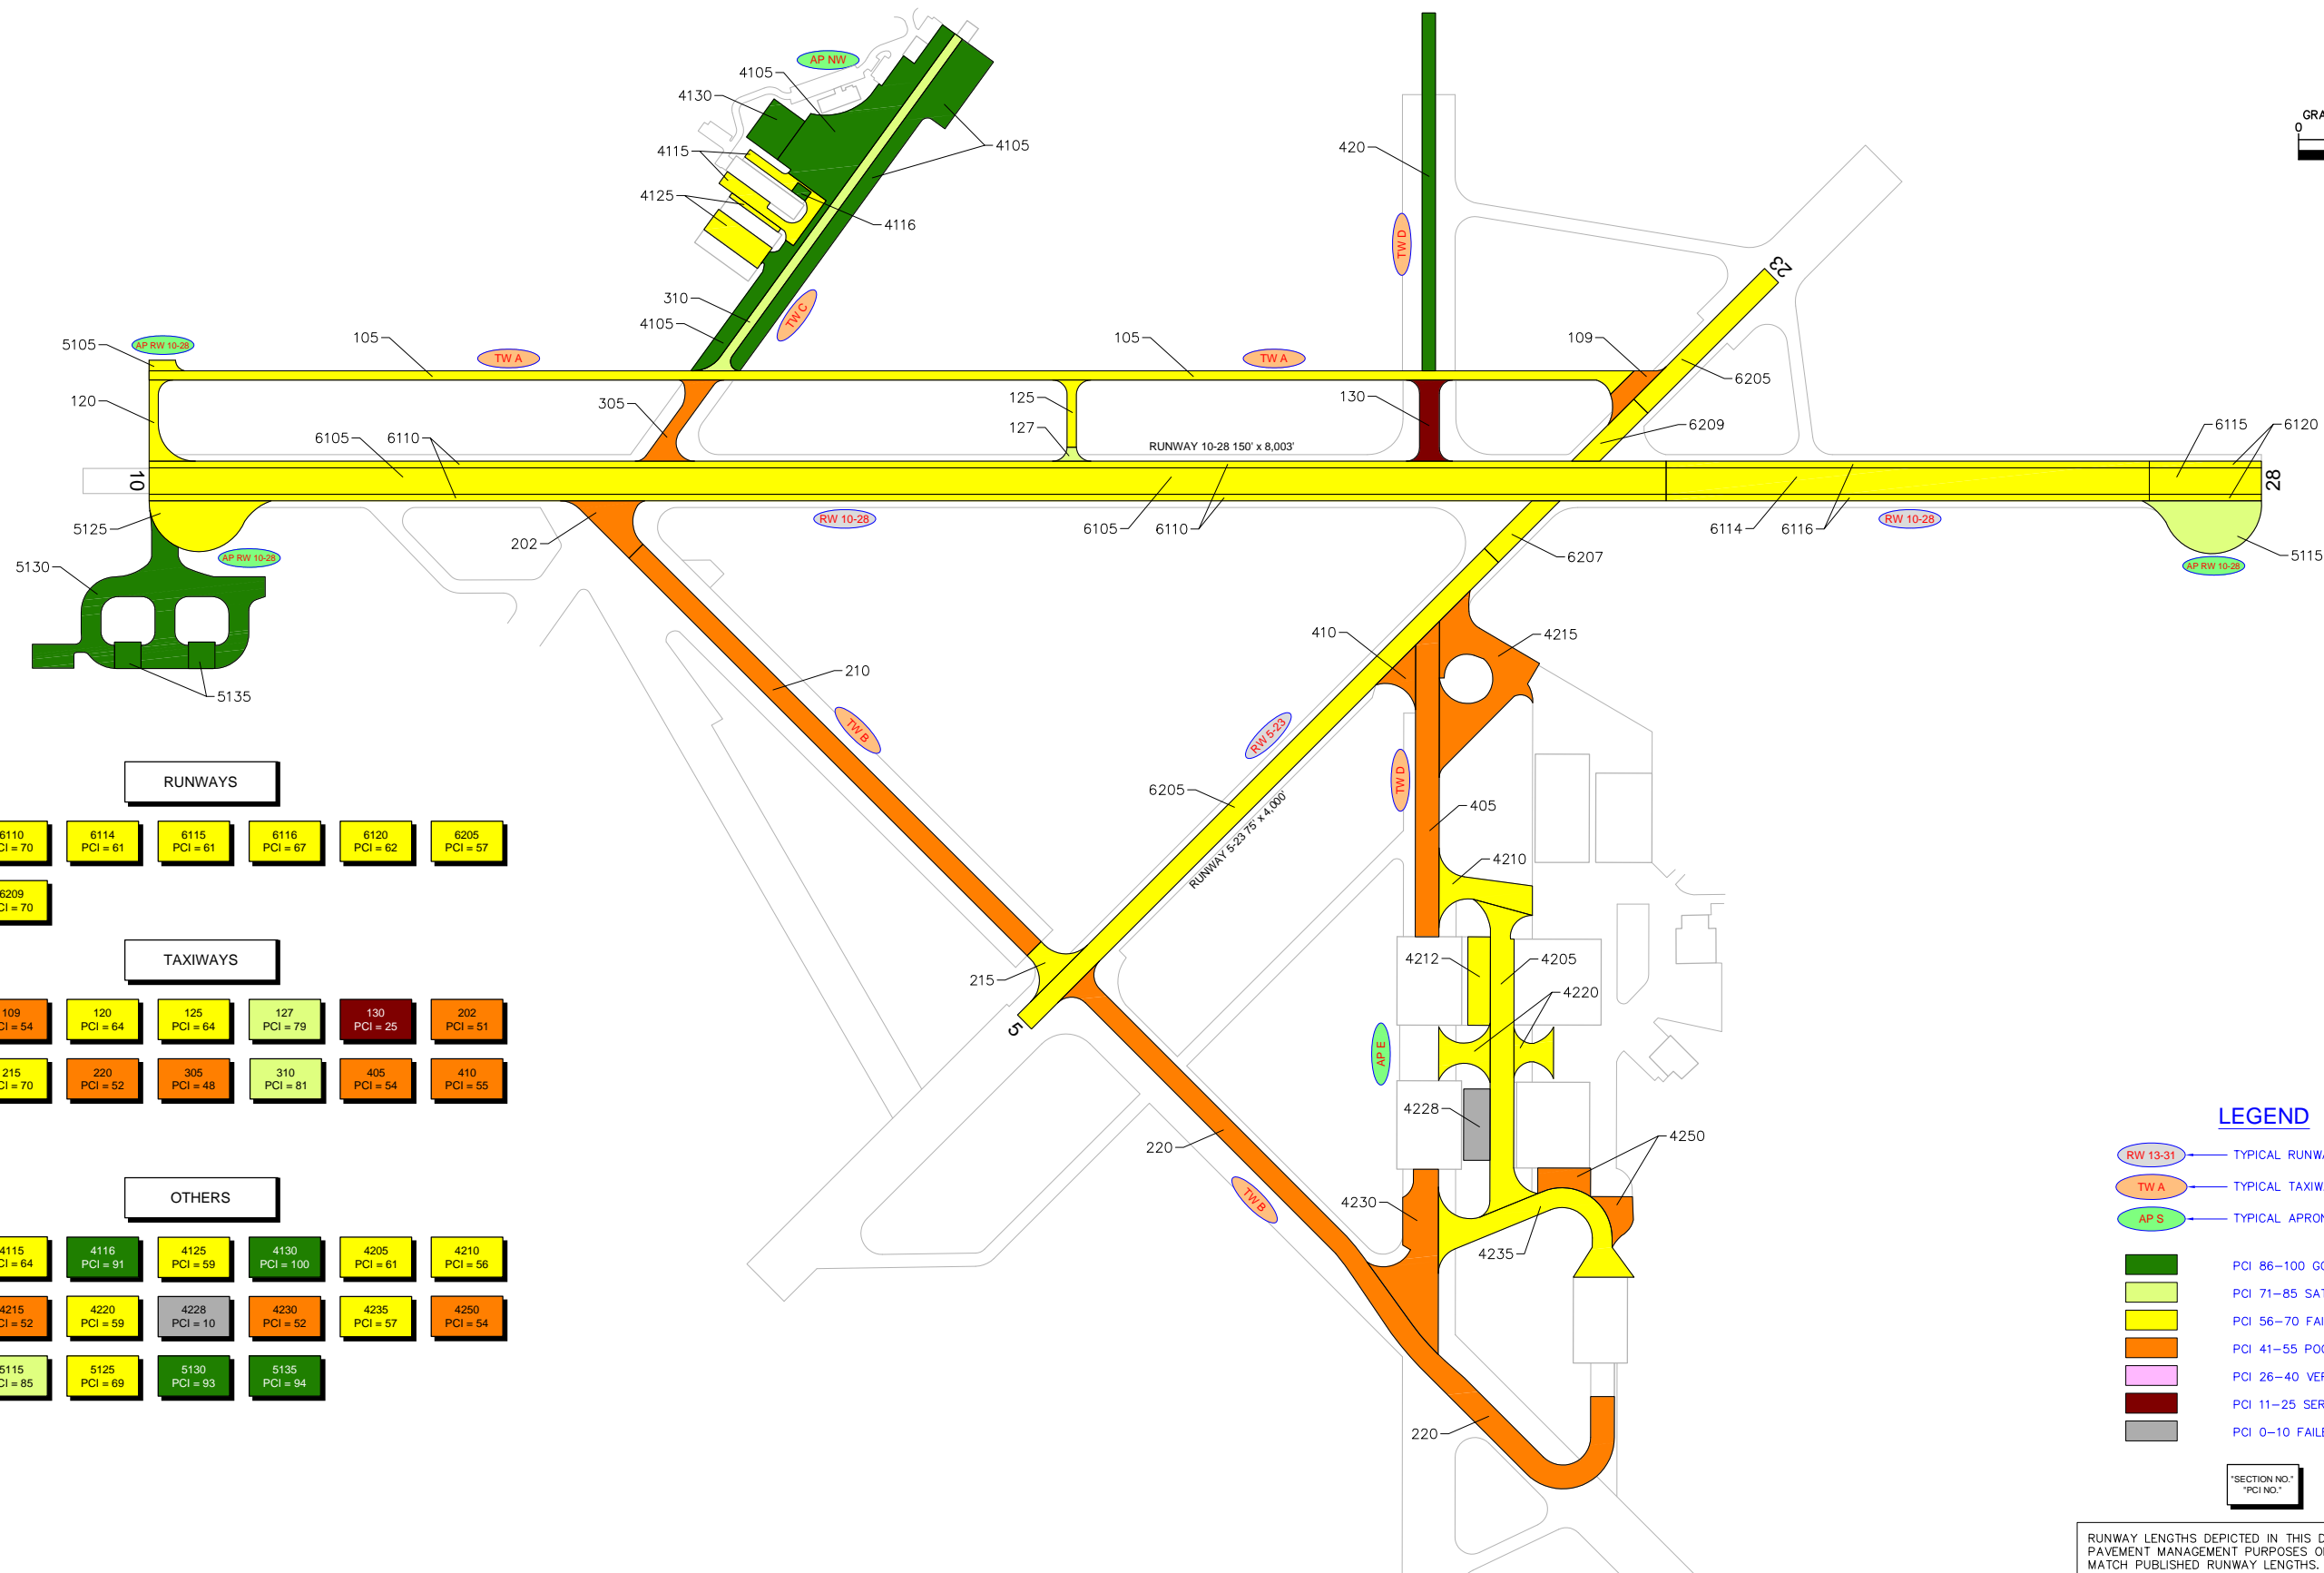
- AIRFIELD PAVEMENT CONDITION INDEX RATING EXHIBIT
- PAVEMENT CONDITION INDEX INVENTORY

6105 PCI = 64	6110 PCI = 70	6114 PCI = 61	6115 PCI = 61	6116 PCI = 67	6120 PCI = 62	6205 PCI = 57
6207 PCI = 64	6209 PCI = 70
