FLORIDA DEPARTMENT OF TRANSPORTATION

AVIATION AND SPACEPORT OFFICE

During MAY 2013, a PCI survey inspection was performed at Marco Island Airport. The results of the inspection indicate that, based on ASTM 5340-11, the airport's airfield pavement facilities had an overall area-weighted average PCI 58, representing a FAIR overall network condition. Table I summarizes the overall condition summary by network level branch in comparison to the FDOT recommended minimum service level.

From the condition survey inspection performed in 2013 at Marco Island Airport, the overall weighted average PCI value is 58 representing a condition rating of FAIR.

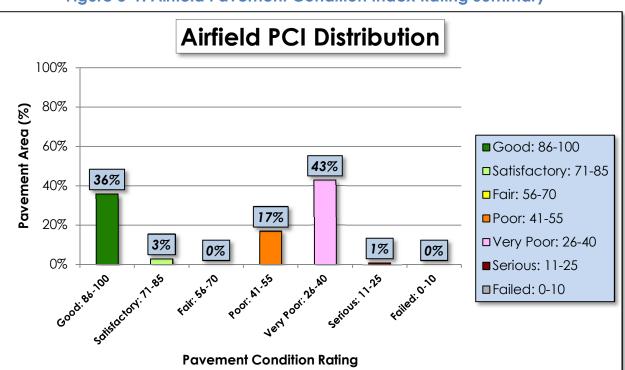
Figure 3-1: Airfield Pavement Condition Index Rating Summary

The pavement condition at Marco Island Airport is represented in **Figure 3-1** in accordance with the condition categories and PCI scale referenced in ASTM D 5340. Further detail is provided in **Table 3-3** which describes the breakdown of the airport's airfield conditions according to area and use.

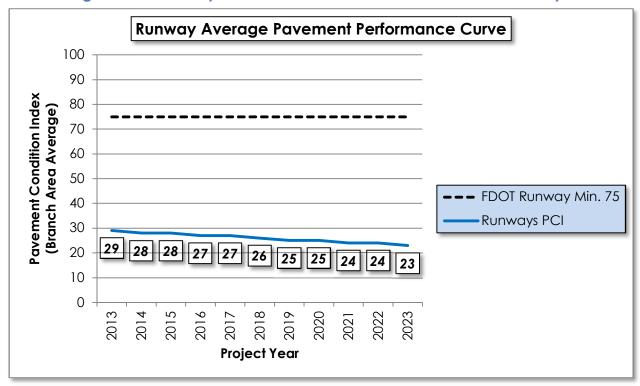
Figure 4-1: Runway Pavement Performance Prediction Summary

Each airport's airfield pavement section condition, for a given inspection year, is one data point that was used as the basis of each performance trend using a performance model based on pavements of similar background. **Figures 4-1, 4-2**, and **4-3** represent the pavement performance prediction at Marco Island Airport based on pavement use. Each figure depicts the FDOT recommended Minimum Service Level PCI value for each pavement type.

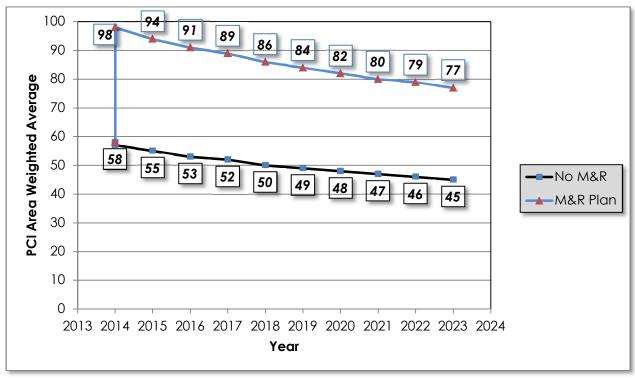
Figure 6-1: 10-Year Major Rehabilitation Budget Scenario Analysis

The 10-year major rehabilitation program addresses those pavement sections that have a current or project PCI that is below the Critical PCI of 65 during the 10-year analysis period. The unconstrained or "unlimited budget" Major Rehabilitation Program is compared to a "No Major Rehabilitation Program" scenario in **Figure 6-1**. As shown, if no major rehabilitation work is completed in the next 10 years at your airport, the average PCI may be 32 points less than a plan that provides timely repairs to the airfield pavements.
