FLORIDA DEPARTMENT OF TRANSPORTATION AVIATION AND SPACEPORT OFFICE

Pavement Evaluation Report - Plant City Airport

EXECUTIVE SUMMARY

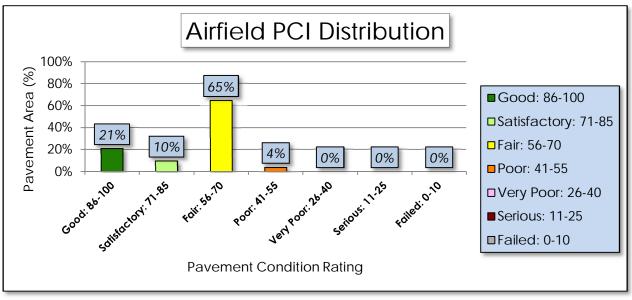
Figure 3-1: Airfield Pavement Condition Index Rating Summary

The pavement condition at Plant City Airport is represented in Figure 3-1 in accordance with the condition categories and PCI scale referenced in ASTM D 5340. Further detail is provided in Table 3-3 which describes the breakdown of the airport's airfield conditions according to area and use.

Approximately 31% of the airfield network is in Good and Satisfactory condition; while 4% of the network is in a Poor to Serious condition. Table 3-3 provides a breakdown of total area for each pavement by condition rating. Figures 3.2 a, b, c depict the condition rating of the airfield pavement by Branch Use. Photographs taken during the condition survey inspection are included in Appendix G. The photographs included are intended to be representative of the distress observed.

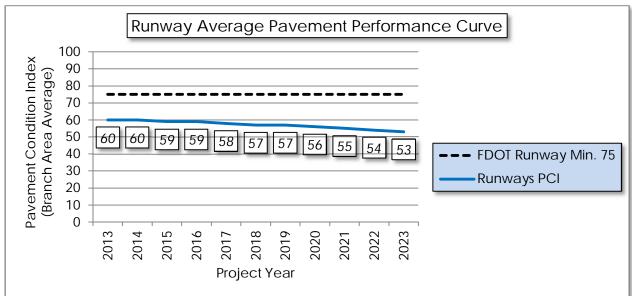
Figure 4-1: Runway Pavement Performance Prediction Summary

Each airport's airfield pavement section condition, for a given inspection year, is one data point that was used as the basis of each performance trend using a performance model based on pavements of similar background. Figures 4-1, 4-2, and 4-3 represent the pavement performance prediction at Plant City Airport based on pavement use. Each figure depicts the FDOT recommended Minimum Service Level PCI value for each pavement type.

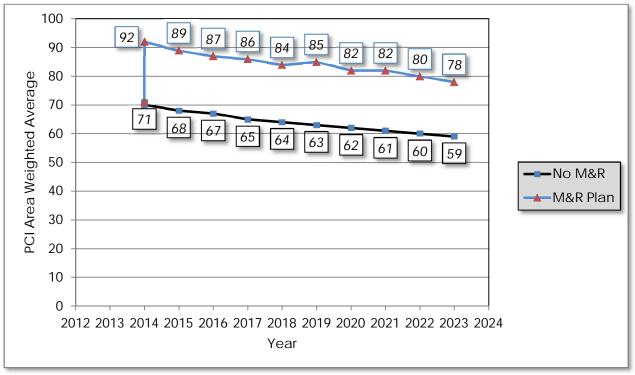
Figure 6-1: 10-Year Major Rehabilitation Budget Scenario Analysis

The 10-year major rehabilitation program addresses those pavement sections that have a current or projected PCI that are below the Critical PCI of 65 during the 10-year analysis period. The unconstrained or "unlimited budget" Major Rehabilitation Program is compared to a "No Major Rehabilitation Program" scenario in Figure 6-1. As shown, if no major rehabilitation work is completed in the next 10 years at your airport, the average PCI may be 19 points less than a plan that provides timely repairs to the airfield pavements.

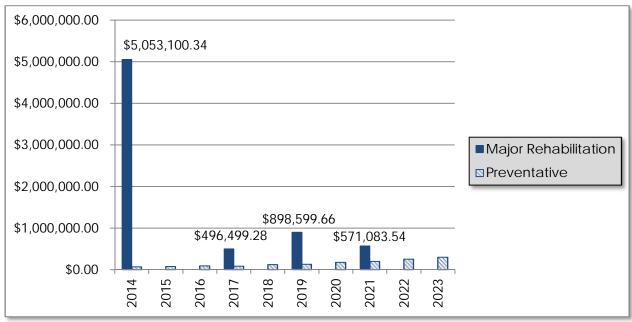
Figure 7-1: 10-Year Preventative and Major Rehabilitation Summary

In an effort to identify appropriate budget levels, the 10-year Preventative and Major Rehabilitation analysis evaluated projected budget needs based on predicted PCI of each pavement section. Table 7-1 and Figure 7-1 provides a summary of the expected preventative and major rehabilitation for each program year.
