FLORIDA DEPARTMENT OF TRANSPORTATION  
AVIATION AND SPACEPORT OFFICE

PALM BEACH  
COUNTY GLADES  
AIRPORT (PHK)

DECEMBER 2013

# STATEWIDE Airfield Pavement Management PROGRAM

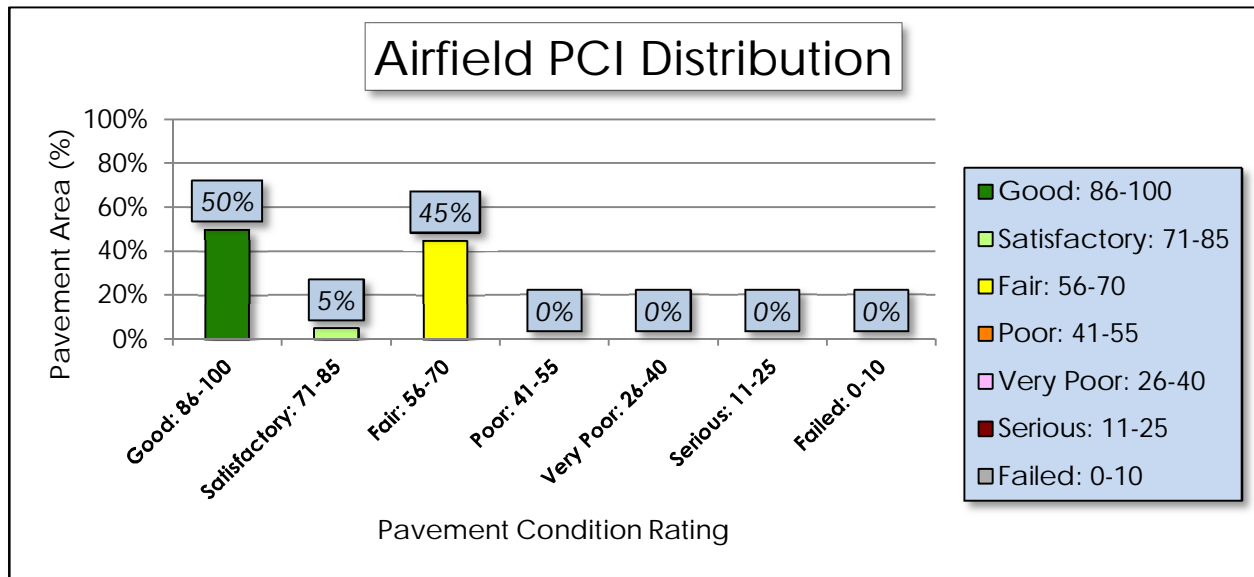
Figure 3-1: Airfield Pavement Condition Index Rating Summary

The pavement condition at Palm Beach County Glades Airport is represented in Figure 3-1 in accordance with the condition categories and PCI scale referenced in ASTM D 5340. Further detail is provided in Table 3-3 which describes the breakdown of the airport's airfield conditions according to area and use.

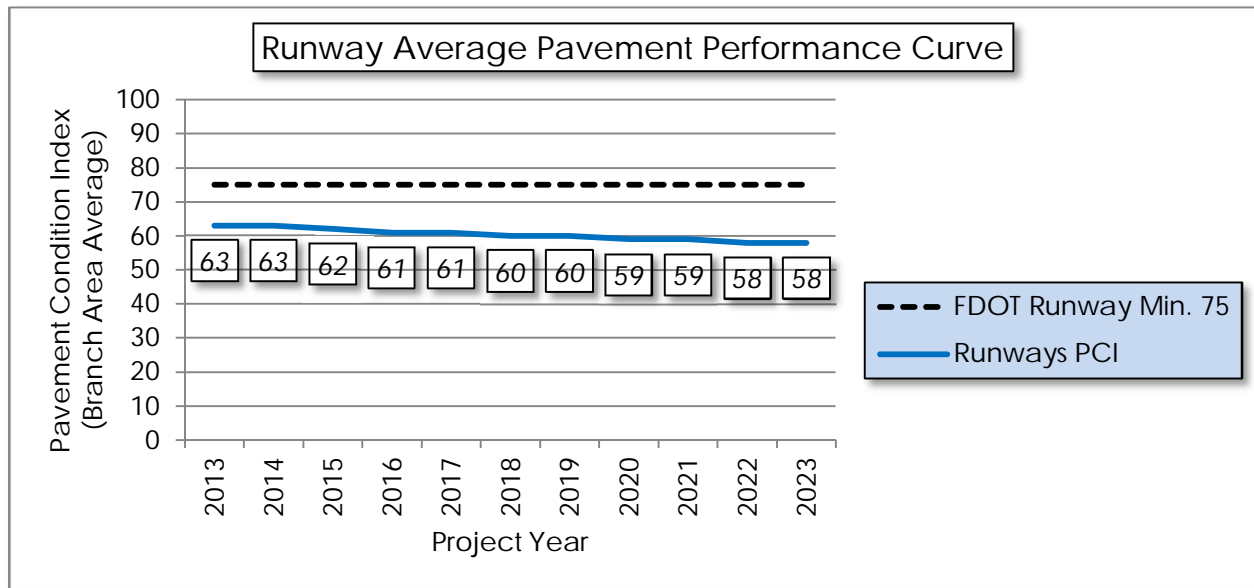
Figure 4-1: Runway Pavement Performance Prediction Summary

Each airport's airfield pavement section condition, for a given inspection year, is one data point that was used as the basis of each performance trend using a performance model based on pavements of similar background. Figures 4-1, 4-2, and 4-3 represent the pavement performance prediction at Palm Beach County Glades Airport based on pavement use. Each figure depicts the FDOT recommended Minimum Service Level PCI value for each pavement type.

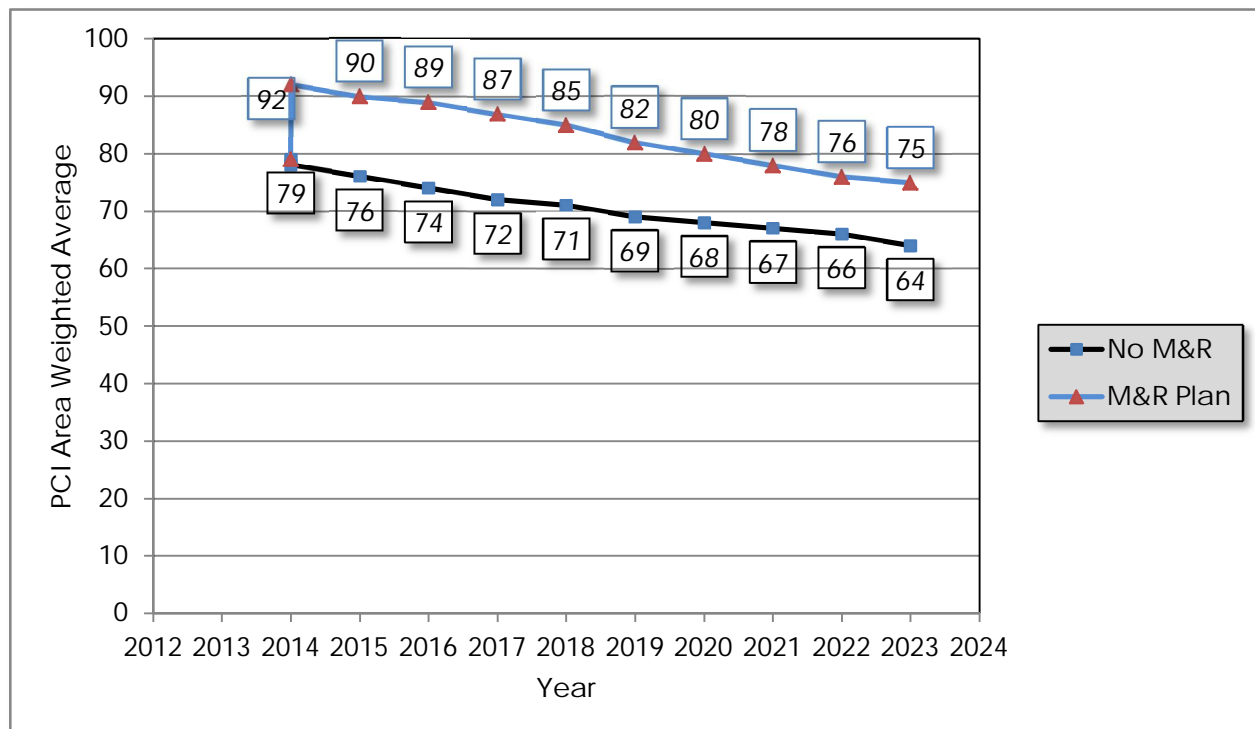
Figure 6-1: 10-Year Major Rehabilitation Budget Scenario Analysis

The 10-year major rehabilitation program addresses those pavement sections that have a current or project PCI that is below the Critical PCI of 65 during the 10-year analysis period. The unconstrained or “unlimited budget” Major Rehabilitation Program is compared to a “No Major Rehabilitation Program” scenario in Figure 6-1. As shown, if no major rehabilitation work is completed in the next 10 years at your airport, the average PCI may be 11 points less than a plan that provides timely repairs to the airfield pavements.

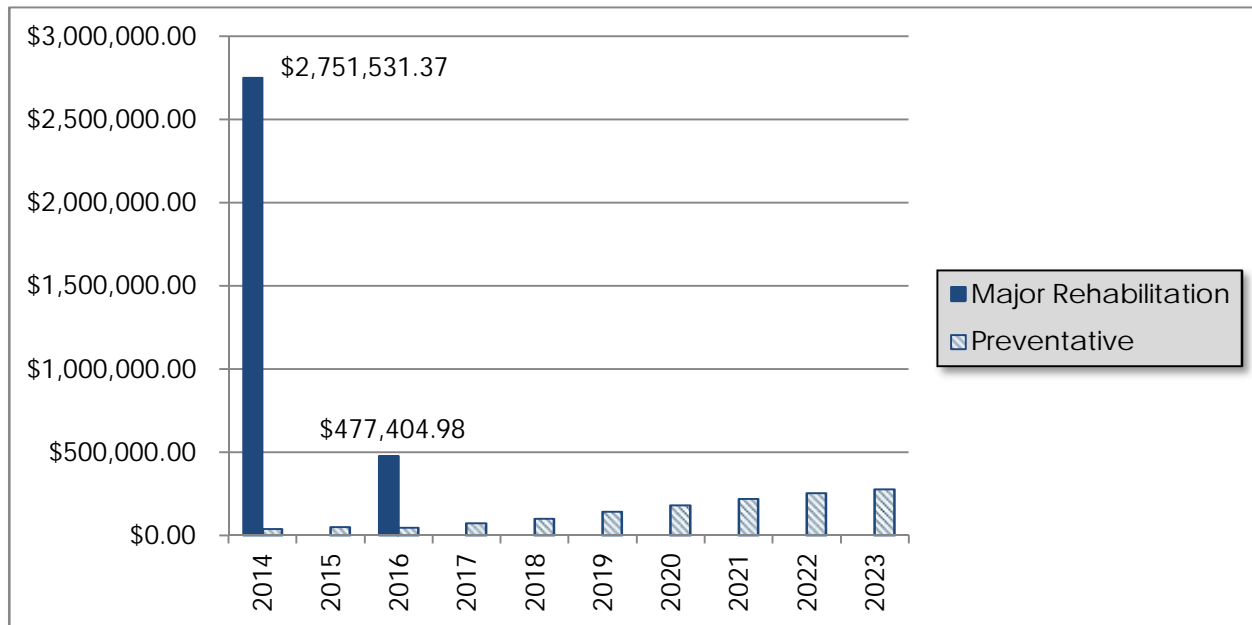
Figure 7-1: 10-Year Preventative and Major Rehabilitation Summary

In an effort to identify appropriate budget levels, the 10-year Preventative and Major Rehabilitation analysis evaluated projected budget needs based on predicted PCI of each pavement section. Table 7-1 and Figure 7-1 provides a summary of the expected preventative and major rehabilitation for each program year.

According to the most recent inspections at the time of this update; the following pavement sections were identified as a Year-1 need for major rehabilitation:

- Runway 17-35 – Section 6110
  - Mill and Overlay attributed to distresses related to climate and age of pavement.
- Taxiway D – Section 110
  - Mill and Overlay attributed to distresses related to subgrade quality, climate, and age of pavement.
