FLORIDA DEPARTMENT OF TRANSPORTATION
AVIATION AND SPACEPORT OFFICE

DADE-COLLIER
TRAINING AND
TRANSITION
CENTER (TNT)

DECEMBER 2013

STATEWIDE
**Airfield
Pavement
Management**
PROGRAM

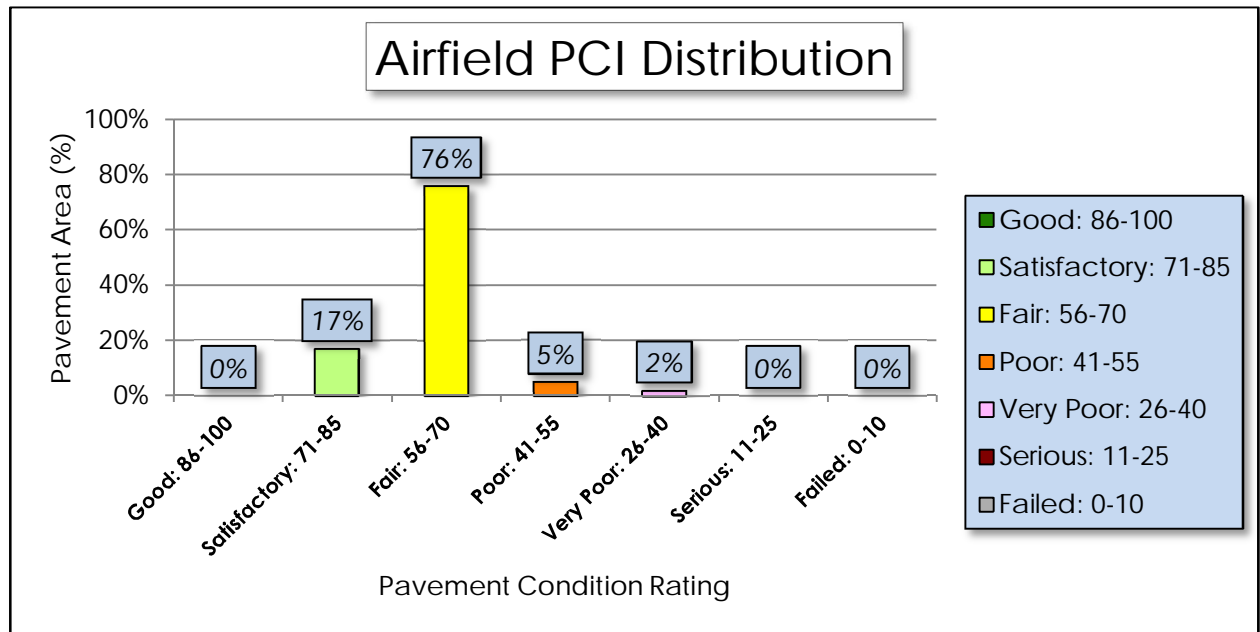
Figure 3-1: Airfield Pavement Condition Index Rating Summary

The pavement condition at Dade-Collier Training and Transition Airport is represented in Figure 3-1 in accordance with the condition categories and PCI scale referenced in ASTM D 5340. Further detail is provided in Table 3-3 which describes the breakdown of the airport's airfield conditions according to area and use.

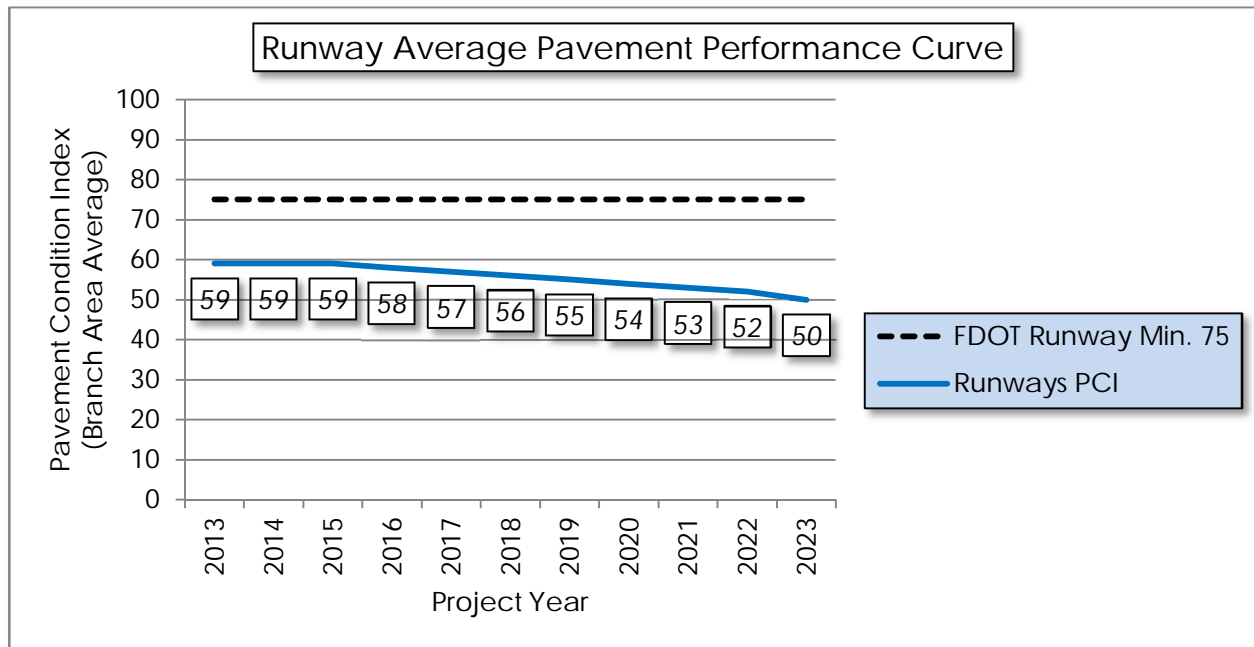
Figure 4-1: Runway Pavement Performance Prediction Summary

Each airport's airfield pavement section condition, for a given inspection year, is one data point that was used as the basis of each performance trend using a performance model based on pavements of similar background. Figures 4-1, 4-2, and 4-3 represent the pavement performance prediction at Dade-Collier Training and Transition Airport based on pavement use. Each figure depicts the FDOT recommended Minimum Service Level PCI value for each pavement type.

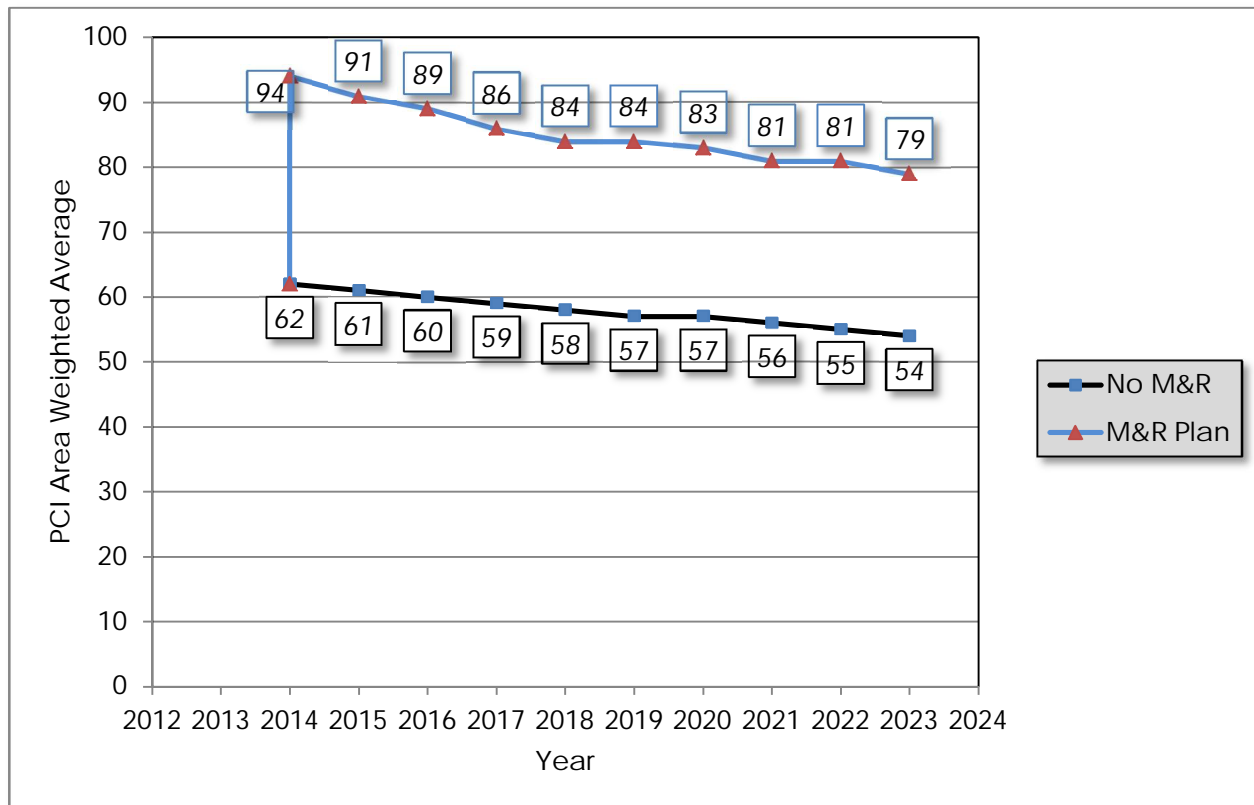
Figure 6-1: 10-Year Major Rehabilitation Budget Scenario Analysis

The 10-year major rehabilitation program addresses those pavement sections that have a current or project PCI that is below the Critical PCI of 65 during the 10-year analysis period. The unconstrained or “unlimited budget” Major Rehabilitation Program is compared to a “No Major Rehabilitation Program” scenario in Figure 6-1. As shown, if no major rehabilitation work is completed in the next 10 years at your airport, the average PCI may be 25 points less than a plan that provides timely repairs to the airfield pavements.

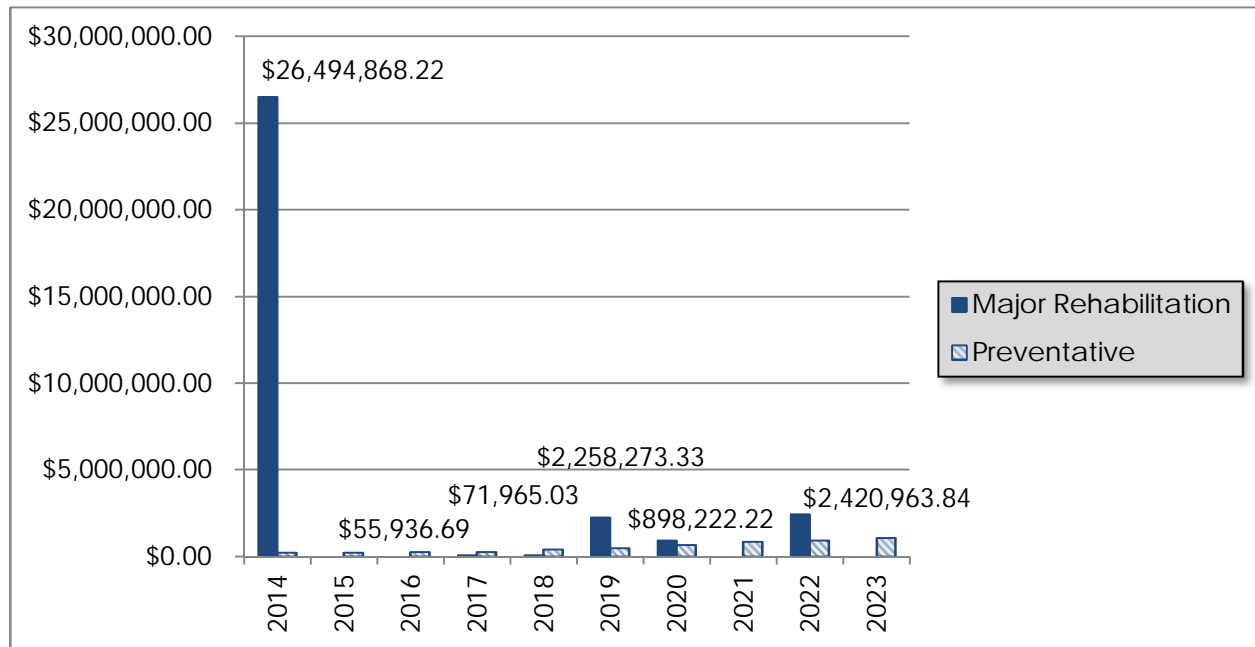
Figure 7-1: 10-Year Preventative and Major Rehabilitation Summary

In an effort to identify appropriate budget levels, the 10-year Preventative and Major Rehabilitation analysis evaluated projected budget needs based on predicted PCI of each pavement section. Table 7-1 and Figure 7-1 provides a summary of the expected preventative and major rehabilitation for each program year.

- ⦿ Runway 9-27 – Sections 6110 and 6105
 - Mill and Overlay attributed to distresses related to subgrade quality, climate, and age of pavement.
- ⦿ North Apron – Section 4105
 - Mill and Overlay attributed to distresses related to climate and age of pavement.
- ⦿ Taxiway B – Section 215
 - Mill and Overlay attributed to distresses related to climate and age of pavement.
- ⦿ Taxiway A6 – Section 170
 - Mill and Overlay attributed to distresses related to climate and age of pavement.
- ⦿ Taxiway A1 – Section 120
 - Reconstruction attributed to distresses related to climate and age of pavement.
- ⦿ Taxiway A – Sections 110 and 105
 - Mill and Overlay attributed to distresses related to loading, climate, and age of pavement.
