FLORIDA DEPARTMENT OF TRANSPORTATION  
AVIATION AND SPACEPORT OFFICE

**CECIL AIRPORT (VOQ)**

DECEMBER 2013

STATEWIDE  
**Airfield  
Pavement  
Management**  
PROGRAM

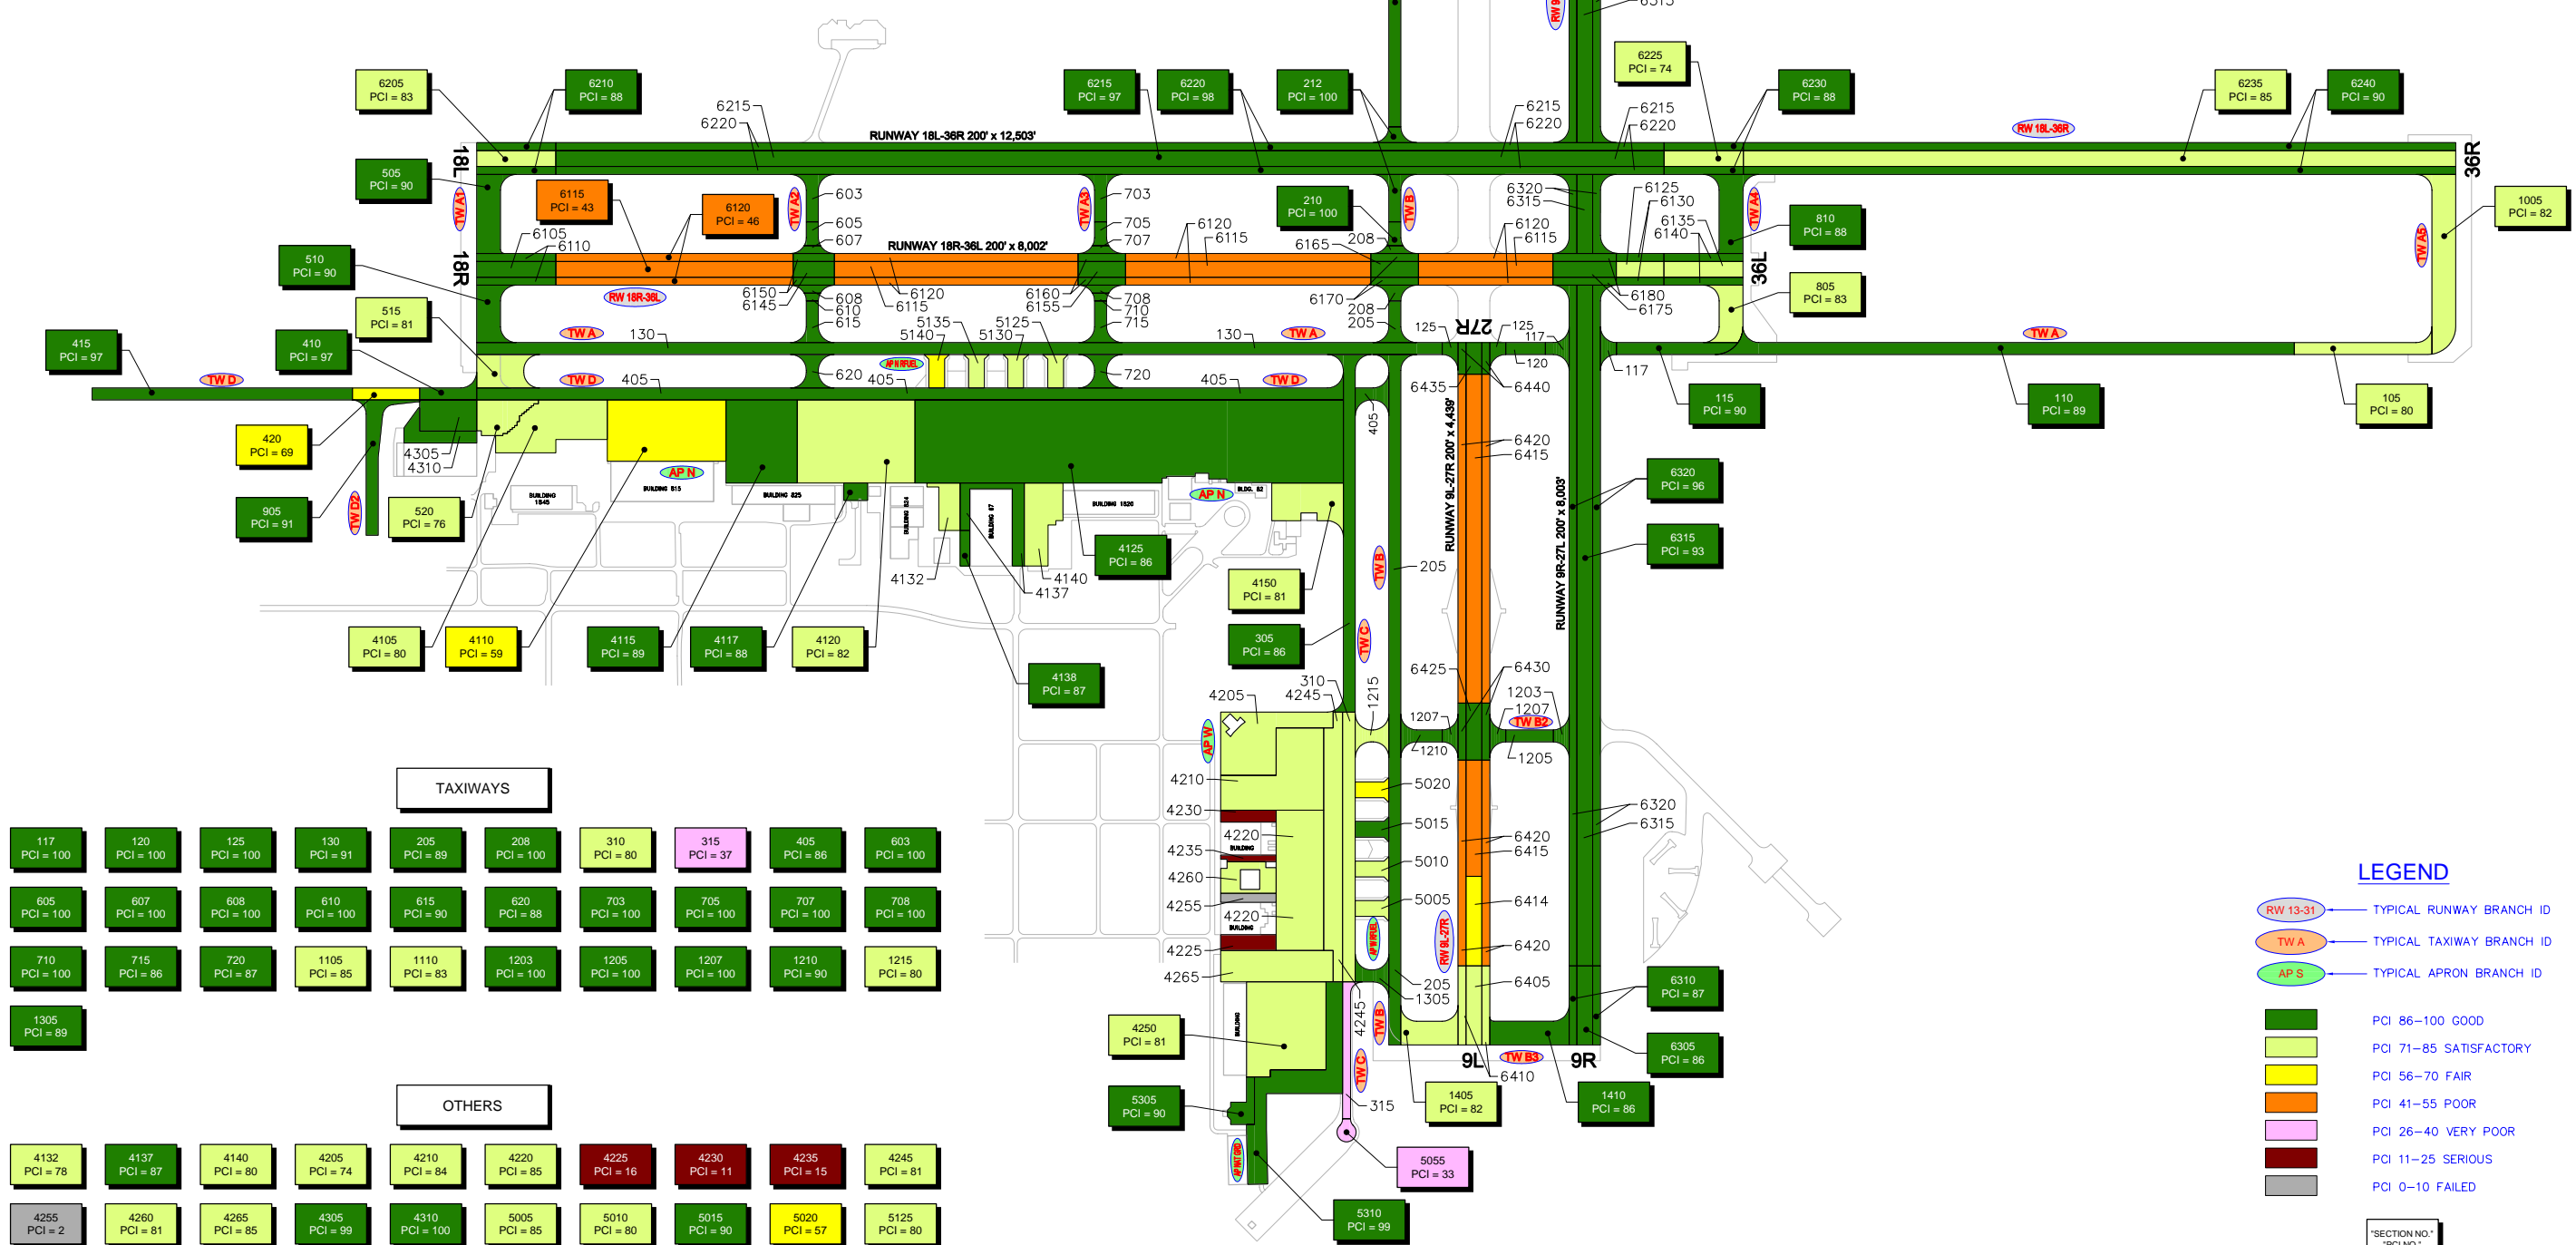
- AIRFIELD PAVEMENT CONDITION INDEX RATING EXHIBIT
- PAVEMENT CONDITION INDEX INVENTORY

6105 PCI = 90	6110 PCI = 89	6125 PCI = 79	6130 PCI = 91	6135 PCI = 85	6140 PCI = 91	6145 PCI = 100	6150 PCI = 100	6155 PCI = 100	6160 PCI = 98
6165 PCI = 100	6170 PCI = 100	6175 PCI = 95	6180 PCI = 96	6325 PCI = 92	6330 PCI = 91	6335 PCI = 86	6340 PCI = 79	6405 PCI = 84	6410 PCI = 83
6414 PCI = 62	6415 PCI = 41	6420 PCI = 46	6425 PCI = 98	6430 PCI = 100	6435 PCI = 100	6440 PCI = 100

117 PCI = 100	120 PCI = 100	125 PCI = 100	130 PCI = 91	205 PCI = 89	208 PCI = 100	310 PCI = 80	315 PCI = 37	405 PCI = 86	603 PCI = 100
605 PCI = 100	607 PCI = 100	608 PCI = 100	610 PCI = 100	615 PCI = 90	620 PCI = 88	703 PCI = 100	705 PCI = 100	707 PCI = 100	708 PCI = 100
710 PCI = 100	715 PCI = 86	720 PCI = 87	1105 PCI = 85	1110 PCI = 83	1203 PCI = 100	1205 PCI = 100	1207 PCI = 100	1210 PCI = 90	1215 PCI = 80
1305 PCI = 89

4132 PCI = 78	4137 PCI = 87	4140 PCI = 80	4205 PCI = 74	4210 PCI = 84	4220 PCI = 85	4225 PCI = 16	4230 PCI = 11	4235 PCI = 15	4245 PCI = 81
4255 PCI = 2	4260 PCI = 81	4265 PCI = 85	4305 PCI = 99	4310 PCI = 100	5005 PCI = 85	5010 PCI = 80	5015 PCI = 90	5020 PCI = 57	5125 PCI = 80
5130 PCI = 83	5135 PCI = 76	5140 PCI = 61

- Runway 9L-27R – Sections 6420, 6415, and 6414
  - Mill and Overlay attributed to distresses related to loading, subgrade quality, climate, and age of pavement.
- Runway 18R-36L – Sections 6120 and 6115
  - Mill and Overlay attributed to distresses related to loading, subgrade quality, climate, and age of pavement.
- N Hot Refueling and Compass Rose AP – Section 5140
  - PCC Restoration attributed to distresses related to loading.
- W Hot Refueling and Compass Rose AP – Section 5055
  - Reconstruction attributed to distresses related to loading and construction quality.
- W Hot Refueling and Compass Rose AP – Section 5020
  - PCC Restoration attributed to distresses related to loading and construction quality.
