FLORIDA DEPARTMENT OF TRANSPORTATION
AVIATION AND SPACEPORT OFFICE

LA BELLE
MUNICIPAL
AIRPORT (X14)

DECEMBER 2013

STATEWIDE
**Airfield
Pavement
Management**
PROGRAM

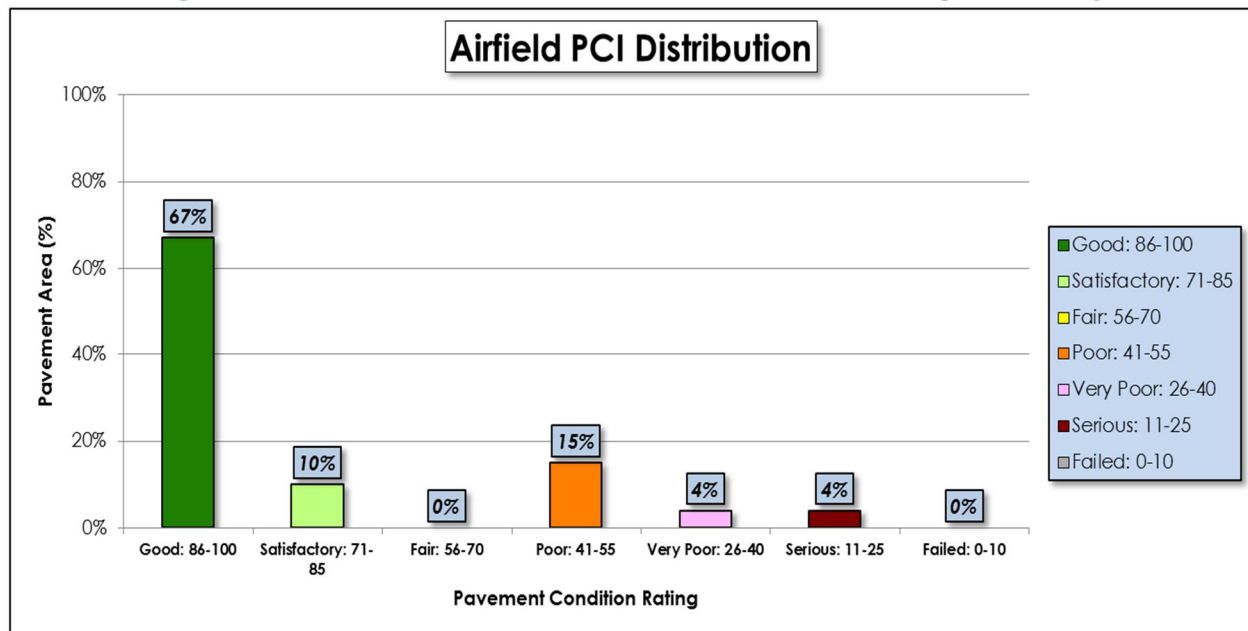
Figure 3-1: Airfield Pavement Condition Index Rating Summary

The pavement condition at La Belle Municipal Airport is represented in Figure 3-1 in accordance with the condition categories and PCI scale referenced in ASTM D 5340. Further detail is provided in Table 3-3 which describes the breakdown of the airport's airfield conditions according to area and use.

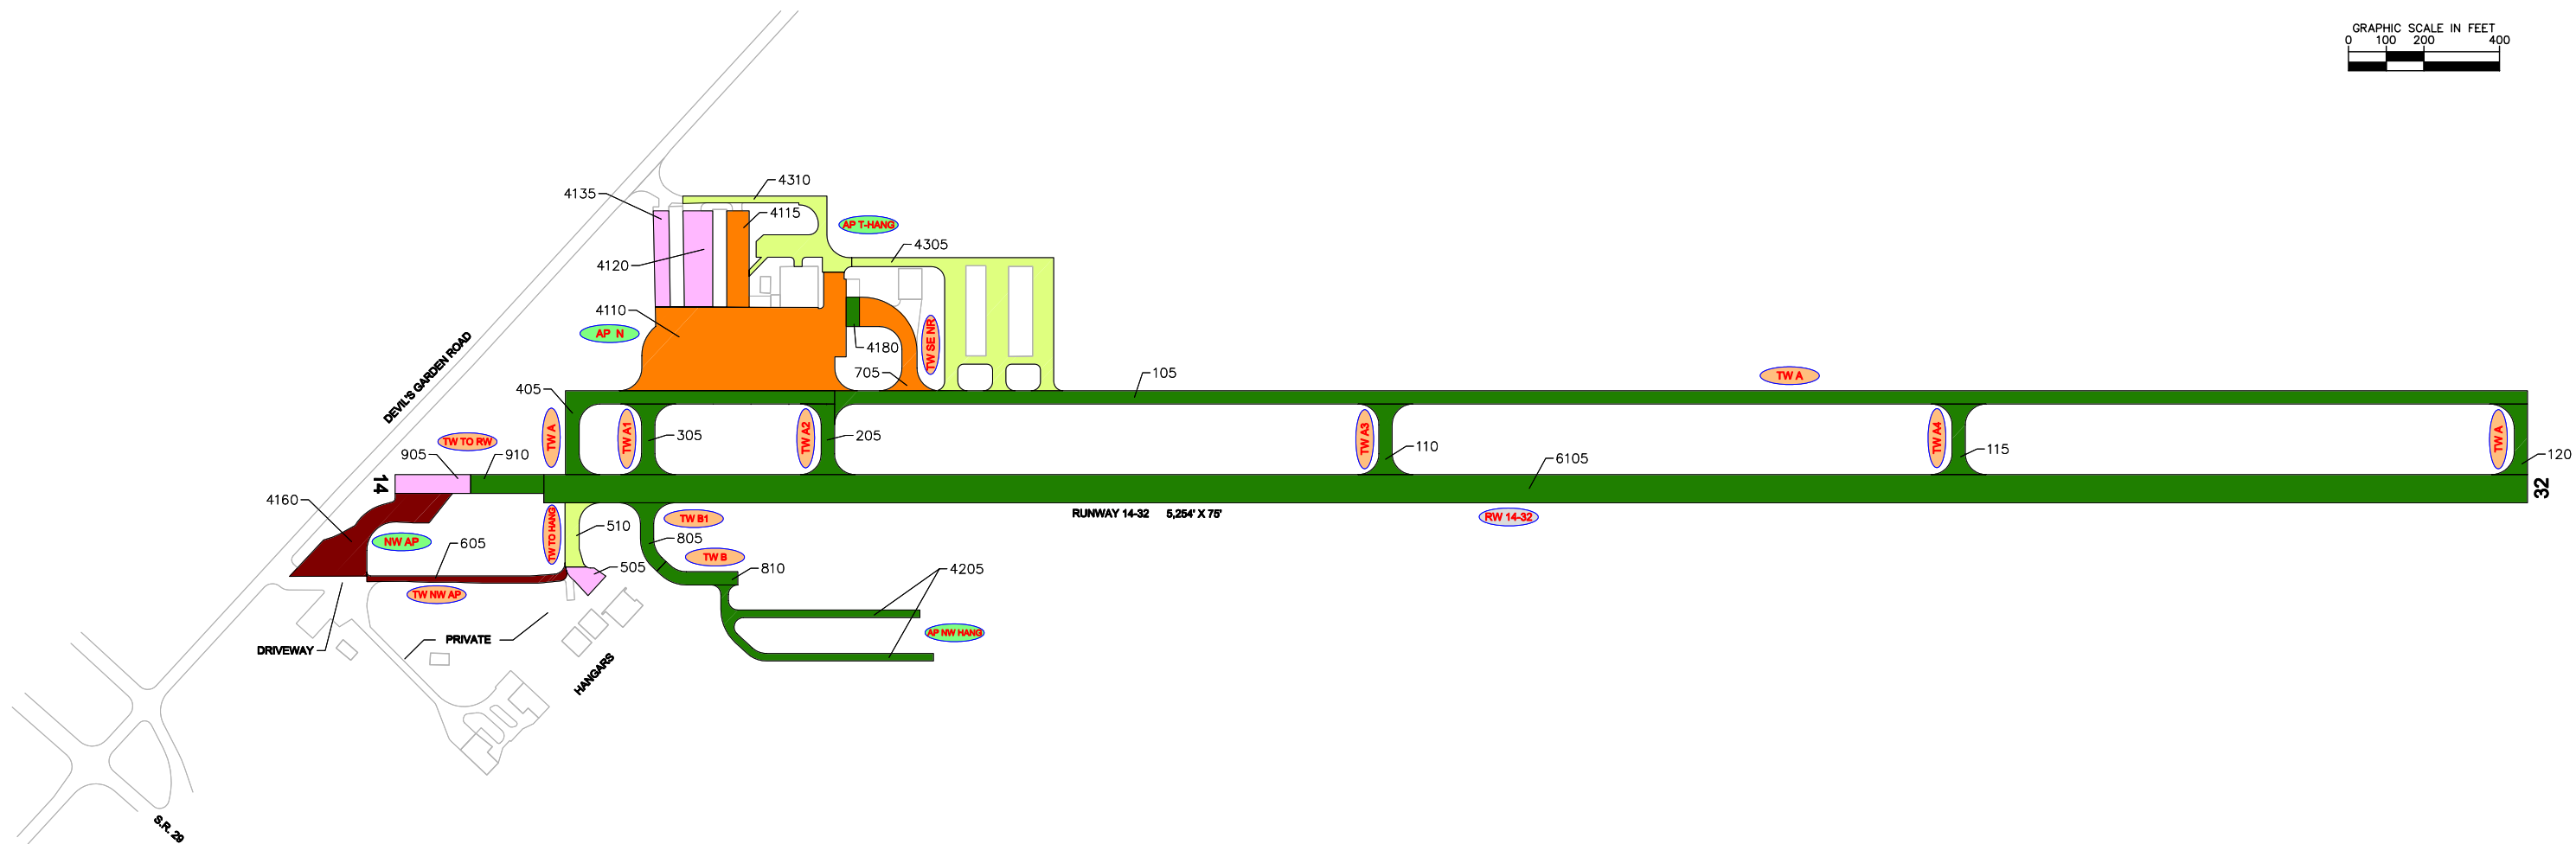
RUNWAY	
6105	PCI = 91

TAXIWAY									
105	PCI = 94	110	PCI = 90	115	PCI = 91	120	PCI = 91	205	PCI = 92
305	PCI = 95	405	PCI = 95	505	PCI = 29	510	PCI = 71	605	PCI = 20
705	PCI = 54	805	PCI = 100	810	PCI = 100	905	PCI = 40	910	PCI = 89
