FLORIDA DEPARTMENT OF TRANSPORTATION
AVIATION AND SPACEPORT OFFICE

**DUNNELLON/
MARION COUNTY
AIRPORT (X35)**

DECEMBER 2013

STATEWIDE
**Airfield
Pavement
Management**
PROGRAM

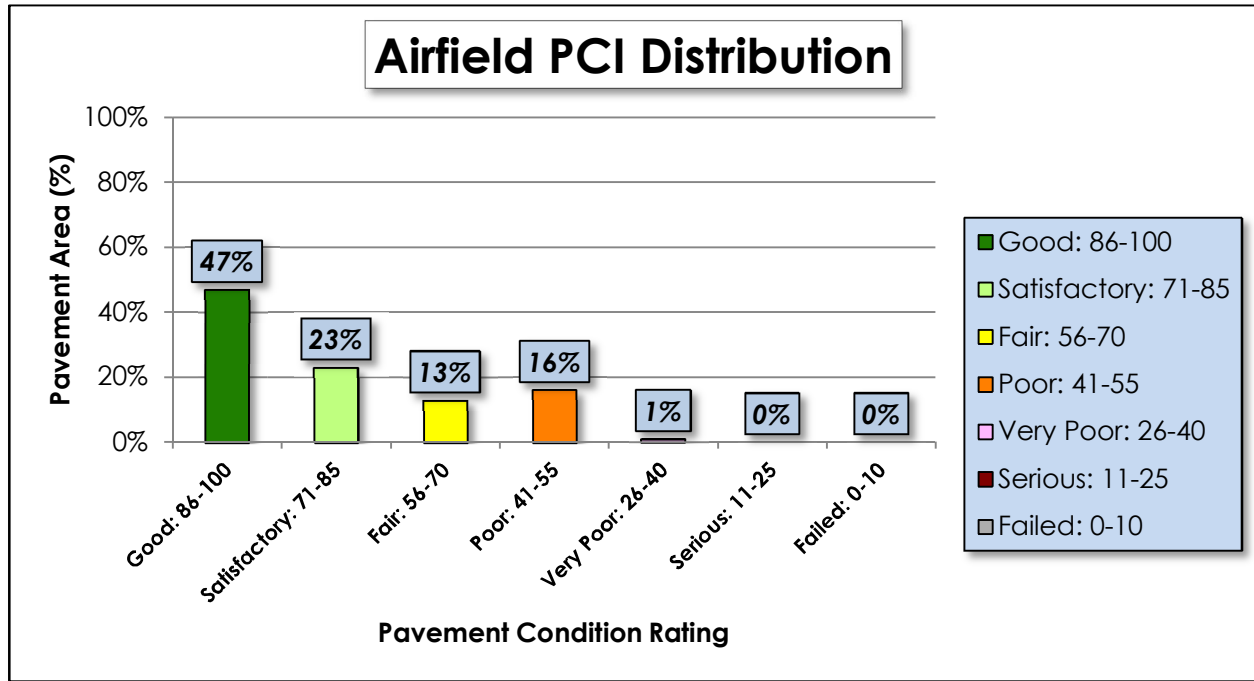
Figure 3-1: Airfield Pavement Condition Index Rating Summary

The pavement condition at Dunnellon / Marion County Airport is represented in **Figure 3-1** in accordance with the condition categories and PCI scale referenced in ASTM D 5340. Further detail is provided in **Table 3-3** which describes the breakdown of the airport's airfield conditions according to area and use.

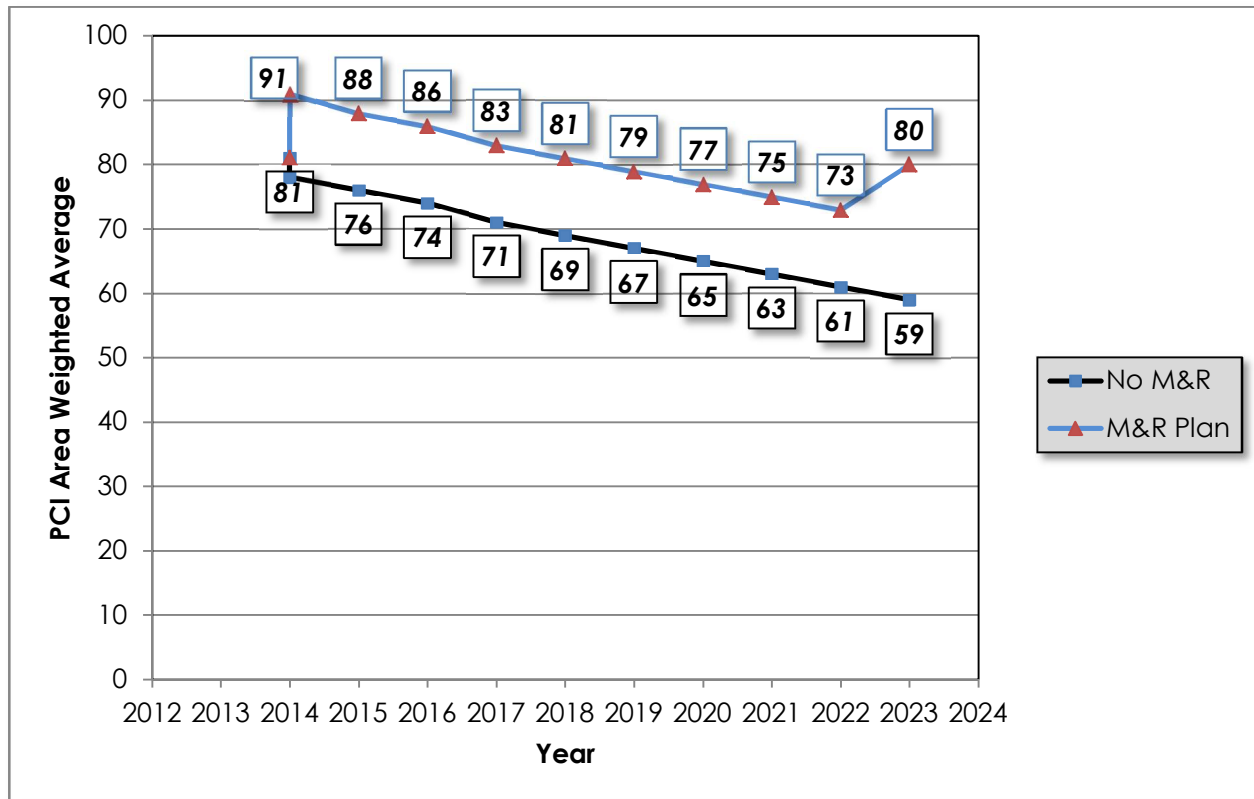
Figure 6-1: 10-Year Major Rehabilitation Budget Scenario Analysis

The 10-year major rehabilitation program addresses those pavement sections that have a current or project PCI that is below the Critical PCI of 65 during the 10-year analysis period. The unconstrained or “unlimited budget” Major Rehabilitation Program is compared to a “No Major Rehabilitation Program” scenario in **Figure 6-1**. As shown, if no major rehabilitation work is completed in the next 10 years at your airport, the average PCI may be 21 points less than a plan that provides timely repairs to the airfield pavements.
