**BOCA RATON
AIRPORT (BCT)**

DISTRICT 4
REGIONAL RELIEVER
AIRPORT
JUNE 2015

STATEWIDE Airfield Pavement Management PROGRAM

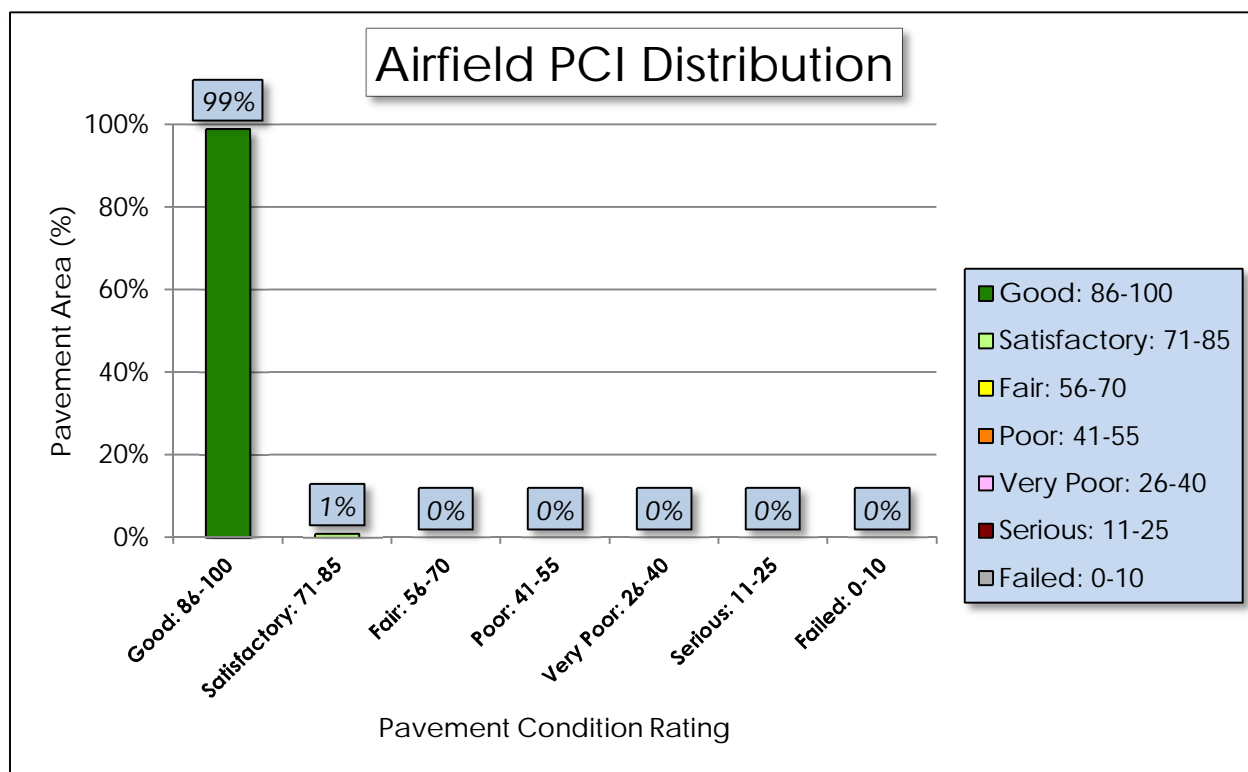
Figure 3-1: Airfield Pavement Condition Index Rating Summary

The pavement condition at Boca Raton Airport is represented in Figure 3-1 in accordance with the condition categories and PCI scale referenced in ASTM D 5340. Further detail is provided in Table 3-3 which describes the breakdown of the airport's airfield conditions according to area and use.
