**CLEARWATER
AIRPARK (CLW)**

DISTRICT 7
REGIONAL RELIEVER
AIRPORT
JUNE 2015

STATEWIDE
**Airfield
Pavement
Management**
PROGRAM

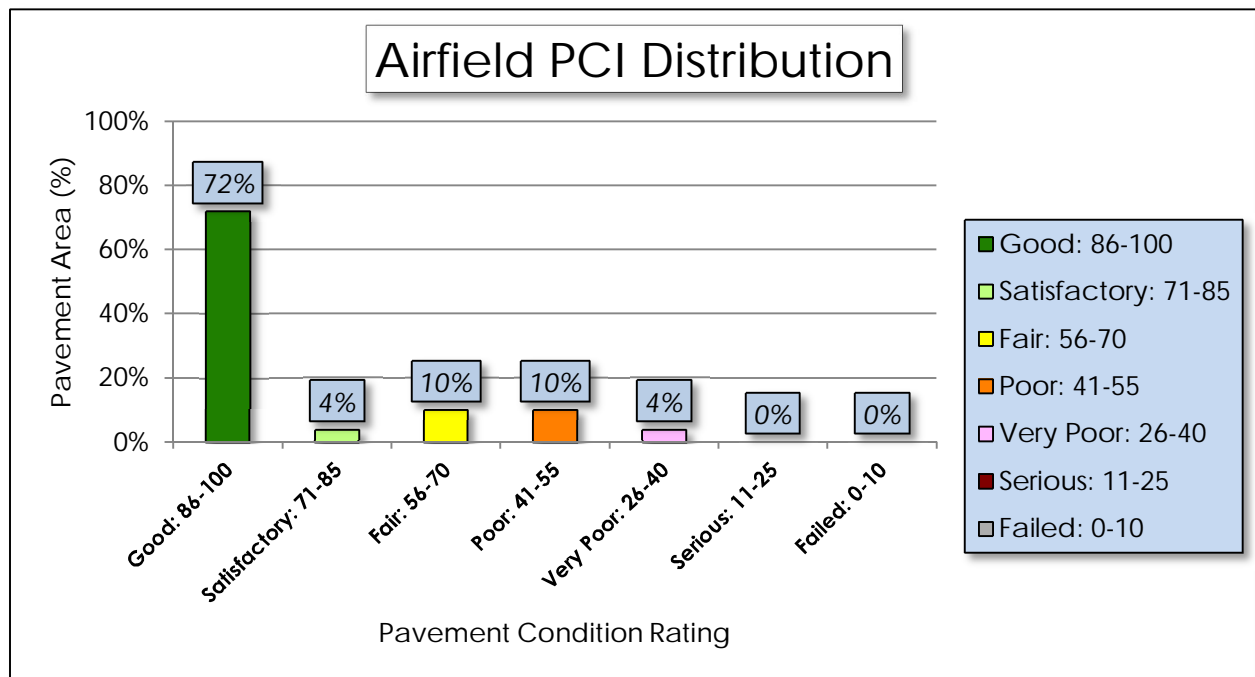
Figure 3-1: Airfield Pavement Condition Index Rating Summary

The pavement condition at Clearwater Airpark is represented in Figure 3-1 in accordance with the condition categories and PCI scale referenced in ASTM D 5340. Further detail is provided in Table 3-3 which describes the breakdown of the airport's airfield conditions according to area and use.

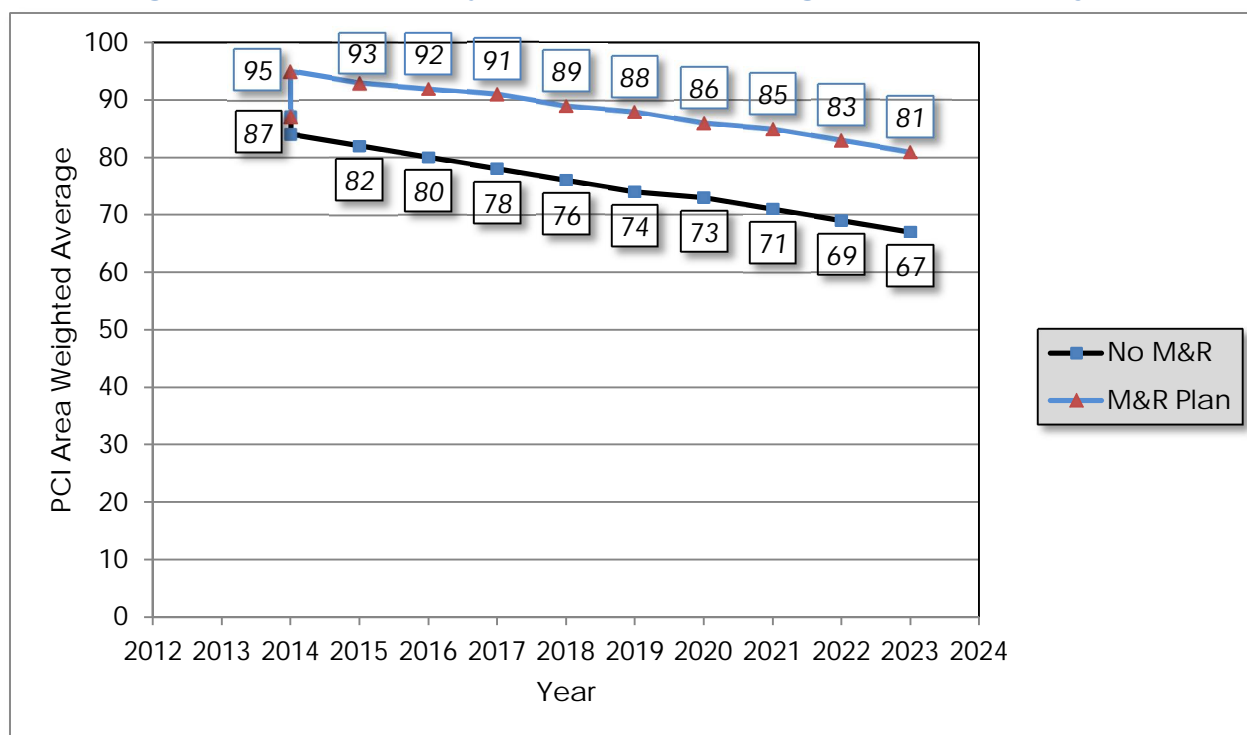
Figure 6-1: 10-Year Major Rehabilitation Budget Scenario Analysis

The 10-year major rehabilitation program addresses those pavement sections that have a current or project PCI that is below the Critical PCI of 65 during the 10-year analysis period. The unconstrained or “unlimited budget” Major Rehabilitation Program is compared to a “No Major Rehabilitation Program” scenario in Figure 6-1. As shown, if no major rehabilitation work is completed in the next 10 years at your airport, the average PCI may be 14 points less than a plan that provides timely repairs to the airfield pavements.
