**JACKSONVILLE
EXECUTIVE AT
CRAIG AIRPORT (CRG)**

DISTRICT 2
REGIONAL RELIEVER
AIRPORT
JUNE 2015

STATEWIDE
**Airfield
Pavement
Management**
PROGRAM

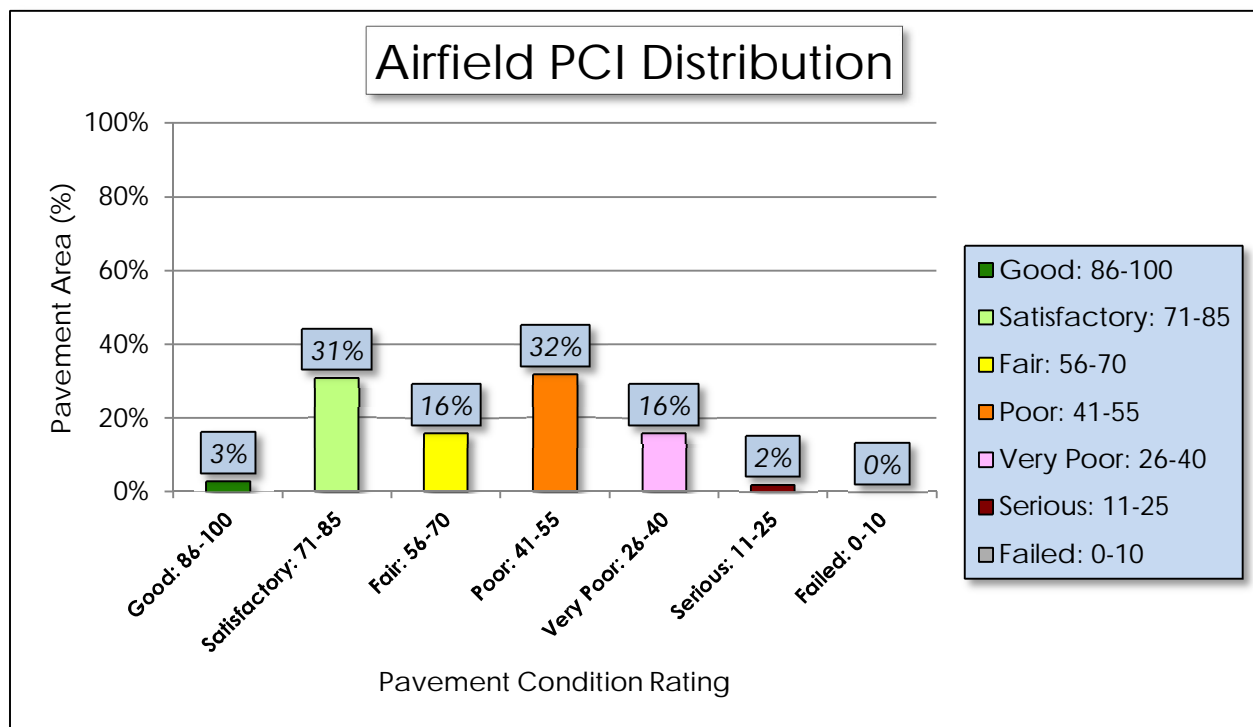
Figure 3-1: Airfield Pavement Condition Index Rating Summary

The pavement condition at Jacksonville Executive at Craig Airport is represented in Figure 3-1 in accordance with the condition categories and PCI scale referenced in ASTM D 5340. Further detail is provided in Table 3-3 which describes the breakdown of the airport's airfield conditions according to area and use.

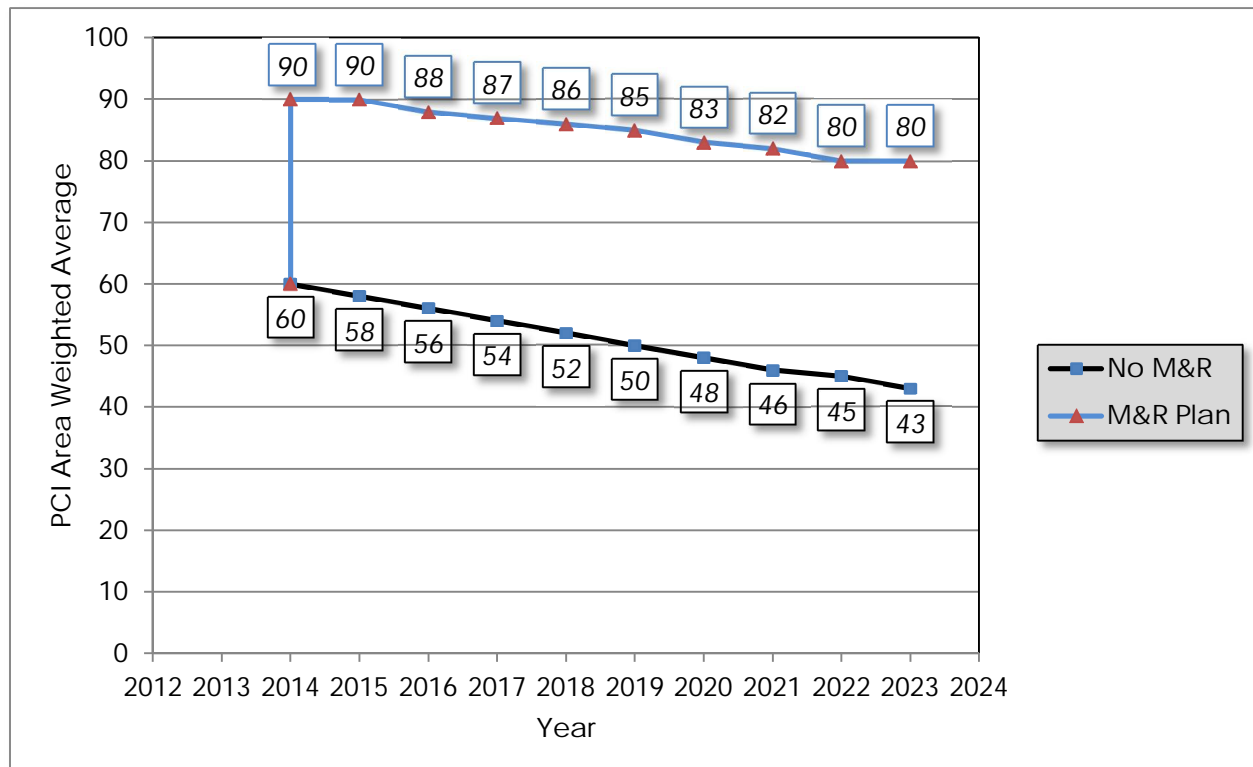
Figure 6-1: 10-Year Major Rehabilitation Budget Scenario Analysis

The 10-year major rehabilitation program addresses those pavement sections that have a current or project PCI that is below the Critical PCI of 65 during the 10-year analysis period. The unconstrained or “unlimited budget” Major Rehabilitation Program is compared to a “No Major Rehabilitation Program” scenario in Figure 6-1. As shown, if no major rehabilitation work is completed in the next 10 years at your airport, the average PCI may be 37 points less than a plan that provides timely repairs to the airfield pavements.
