FLORIDA DEPARTMENT OF TRANSPORTATION  
AVIATION AND SPACEPORT OFFICE

**DELAND  
MUNICIPAL  
AIRPORT - SIDNEY H  
TAYLOR FIELD (DED)**

JUNE 2015

STATEWIDE  
**Airfield  
Pavement  
Management**  
PROGRAM

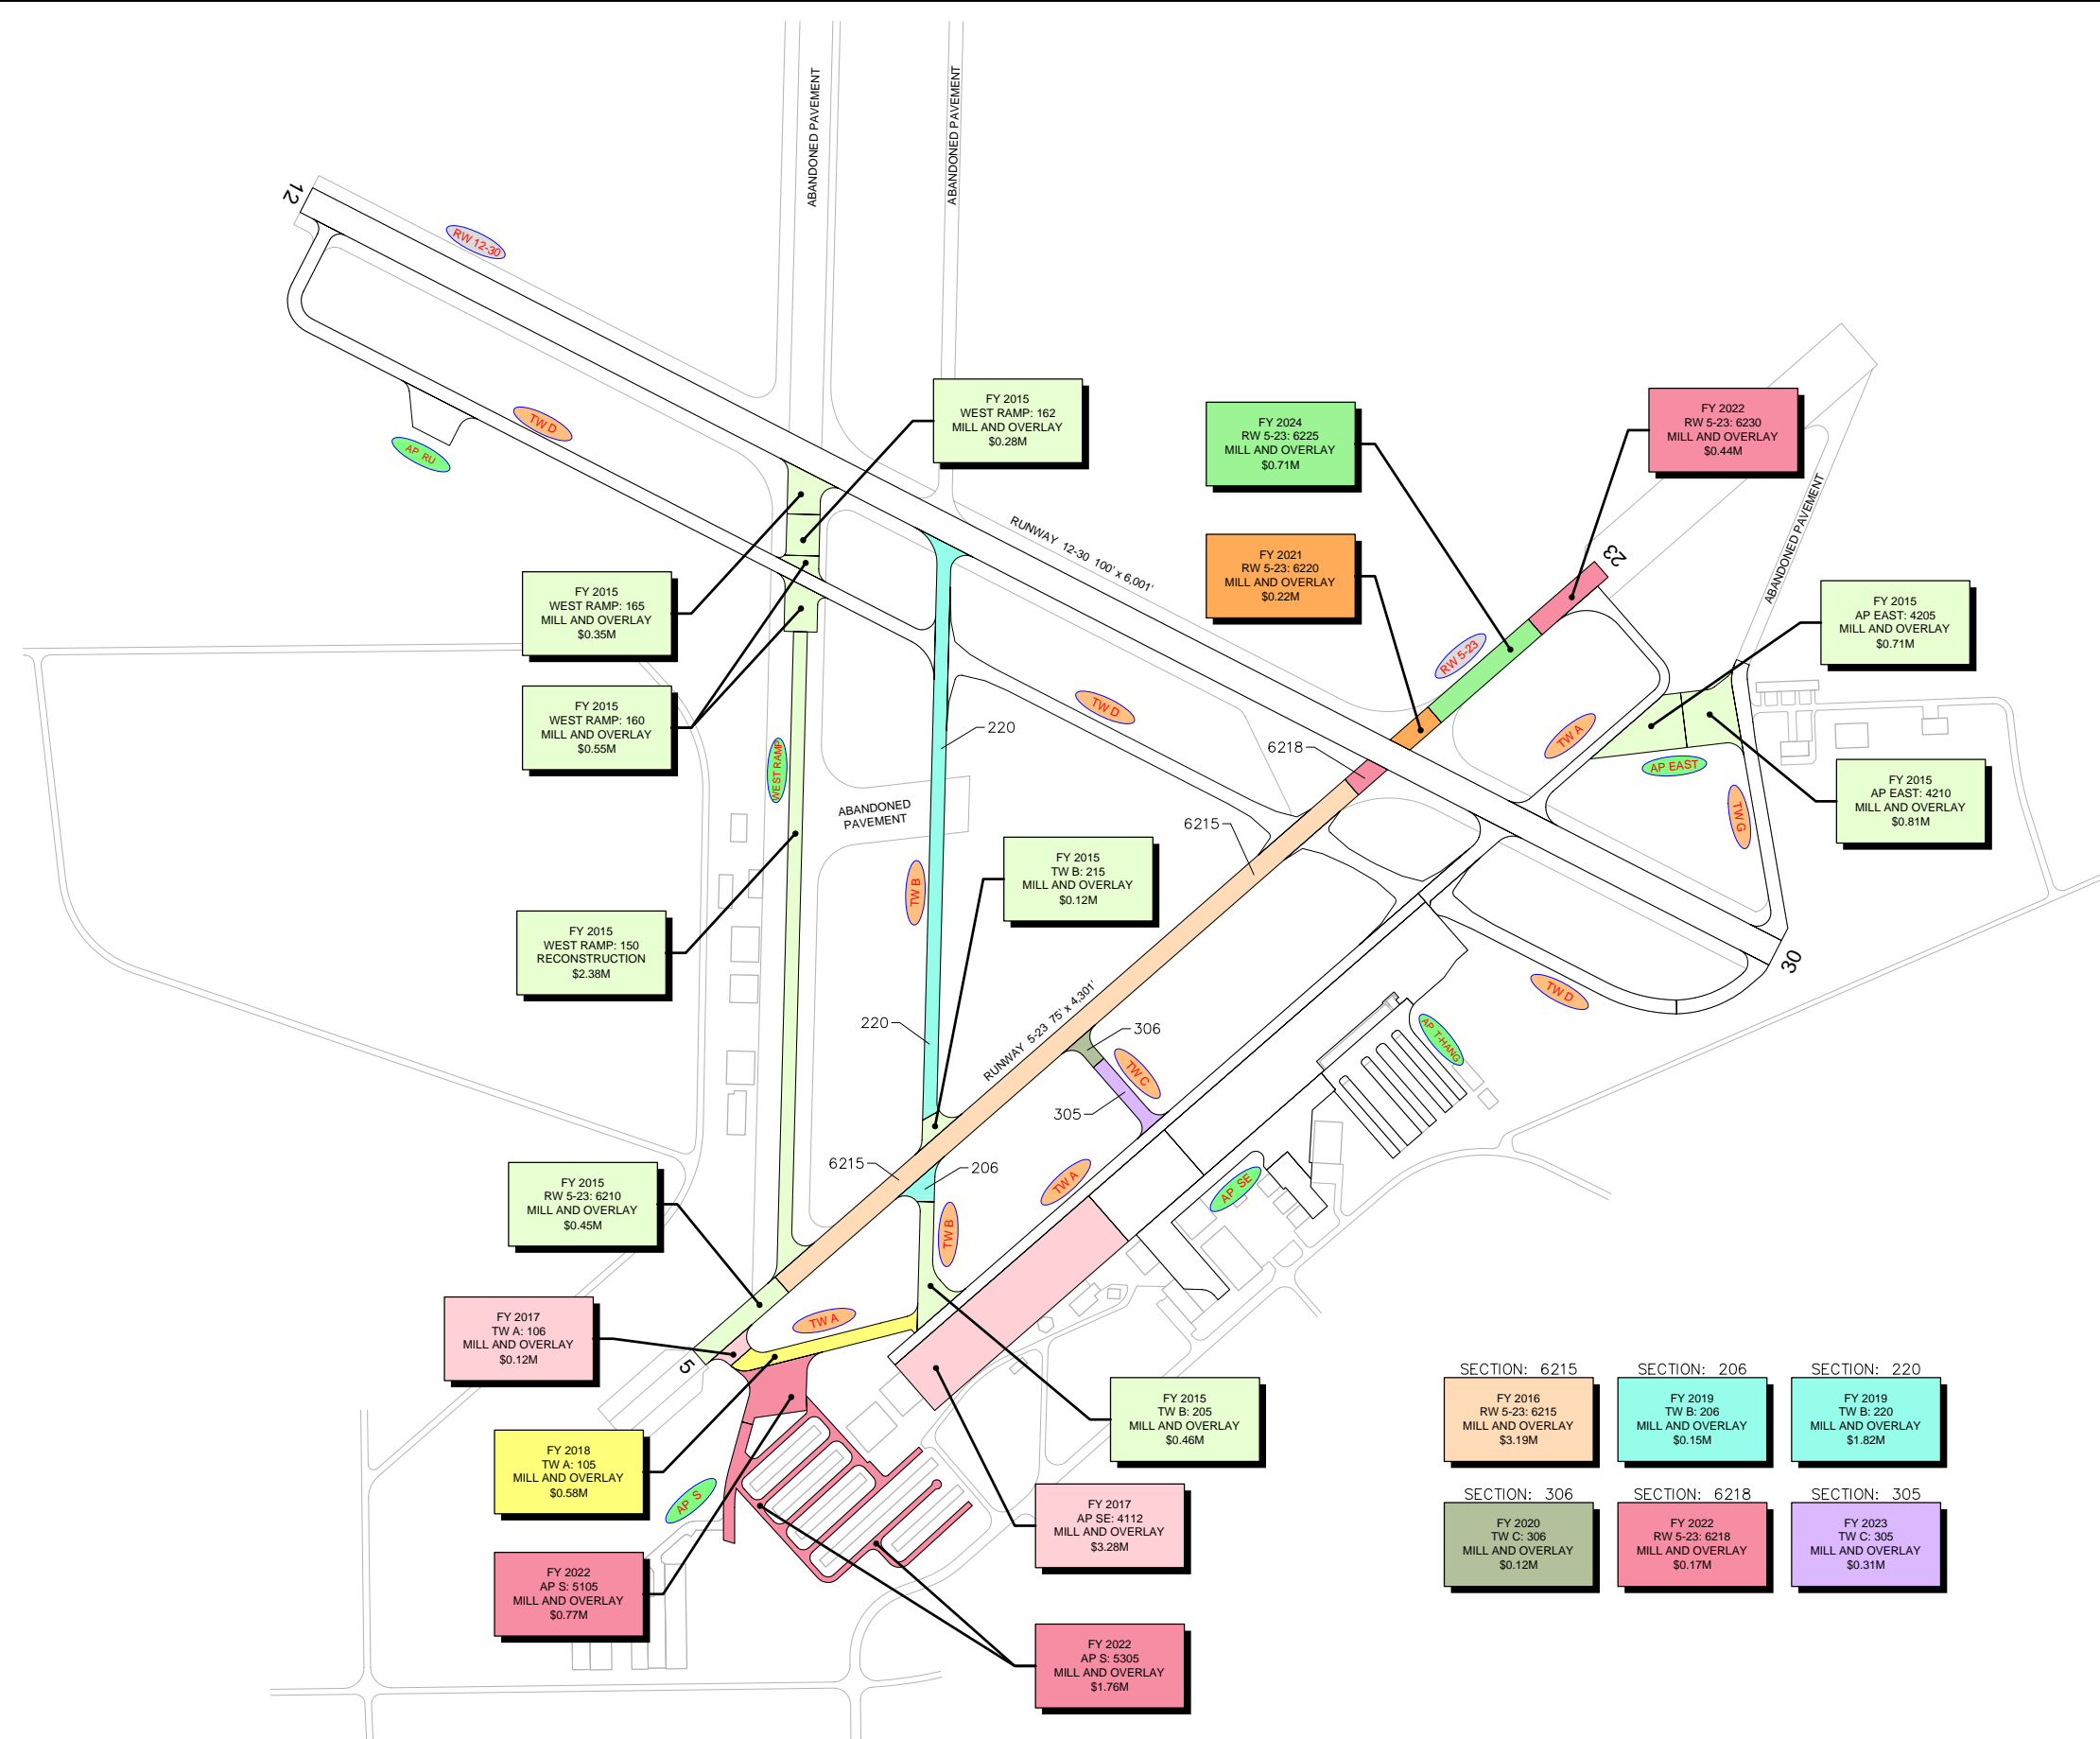
- AIRFIELD PAVEMENT 10-YEAR MAJOR REHABILITATION  
EXHIBIT
- AIRFIELD PAVEMENT 10-YEAR MAJOR REHABILITATION  
TABLE

- Runway 5-23 – Section 6210
  - Mill and Overlay attributed to climate and age of pavement.
- East Apron – Sections 4205 and 4210
  - Mill and Overlay attributed to climate and age of pavement.
- Taxiway B – Sections 205 and 215
  - Mill and Overlay attributed to climate and age of pavement.
- West Ramp – Sections 150, 160, 162, and 165
  - Reconstruction and Mill and Overlay attributed to load, climate, and age of pavement.
