**NEW SMYRNA
BEACH MUNICIPAL
AIRPORT (EVB)**

DISTRICT 5
REGIONAL RELIEVER
AIRPORT
JUNE 2015

STATEWIDE
**Airfield
Pavement
Management**
PROGRAM

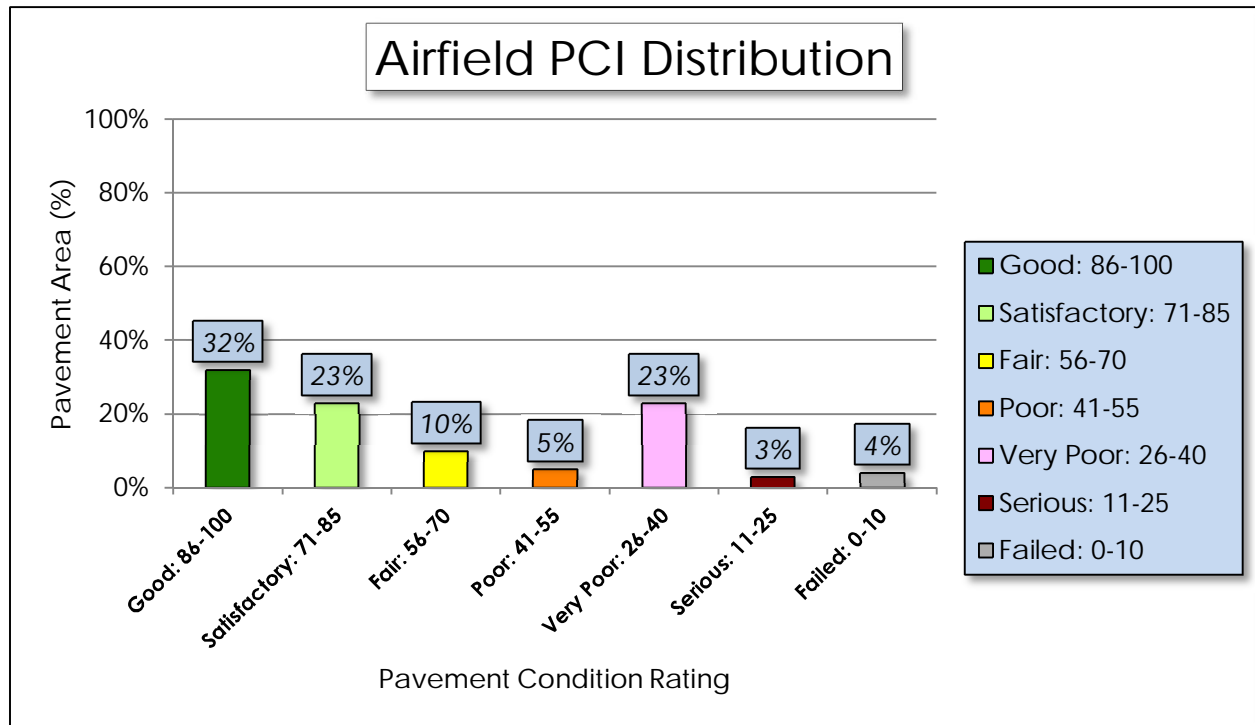
Figure 3-1: Airfield Pavement Condition Index Rating Summary

The pavement condition at New Smyrna Beach Municipal Airport is represented in Figure 3-1 in accordance with the condition categories and PCI scale referenced in ASTM D 5340. Further detail is provided in Table 3-3 which describes the breakdown of the airport's airfield conditions according to area and use.

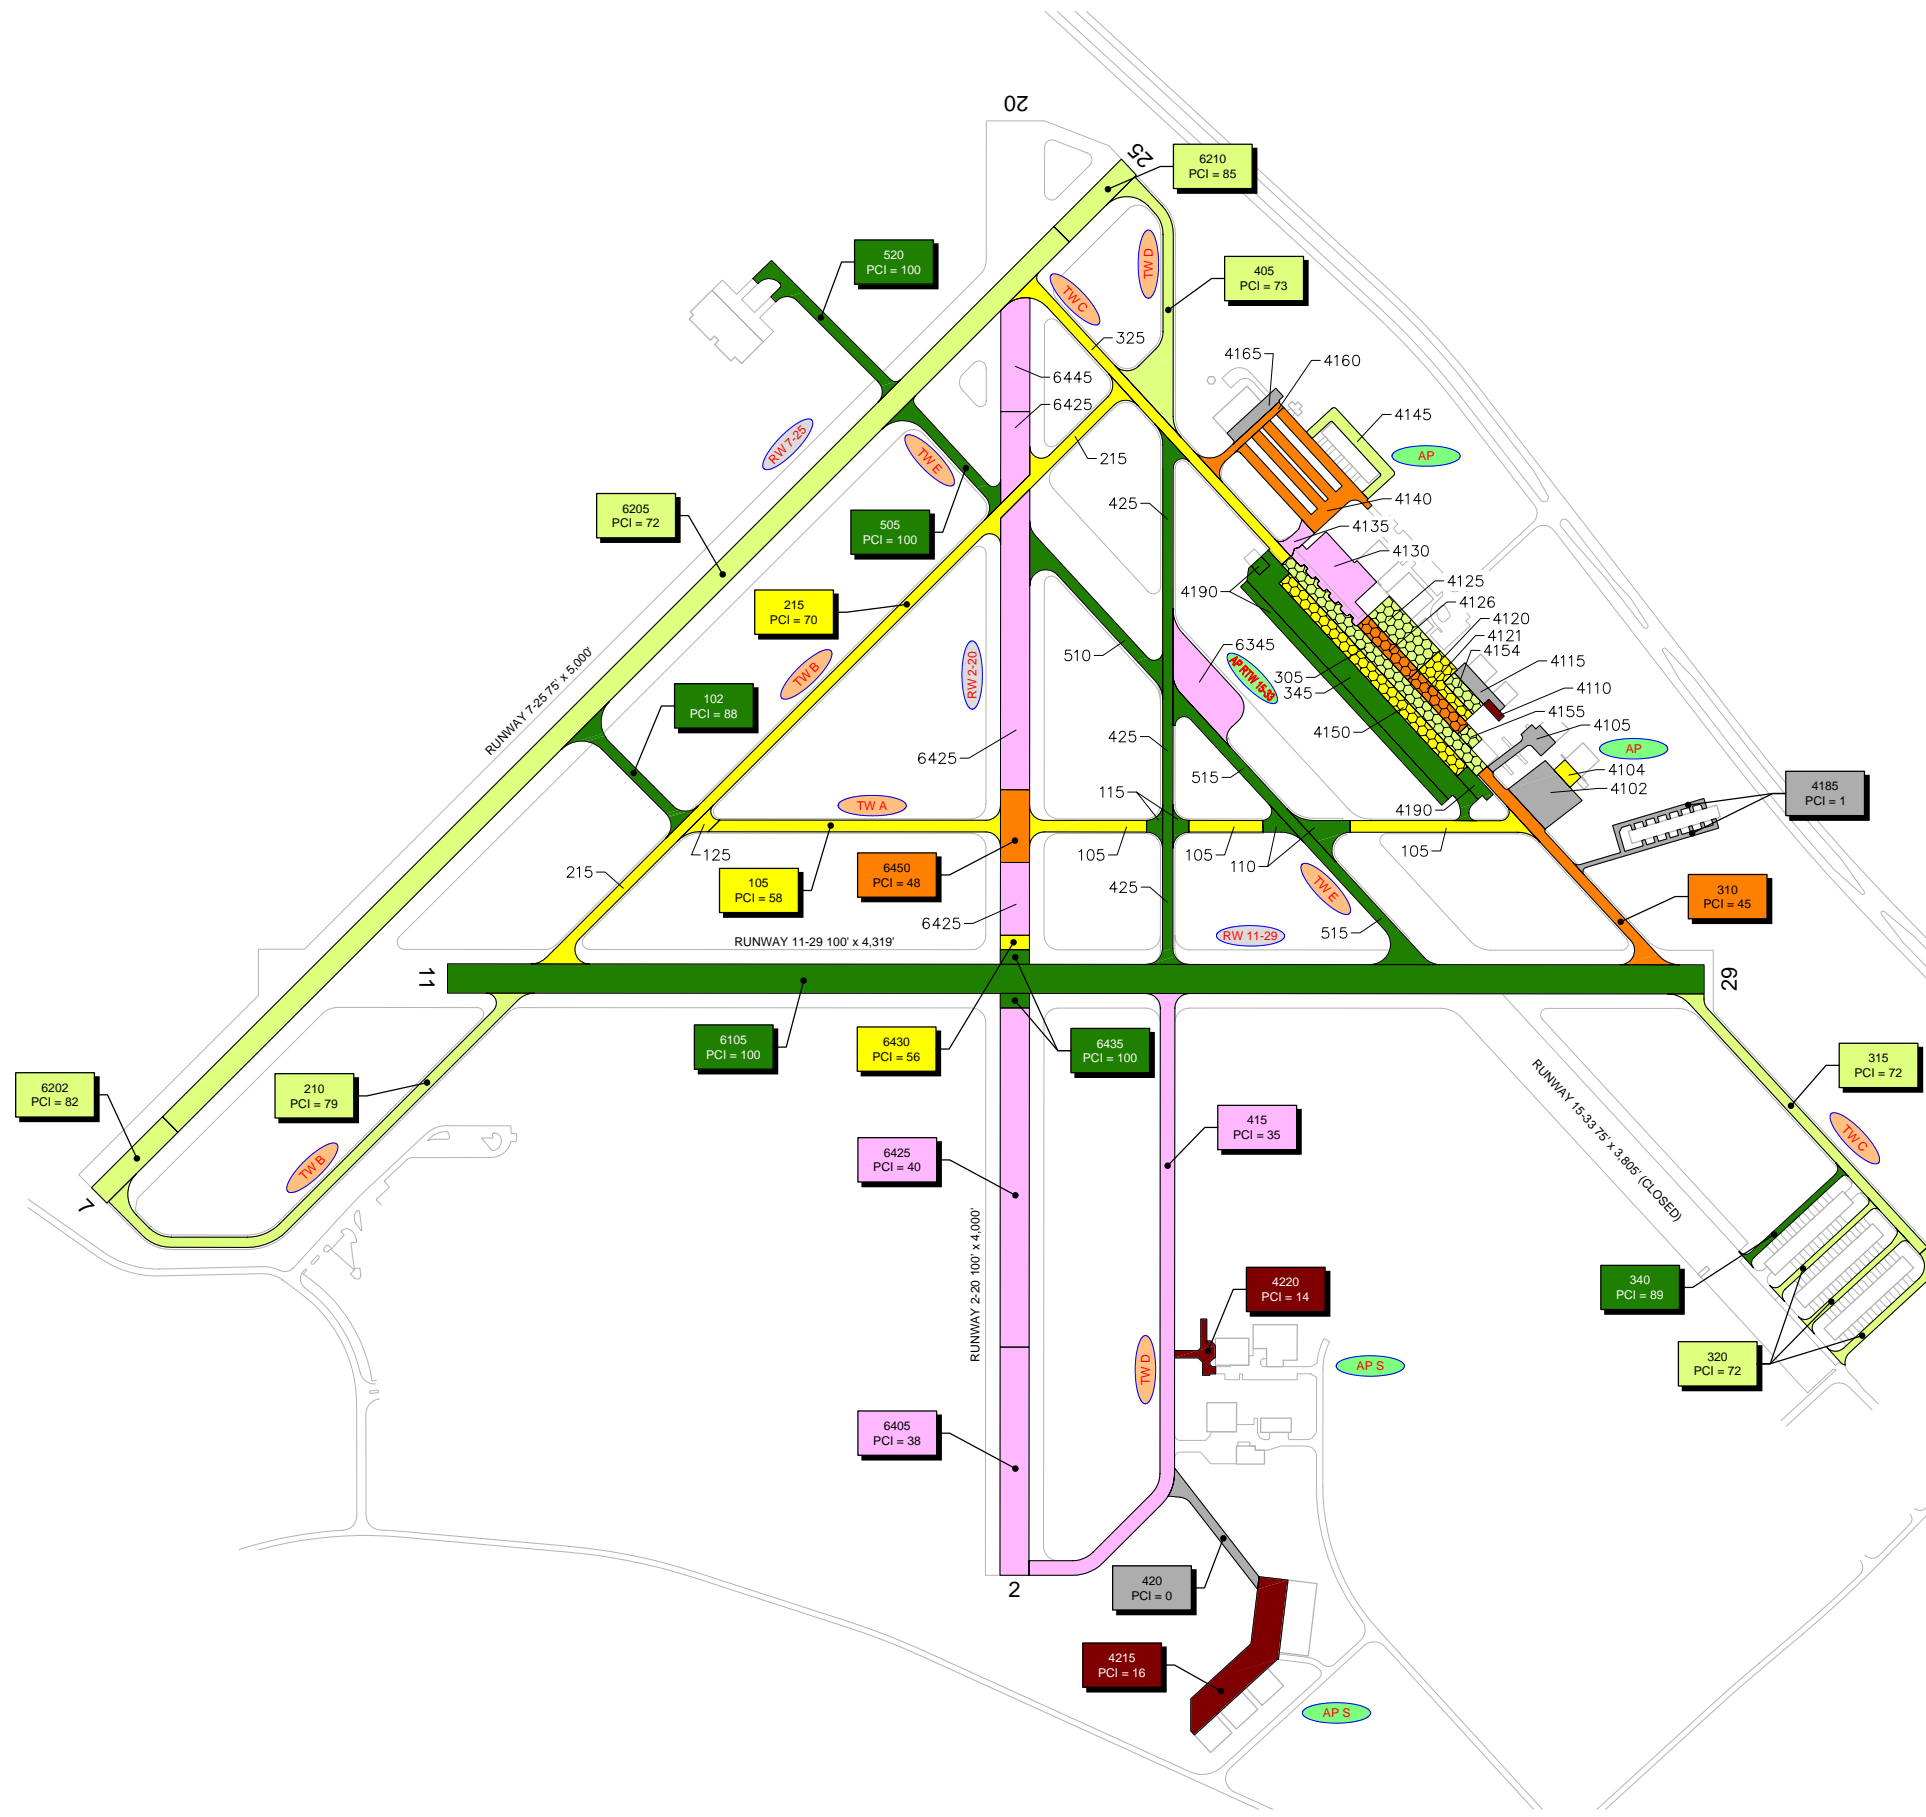
RUNWAYS	
6445	PCI = 38
TAXIWAYS	
110	PCI = 88
115	PCI = 100
125	PCI = 66
305	PCI = 78
325	PCI = 69
345	PCI = 100
425	PCI = 100
510	PCI = 100
515	PCI = 88
OTHERS	
4102	PCI = 7
4104	PCI = 59
4105	PCI = 4
4110	PCI = 13
4115	PCI = 8
4120	PCI = 65
4121	PCI = 54
4125	PCI = 74
4126	PCI = 51
4130	PCI = 34
4135	PCI = 39
4140	PCI = 44
4145	PCI = 74
4150	PCI = 68
4154	PCI = 81
4155	PCI = 72
4180	PCI = 51
4185	PCI = 4
4190	PCI = 100
6345	PCI = 37
