FLORIDA DEPARTMENT OF TRANSPORTATION  
AVIATION AND SPACEPORT OFFICE

**KEY WEST  
INTERNATIONAL  
AIRPORT (EYW)**

JUNE 2015

STATEWIDE  
**Airfield  
Pavement  
Management**  
PROGRAM

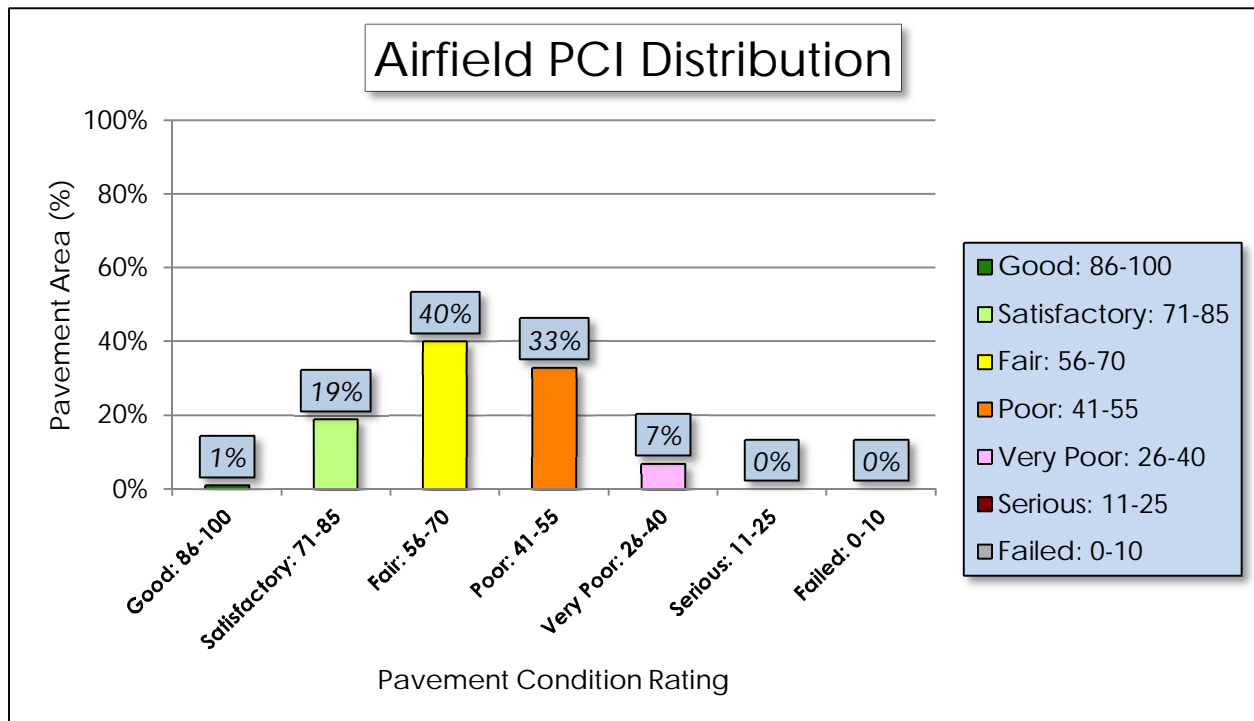
Figure 3-1: Airfield Pavement Condition Index Rating Summary

The pavement condition at Key West International Airport is represented in Figure 3-1 in accordance with the condition categories and PCI scale referenced in ASTM D 5340. Further detail is provided in Table 3-3 which describes the breakdown of the airport's airfield conditions according to area and use.

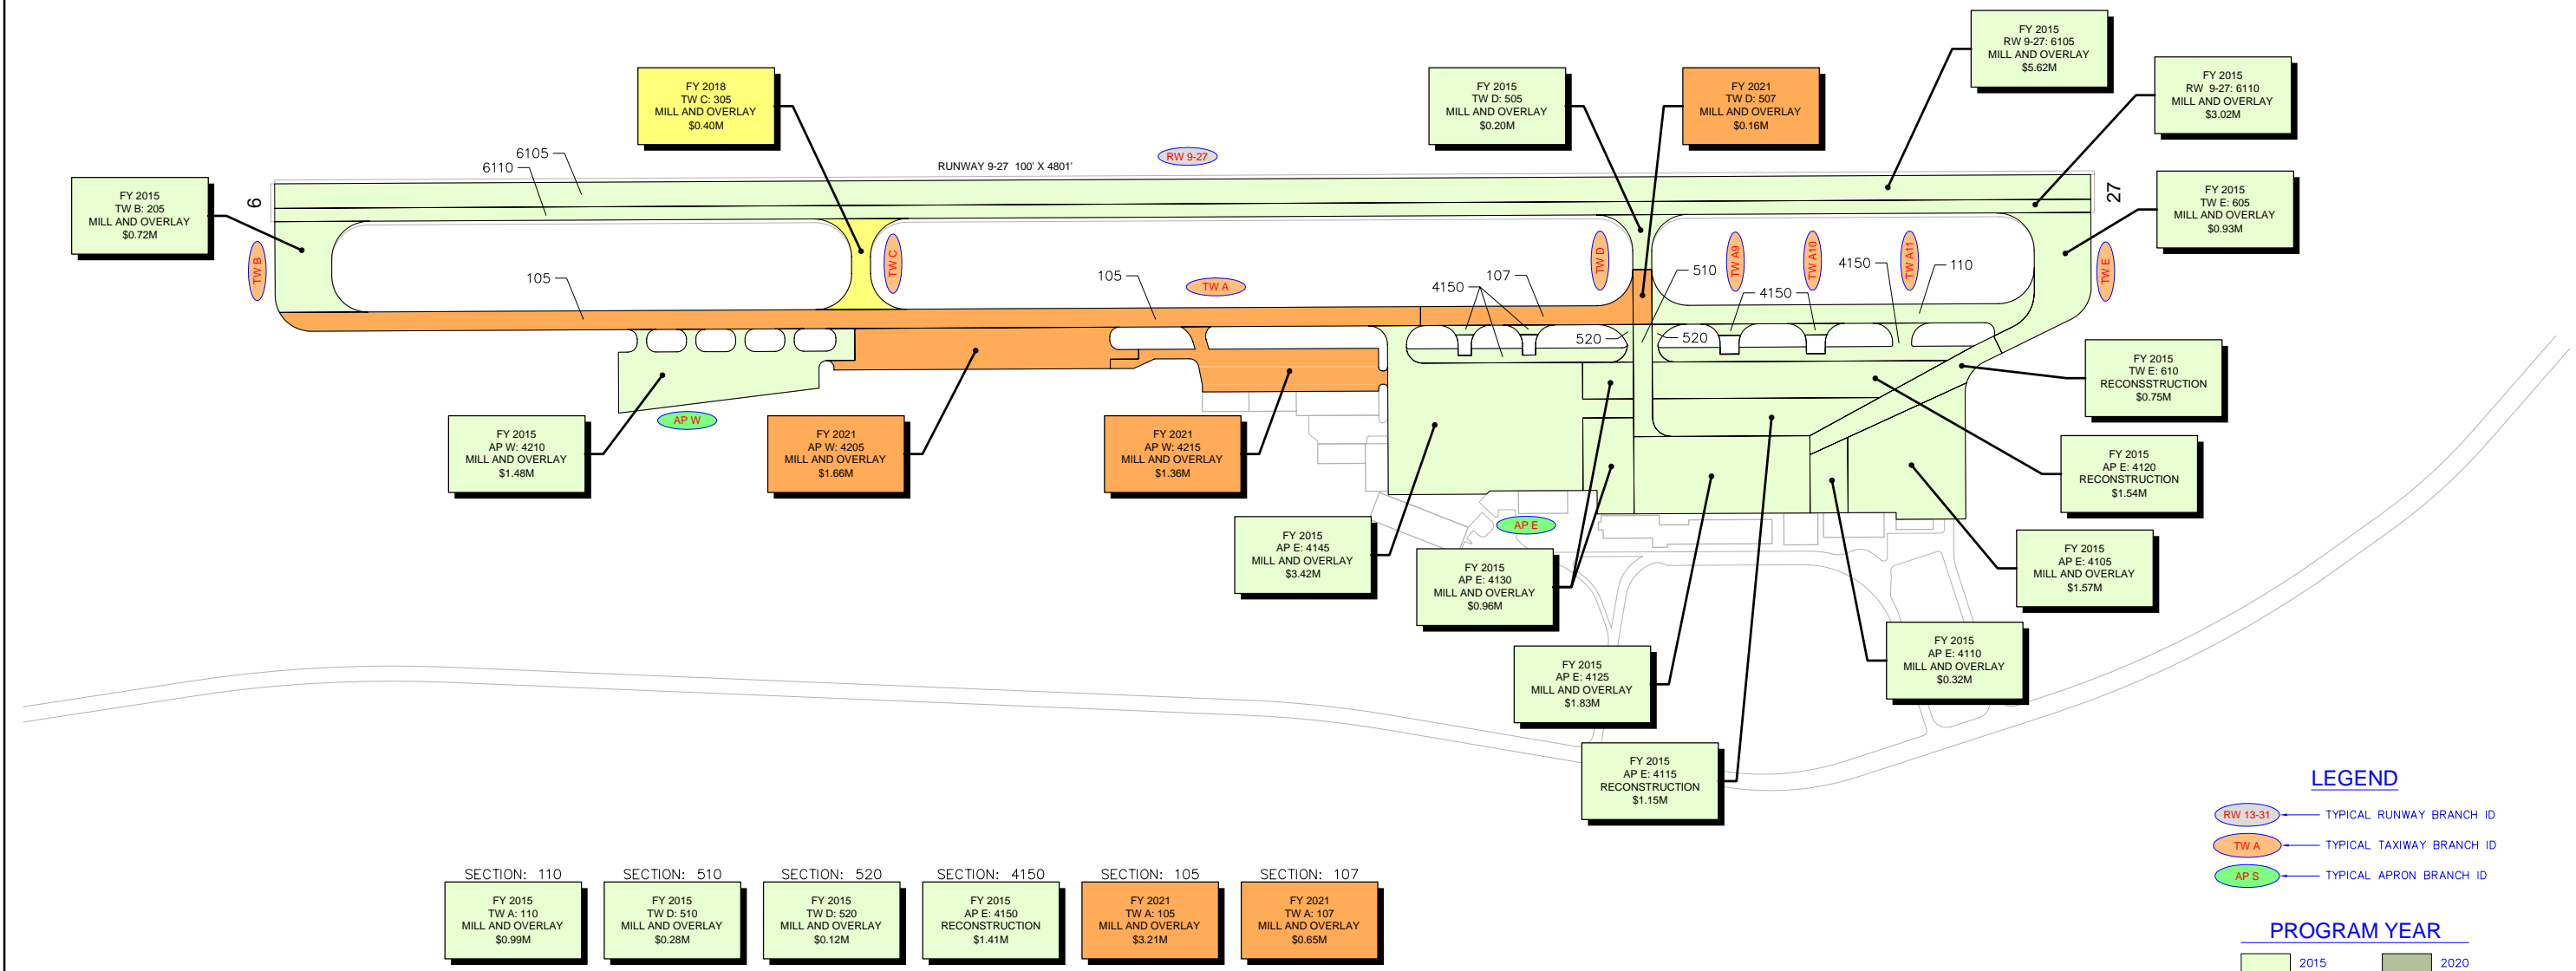
- AIRFIELD PAVEMENT 10-YEAR MAJOR REHABILITATION  
EXHIBIT

According to the most recent inspections at the time of this update; the following pavement sections were identified as a Year-1 need for major rehabilitation:

- ⦿ Runway 9-27 – Sections 6110 and 6105
  - Mill and Overlay attributed to climate and age of pavement.
- ⦿ West Apron – Section 4210
  - Mill and Overlay attributed to climate and age of pavement.
- ⦿ East Apron – Sections 4150, 4145, 4130, 4125, 4120, 4115, 4110, and 4105
  - Reconstruction and Mill and Overlay attributed to load, climate, and age of pavement.
- ⦿ Taxiway E – Sections 610 and 605
  - Reconstruction and Mill and Overlay attributed to load, climate, and age of pavement.
- ⦿ Taxiway D – Sections 520, 510, and 505
  - Mill and Overlay attributed to climate and age of pavement.
- ⦿ Taxiway B – Section 205
  - Mill and Overlay attributed to climate and age of pavement.
