FLORIDA DEPARTMENT OF TRANSPORTATION
AVIATION AND SPACEPORT OFFICE

**CALHOUN COUNTY
AIRPORT (F95)**

JUNE 2015

STATEWIDE
**Airfield
Pavement
Management**
PROGRAM

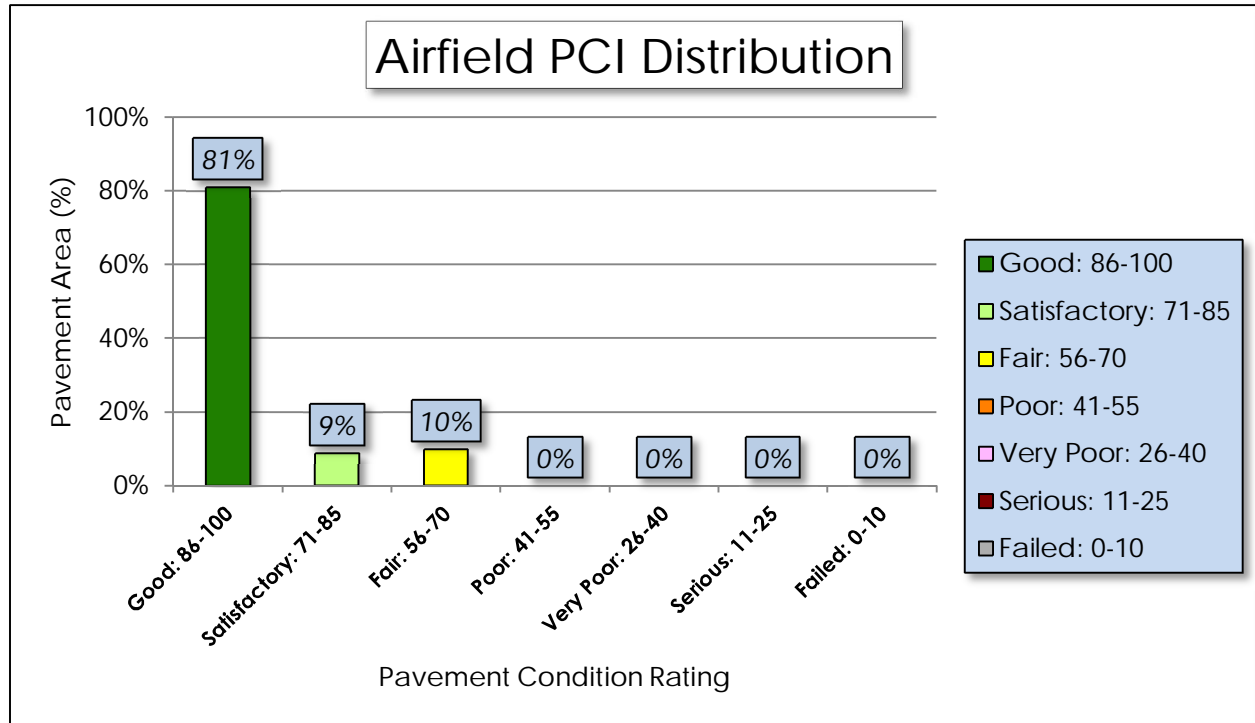
Figure 3-1: Airfield Pavement Condition Index Rating Summary

The pavement condition at Calhoun County Airport is represented in Figure 3-1 in accordance with the condition categories and PCI scale referenced in ASTM D 5340. Further detail is provided in Table 3-3 which describes the breakdown of the airport's airfield conditions according to area and use.

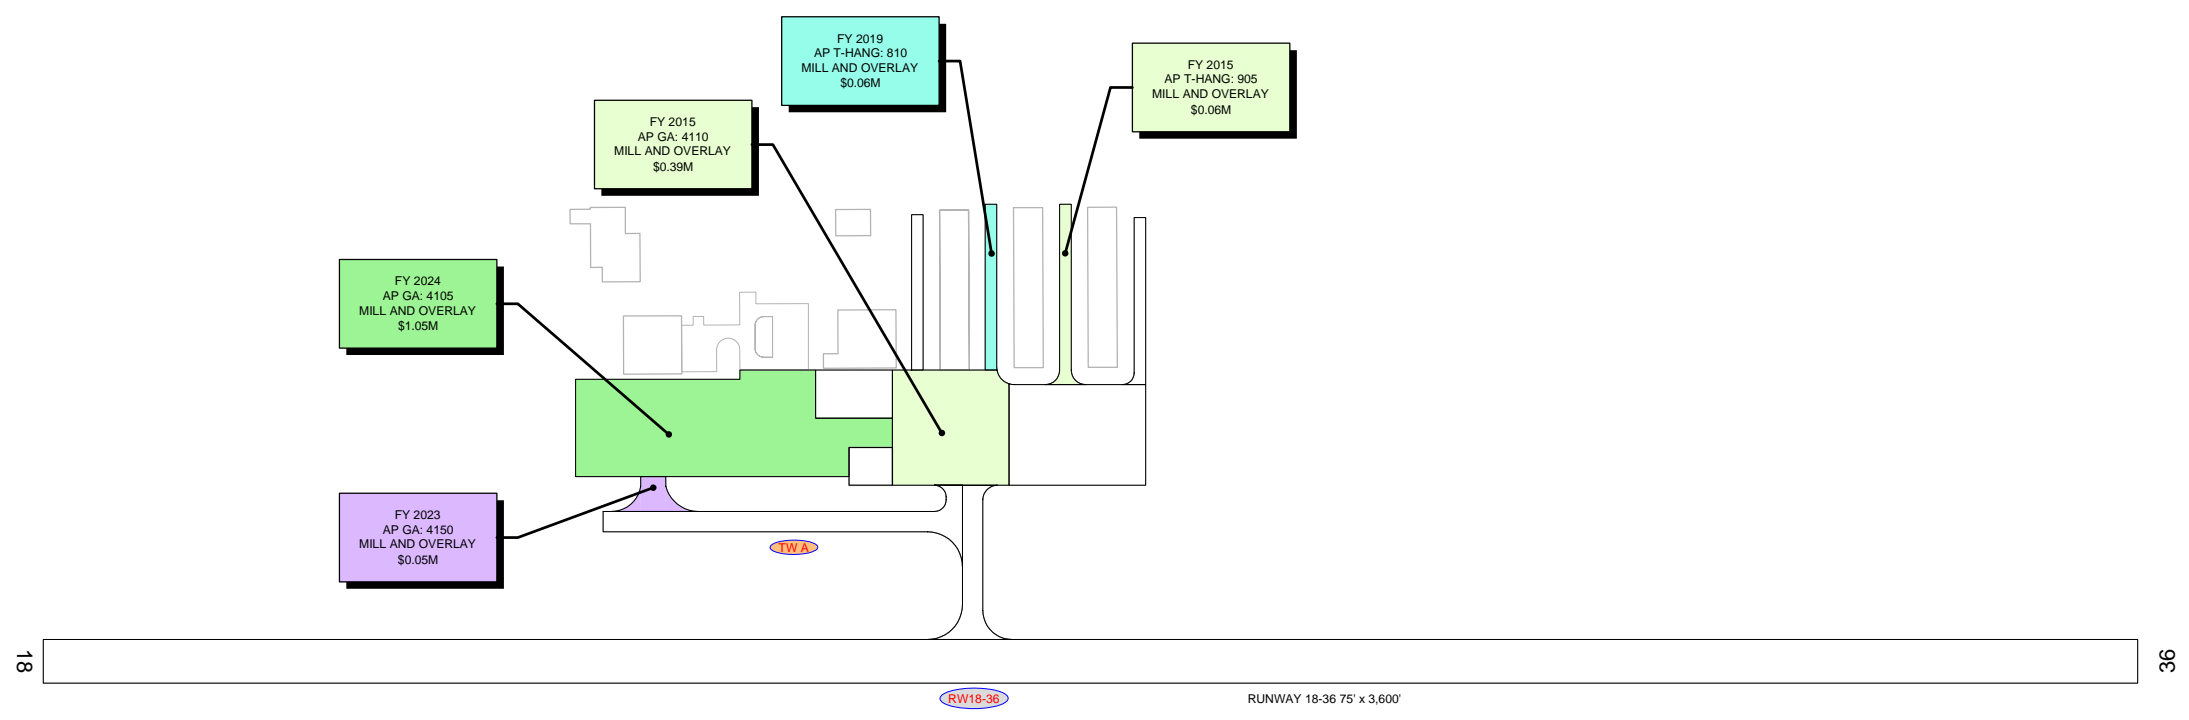
- General Aviation Apron – Section 4110.
 - Mill and Overlay attributed to climate and age of pavement.
- T-Hangar Apron – Section 905
 - Mill and Overlay attributed to climate and age of pavement.
