**FERNANDINA BEACH
MUNICIPAL AIRPORT
(FHB)**

JUNE 2015

STATEWIDE
**Airfield
Pavement
Management**
PROGRAM

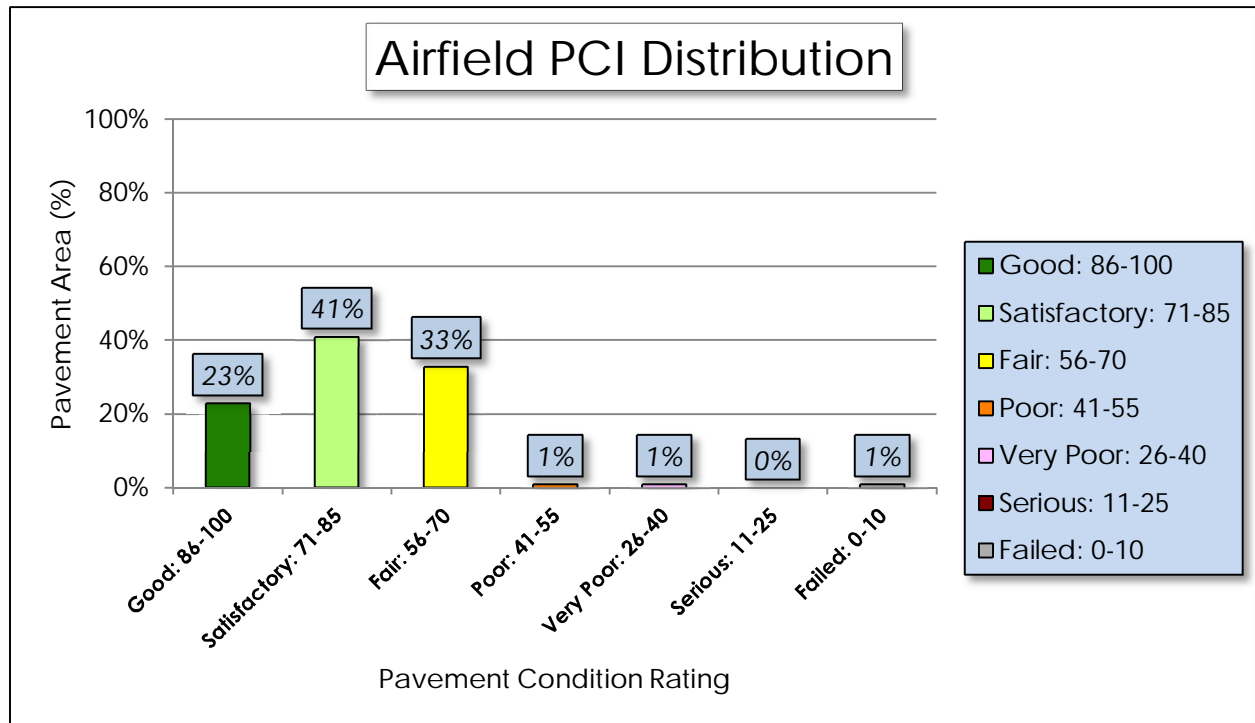
Figure 3-1: Airfield Pavement Condition Index Rating Summary

The pavement condition at Fernandina Beach Municipal Airport is represented in Figure 3-1 in accordance with the condition categories and PCI scale referenced in ASTM D 5340. Further detail is provided in Table 3-3 which describes the breakdown of the airport's airfield conditions according to area and use.

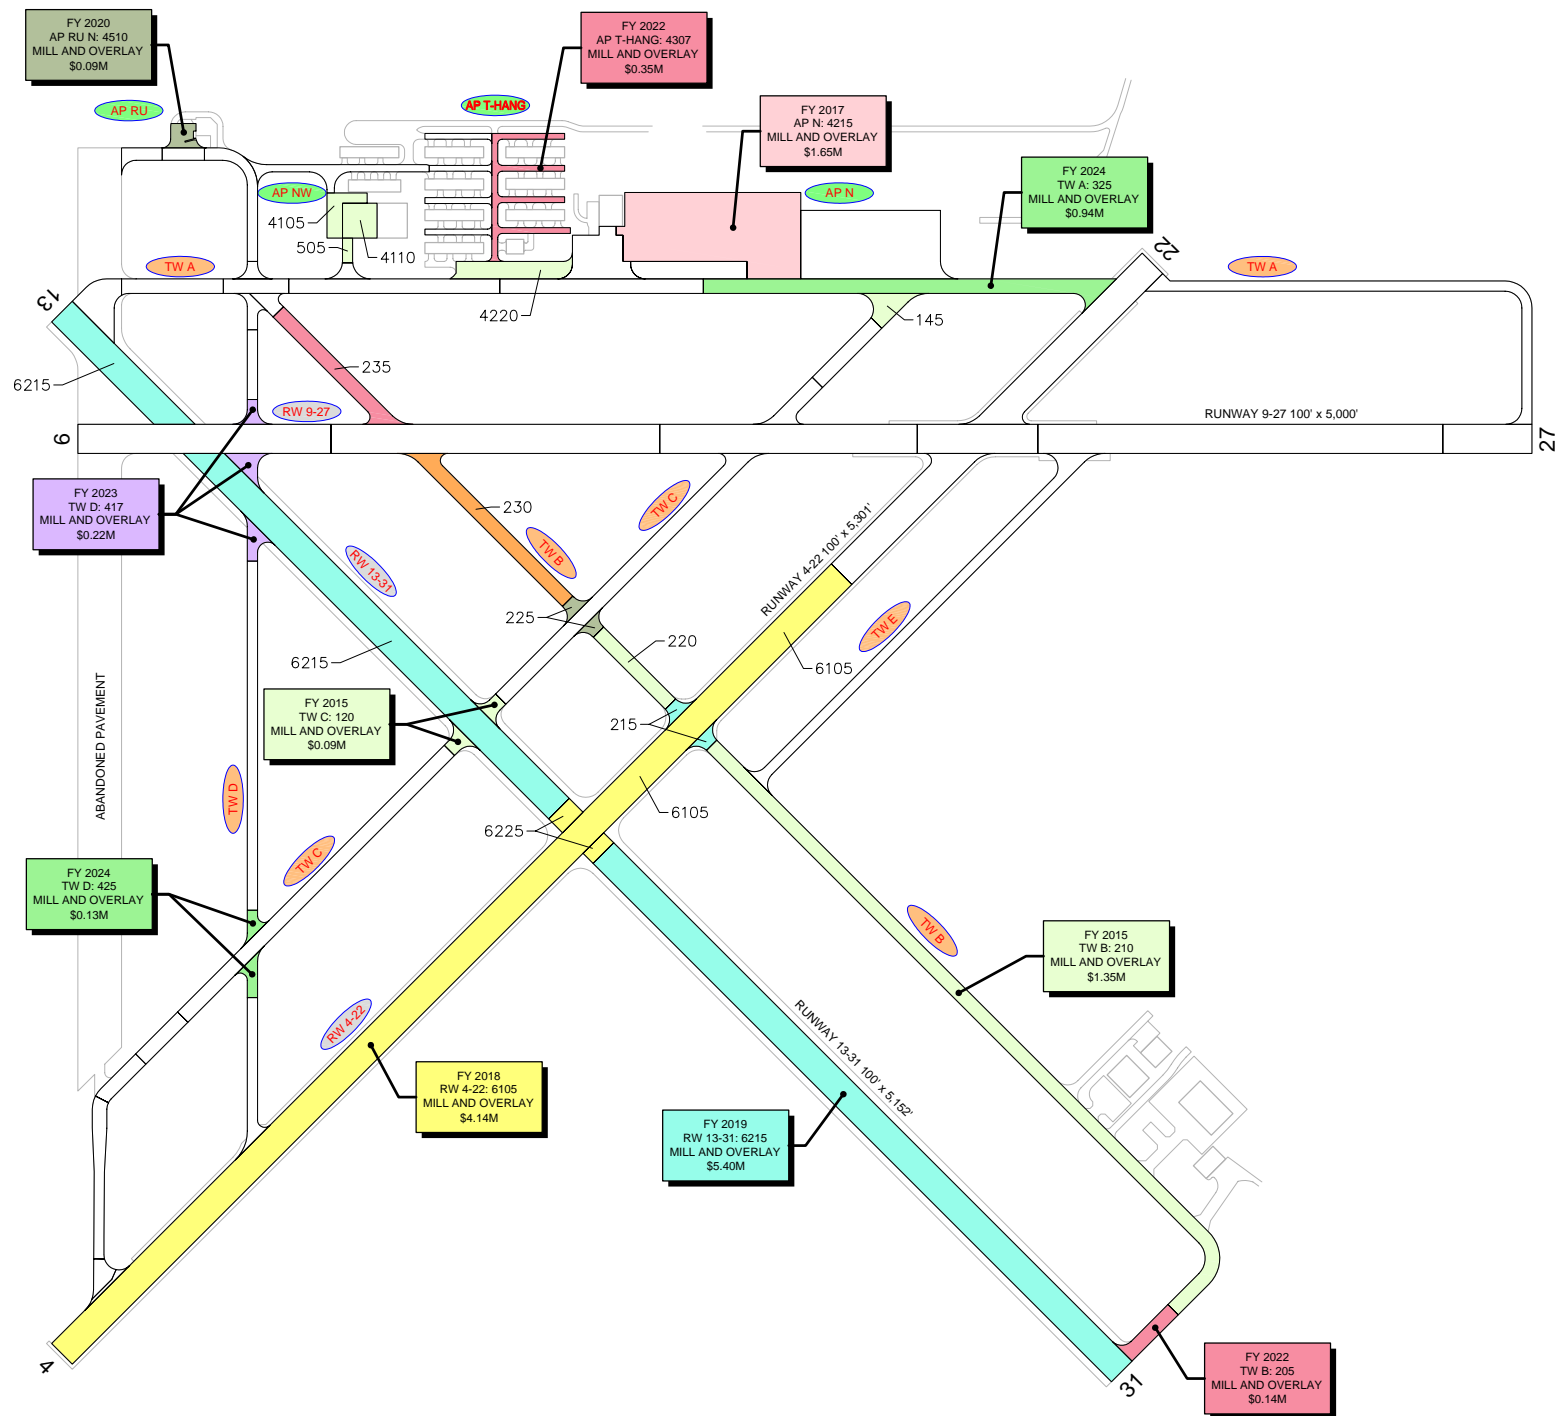
SECTION: 145 FY 2015 TW C: 145 RECONSTRUCTION \$0.17M	SECTION: 220 FY 2015 TW B: 220 MILL AND OVERLAY \$0.18M	SECTION: 505 FY 2015 TW NW AP: 505 MILL AND OVERLAY \$0.03M	SECTION: 4105 FY 2015 AP NW: 4105 MILL AND OVERLAY \$0.16M
SECTION: 4110 FY 2015 AP NW: 4110 MILL AND OVERLAY \$0.15M	SECTION: 4220 FY 2015 AP N: 4220 RECONSTRUCTION \$0.36M	SECTION: 6225 FY 2018 RW 13-31: 6225 MILL AND OVERLAY \$0.13M	SECTION: 215 FY 2019 TW B: 215 MILL AND OVERLAY \$0.08M
SECTION: 225 FY 2020 TW B: 225 MILL AND OVERLAY \$0.08M	SECTION: 230 FY 2021 TW B: 230 MILL AND OVERLAY \$0.44M	SECTION: 235 FY 2022 TW B: 235 MILL AND OVERLAY \$0.35M
