**PALM BEACH
COUNTY PARK
AIRPORT (LNA)**

DISTRICT 4
REGIONAL RELIEVER
AIRPORT
JUNE 2015

STATEWIDE
**Airfield
Pavement
Management**
PROGRAM

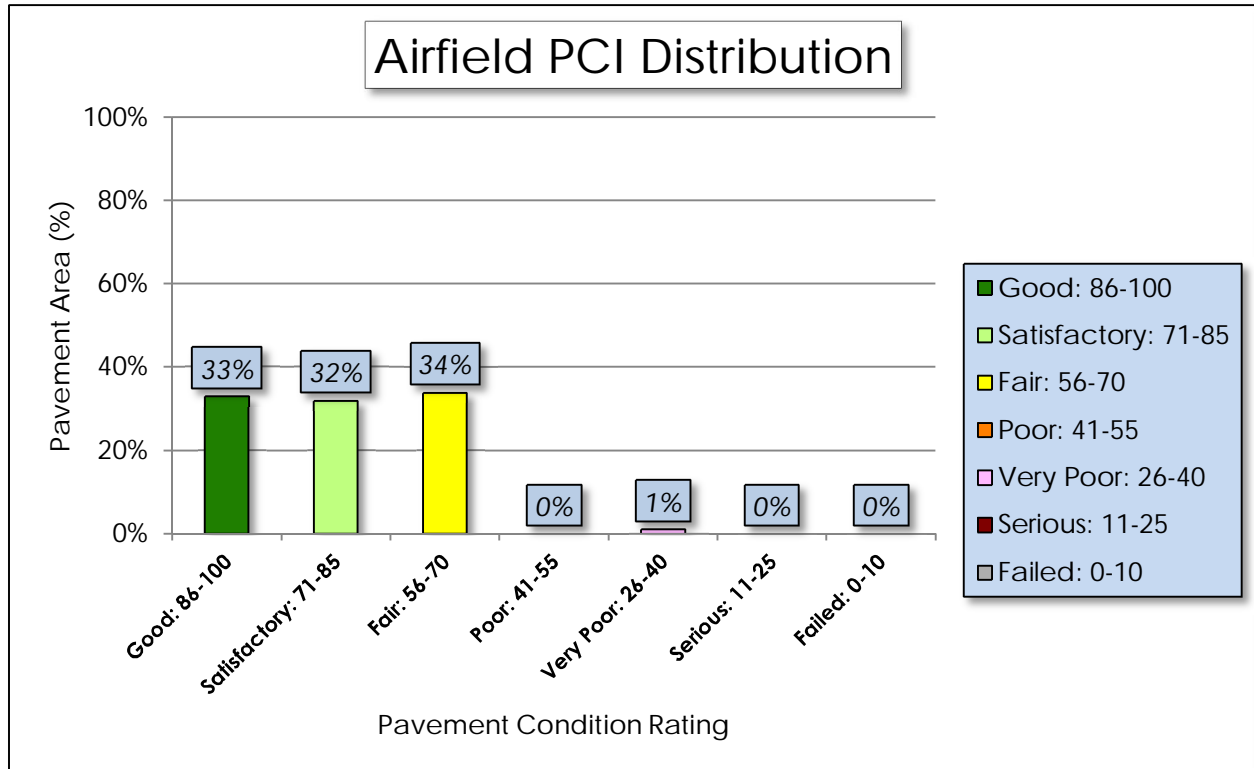
Figure 3-1: Airfield Pavement Condition Index Rating Summary

The pavement condition at Palm Beach County Park Airport is represented in Figure 3-1 in accordance with the condition categories and PCI scale referenced in ASTM D 5340. Further detail is provided in Table 3-3 which describes the breakdown of the airport's airfield conditions according to area and use.
