FLORIDA DEPARTMENT OF TRANSPORTATION
AVIATION AND SPACEPORT OFFICE

**MELBOURNE
INTERNATIONAL
AIRPORT (MLB)**

JUNE 2015

STATEWIDE
**Airfield
Pavement
Management**
PROGRAM

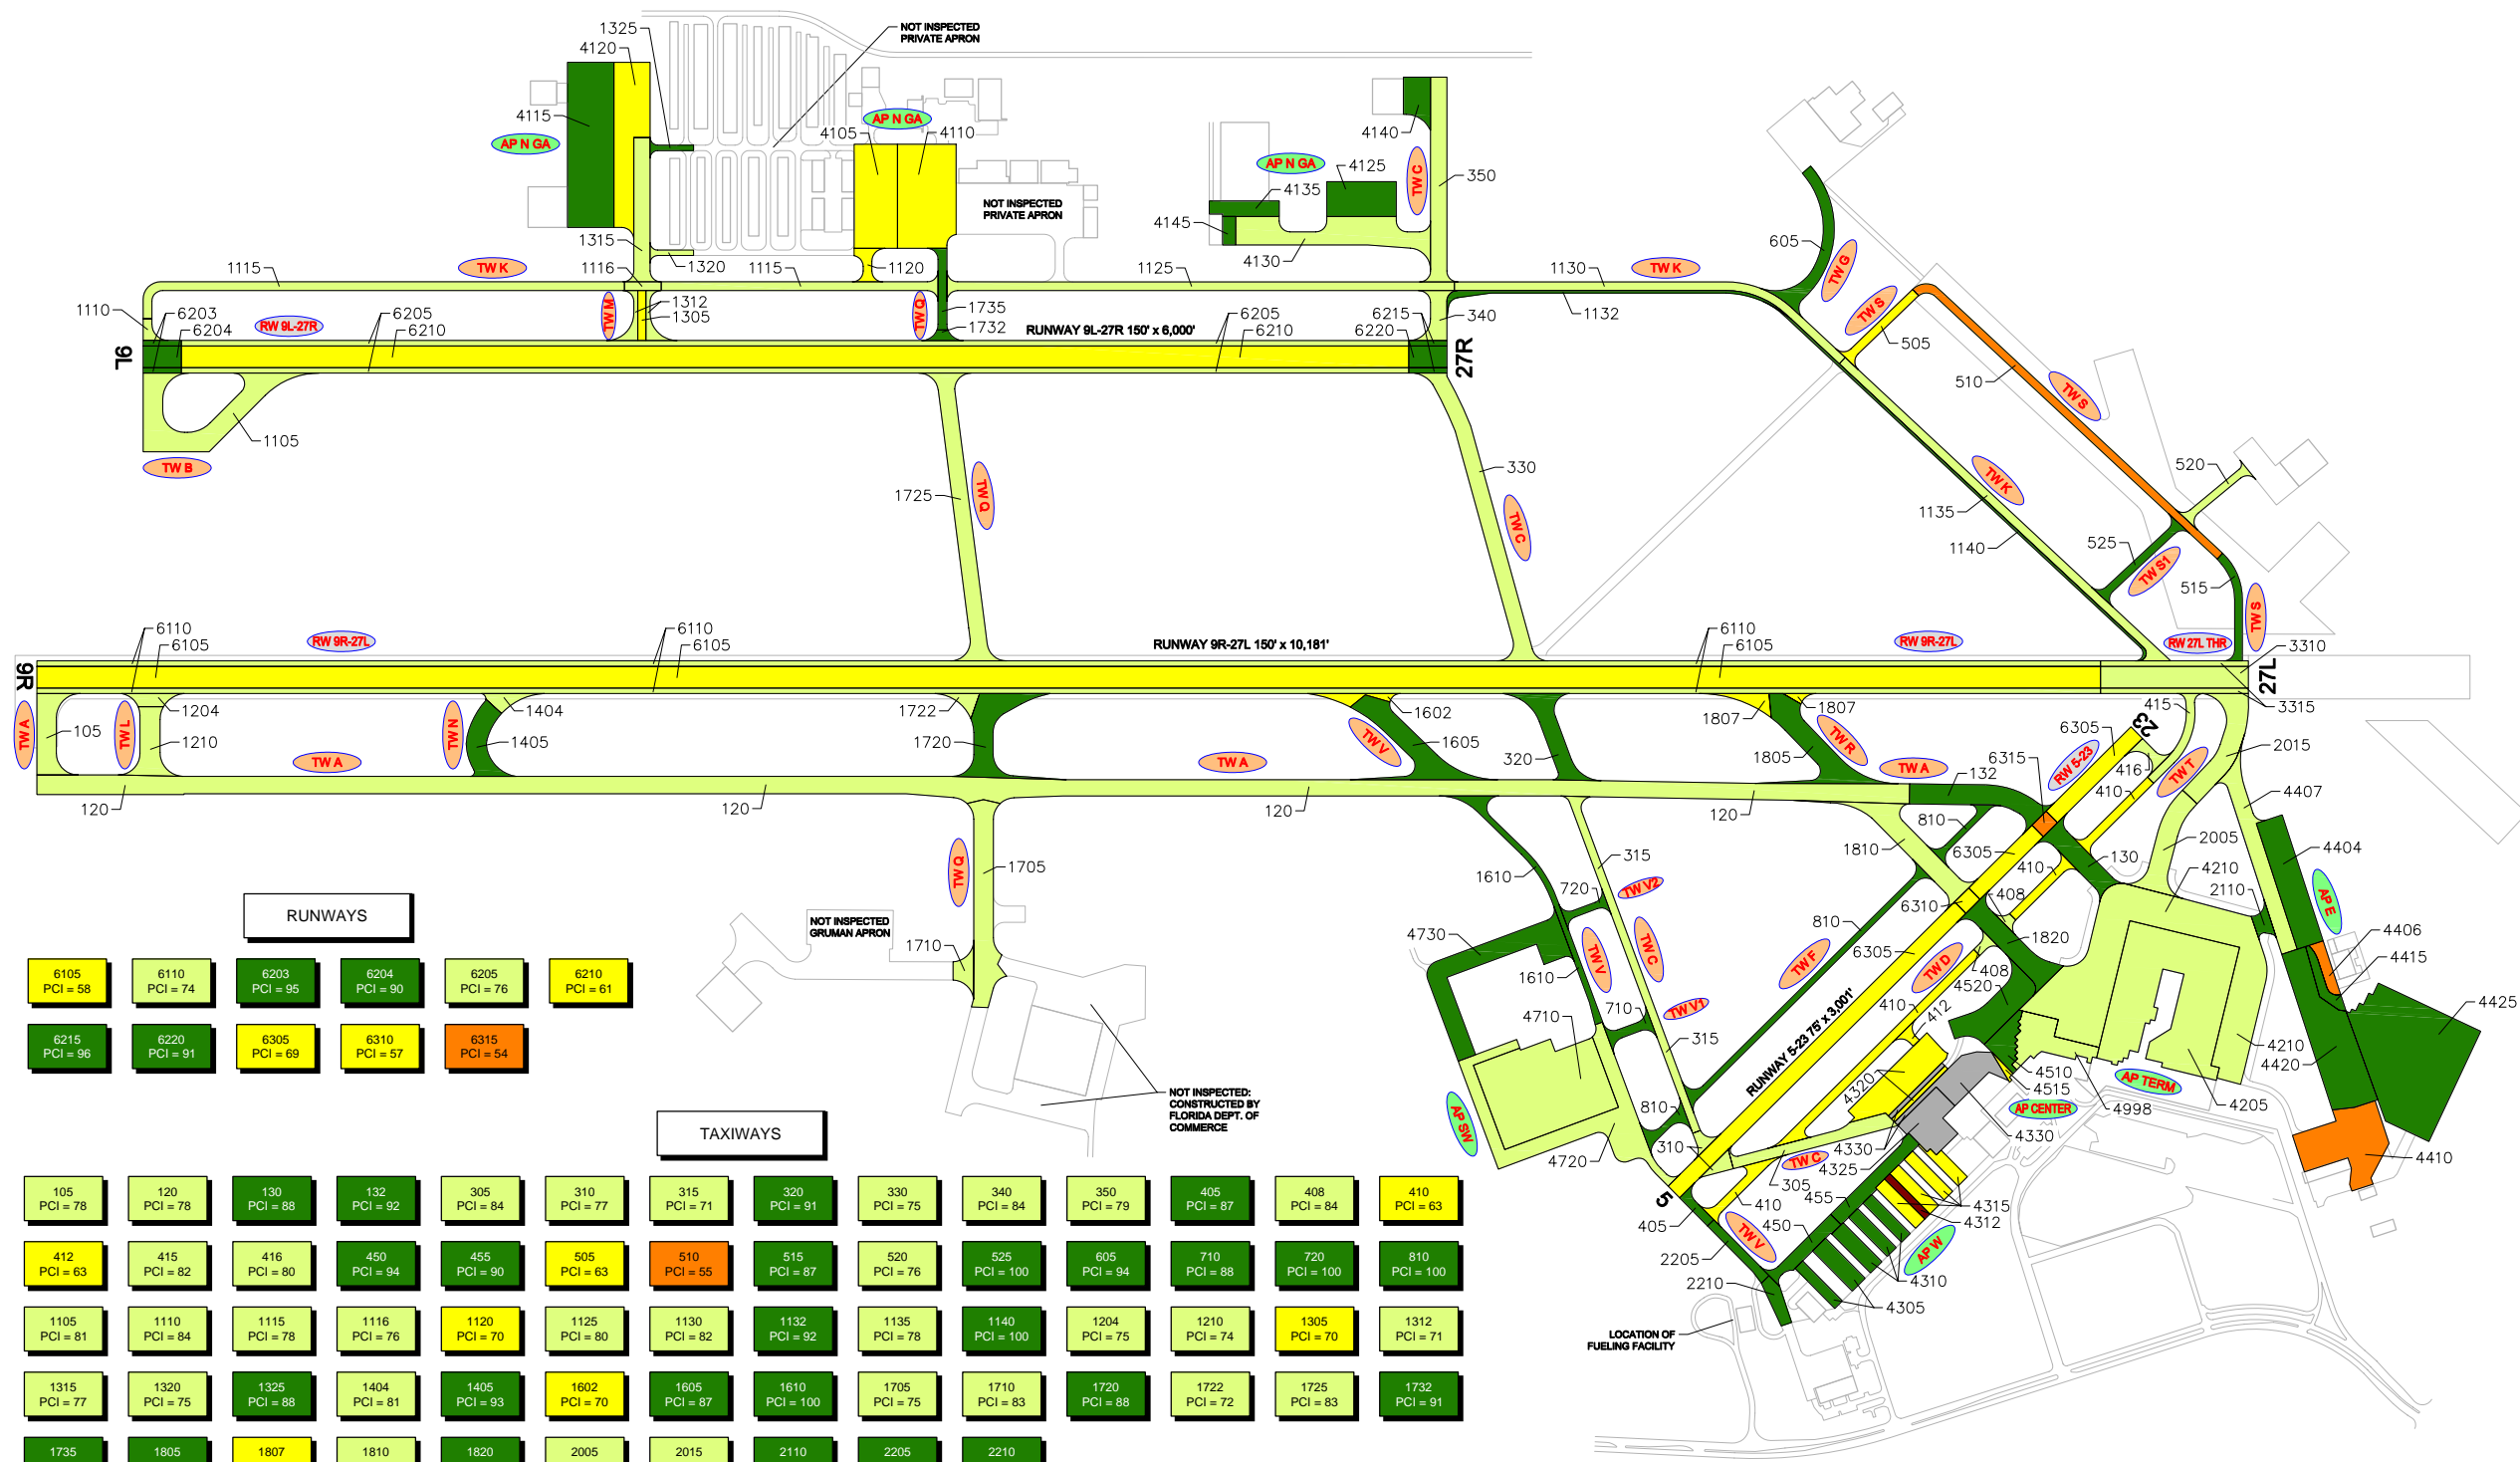
- AIRFIELD PAVEMENT CONDITION INDEX RATING EXHIBIT
- PAVEMENT CONDITION INDEX INVENTORY

| 6105 PCI = 58 | 6110 PCI = 74 | 6203 PCI = 95 | 6204 PCI = 90 | 6205 PCI = 76 | 6210 PCI = 61 |
