**THE FLORIDA KEYS
MARATHON AIRPORT
(MTH)**

JUNE 2015

STATEWIDE Airfield Pavement Management PROGRAM

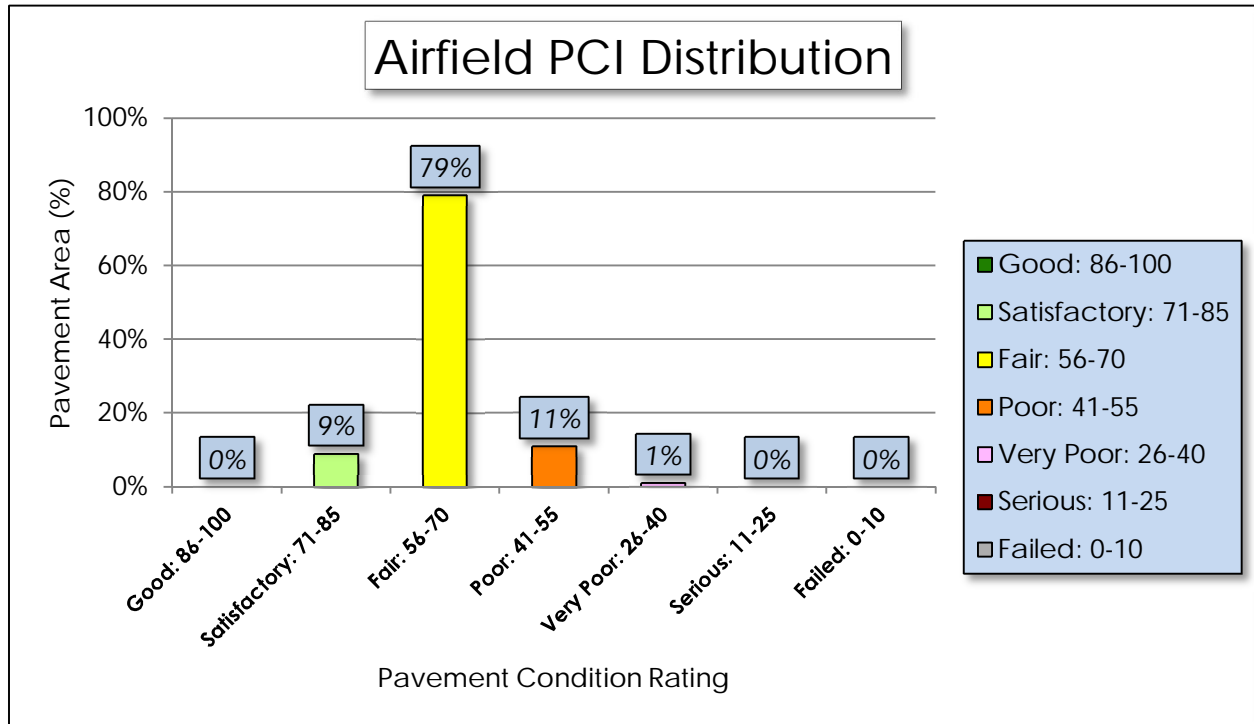
Figure 3-1: Airfield Pavement Condition Index Rating Summary

The pavement condition at The Florida Keys Marathon Airport is represented in Figure 3-1 in accordance with the condition categories and PCI scale referenced

Airfield Pavement Use		
Use	Average Area-Weighted PCI	Condition Rating
Runway	61	FAIR
Taxiway	68	FAIR
Apron	60	FAIR
Condition Area		
Condition Rating	Area (SF)	Relative Area (%)
Good	-	0%
Satisfactory	143,433	9%
Fair	1,305,653	79%
Poor	177,636	11%
Very Poor	23,305	1%
Serious	-	0%
Failed	-	0%

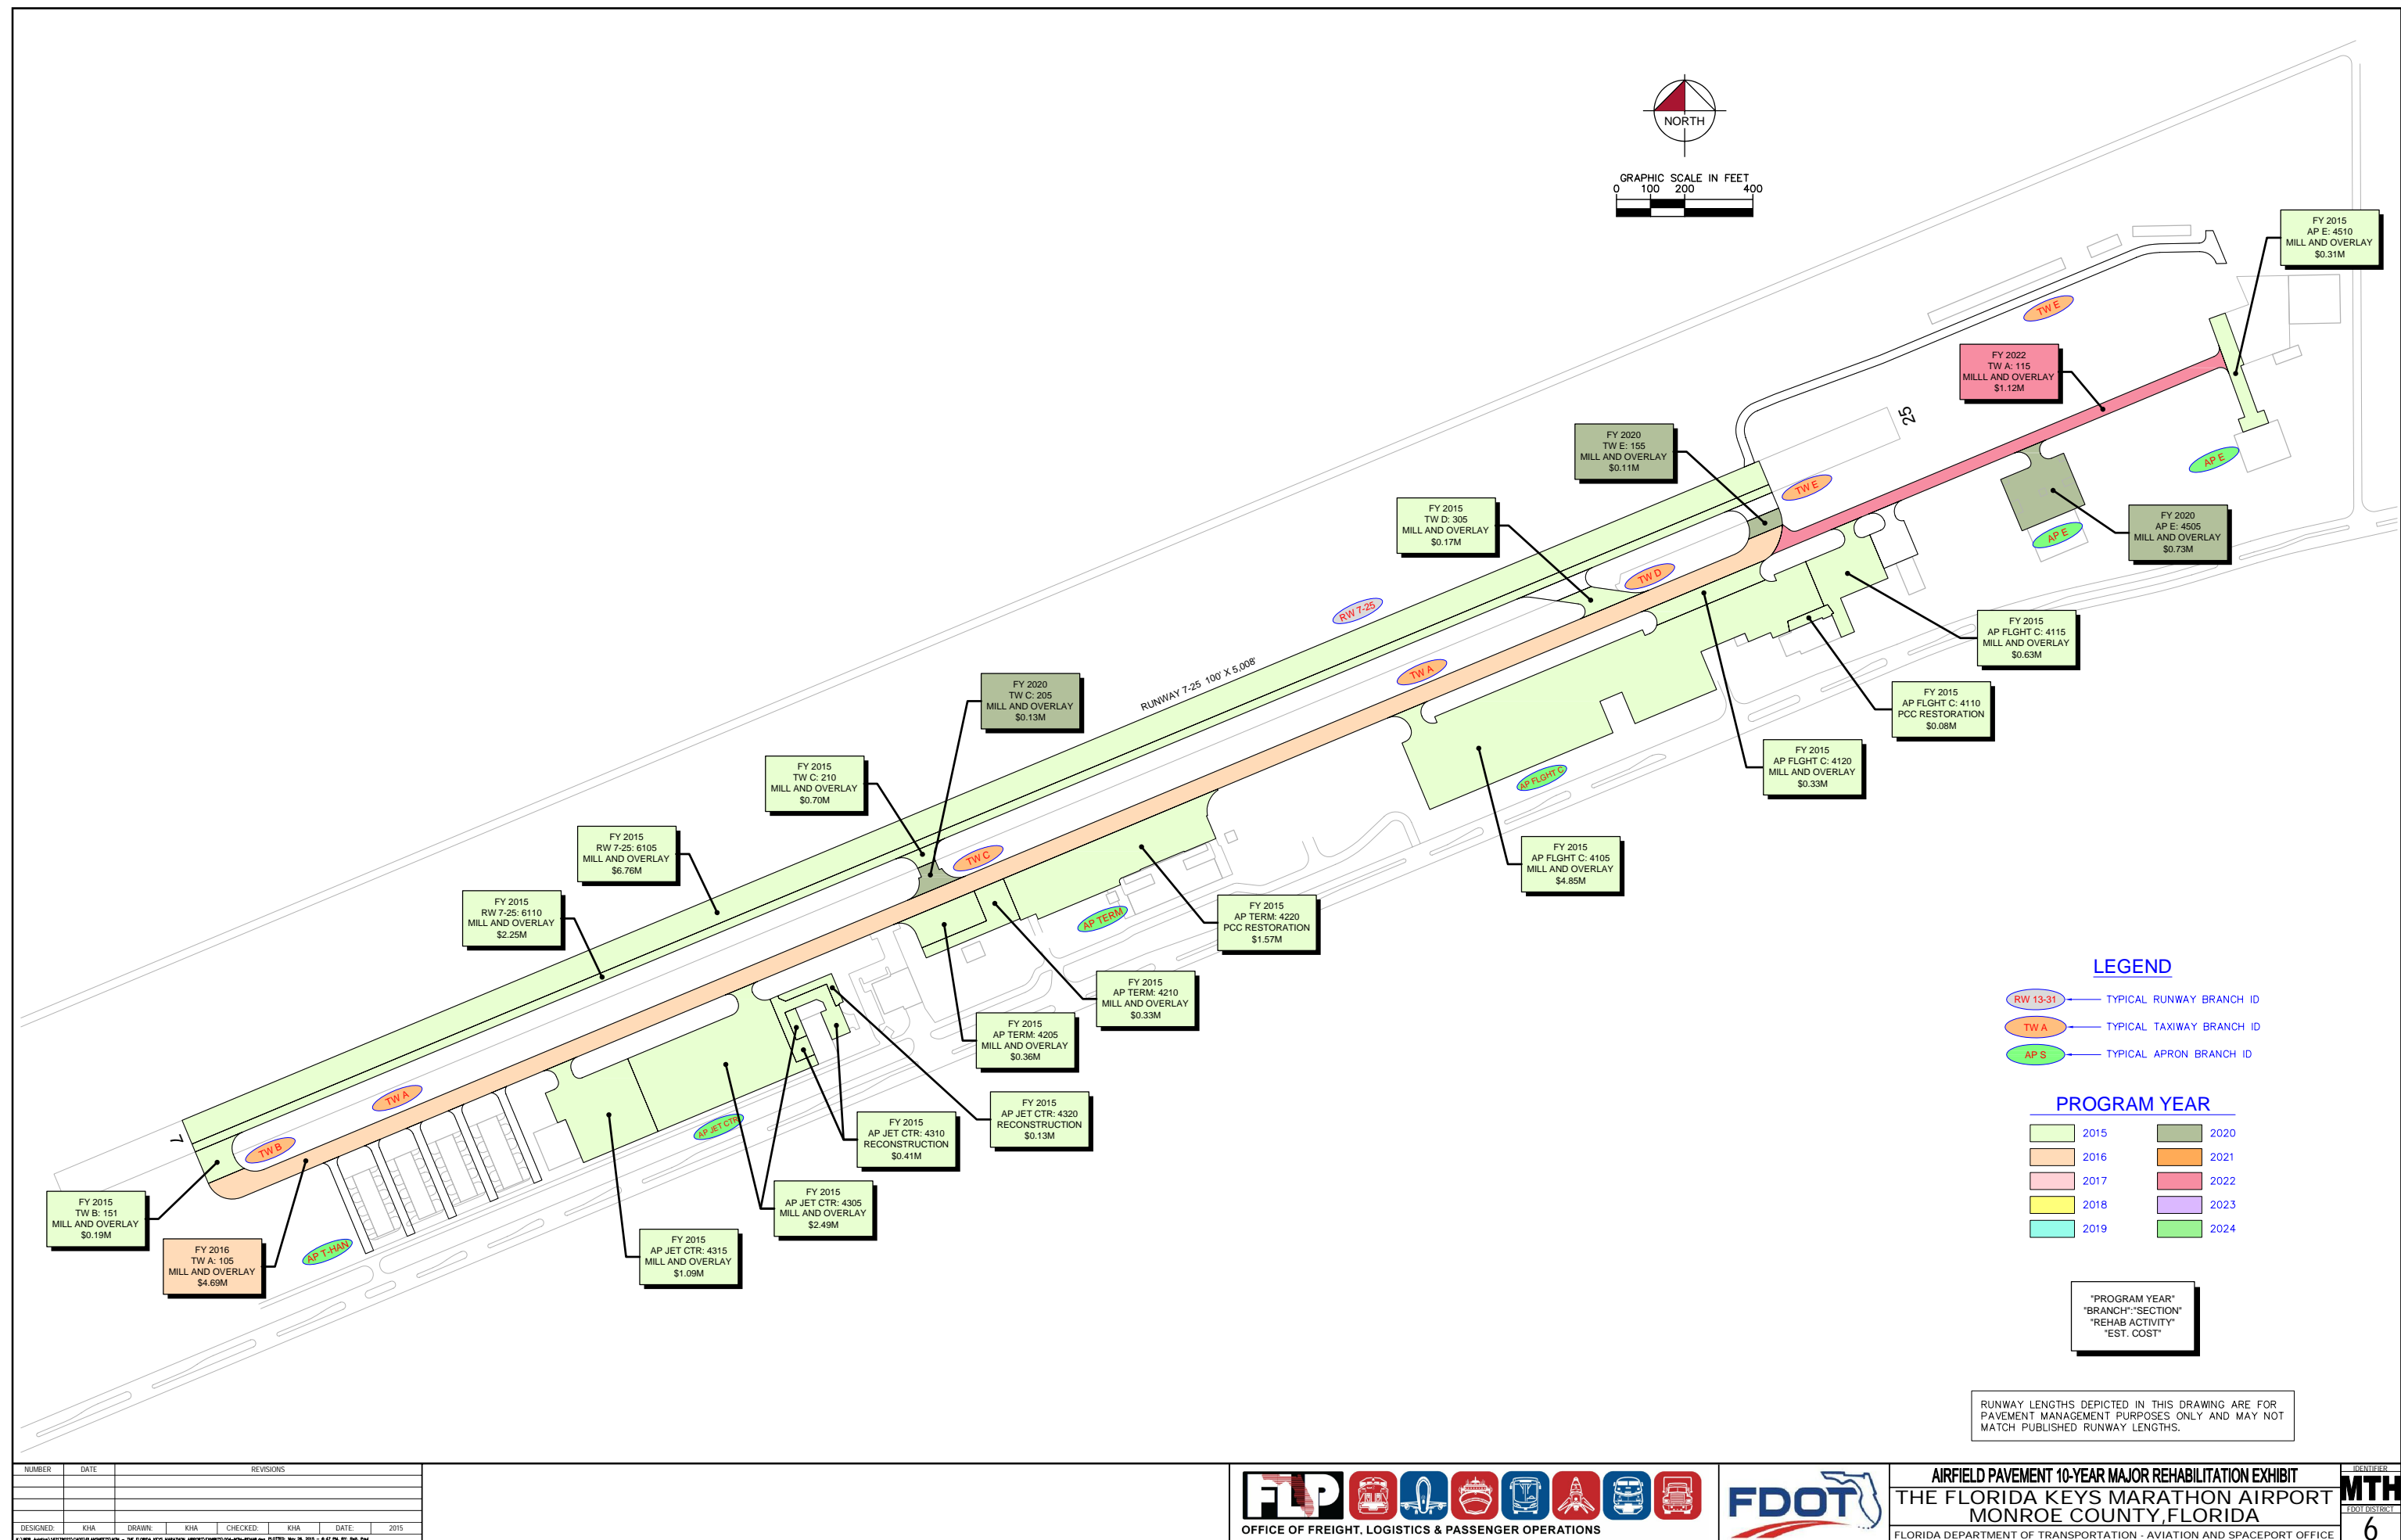
- AIRFIELD PAVEMENT 10-YEAR MAJOR REHABILITATION
EXHIBIT
- AIRFIELD PAVEMENT 10-YEAR MAJOR REHABILITATION
TABLE

Year	Branch ID	Section ID	Major M&R Costs*	PCI Before M&R	M&R Activity	PCI After M&R
2015	AP E	4510	\$ 306,900.00	57	Mill and Overlay	100
2015	AP FLGHT C	4105	\$ 4,853,412.00	65	Mill and Overlay	100
2015	AP FLGHT C	4110	\$ 84,842.00	44	PCC Restoration	100
2015	AP FLGHT C	4115	\$ 632,646.00	59	Mill and Overlay	100
2015	AP FLGHT C	4120	\$ 333,378.00	64	Mill and Overlay	100
2015	AP JET CTR	4305	\$ 2,490,754.00	42	Mill and Overlay	100
2015	AP JET CTR	4310	\$ 409,423.00	31	Reconstruction	100
2015	AP JET CTR	4315	\$ 1,091,358.00	54	Mill and Overlay	100
2015	AP JET CTR	4320	\$ 126,592.00	30	Reconstruction	100
2015	AP TERM	4205	\$ 360,216.00	59	Mill and Overlay	100
2015	AP TERM	4210	\$ 330,678.00	59	Mill and Overlay	100
2015	AP TERM	4220	\$ 1,572,534.00	65	PCC Restoration	100
2015	RW 7-25	6105	\$ 6,760,800.00	61	Mill and Overlay	100
2015	RW 7-25	6110	\$ 2,253,600.00	62	Mill and Overlay	100
2015	TW B	151	\$ 192,798.00	61	Mill and Overlay	100

- Runway 7-25 – Sections 6105 and 6110
 - Mill and Overlay attributed to climate/age.
- East Apron – Section 4510
 - Mill and Overlay attributed to climate/age.
- Jet Center Apron – Sections 4305, 4315, and 4320
 - Reconstruction and Mill and Overlay attributed to climate/age and construction quality.
- Jet Center Apron – Section 4310
 - Reconstruction attributed to structural, climate/age, and construction quality.
- Terminal Apron – Section 4220
 - PCC Restoration attributed to structural, climate/age, and construction quality.
- Terminal Apron – Sections 4205 and 4210
 - Mill and Overlay attributed to climate/age and construction quality.
- Flight Center Apron – Sections 4105, 4115, and 4120
