**OCALA
INTERNATIONAL-
JIM TAYLOR FIELD
(OCF)**

DISTRICT 5
PRIMARY AIRPORT
JUNE 2015

STATEWIDE
**Airfield
Pavement
Management**
PROGRAM

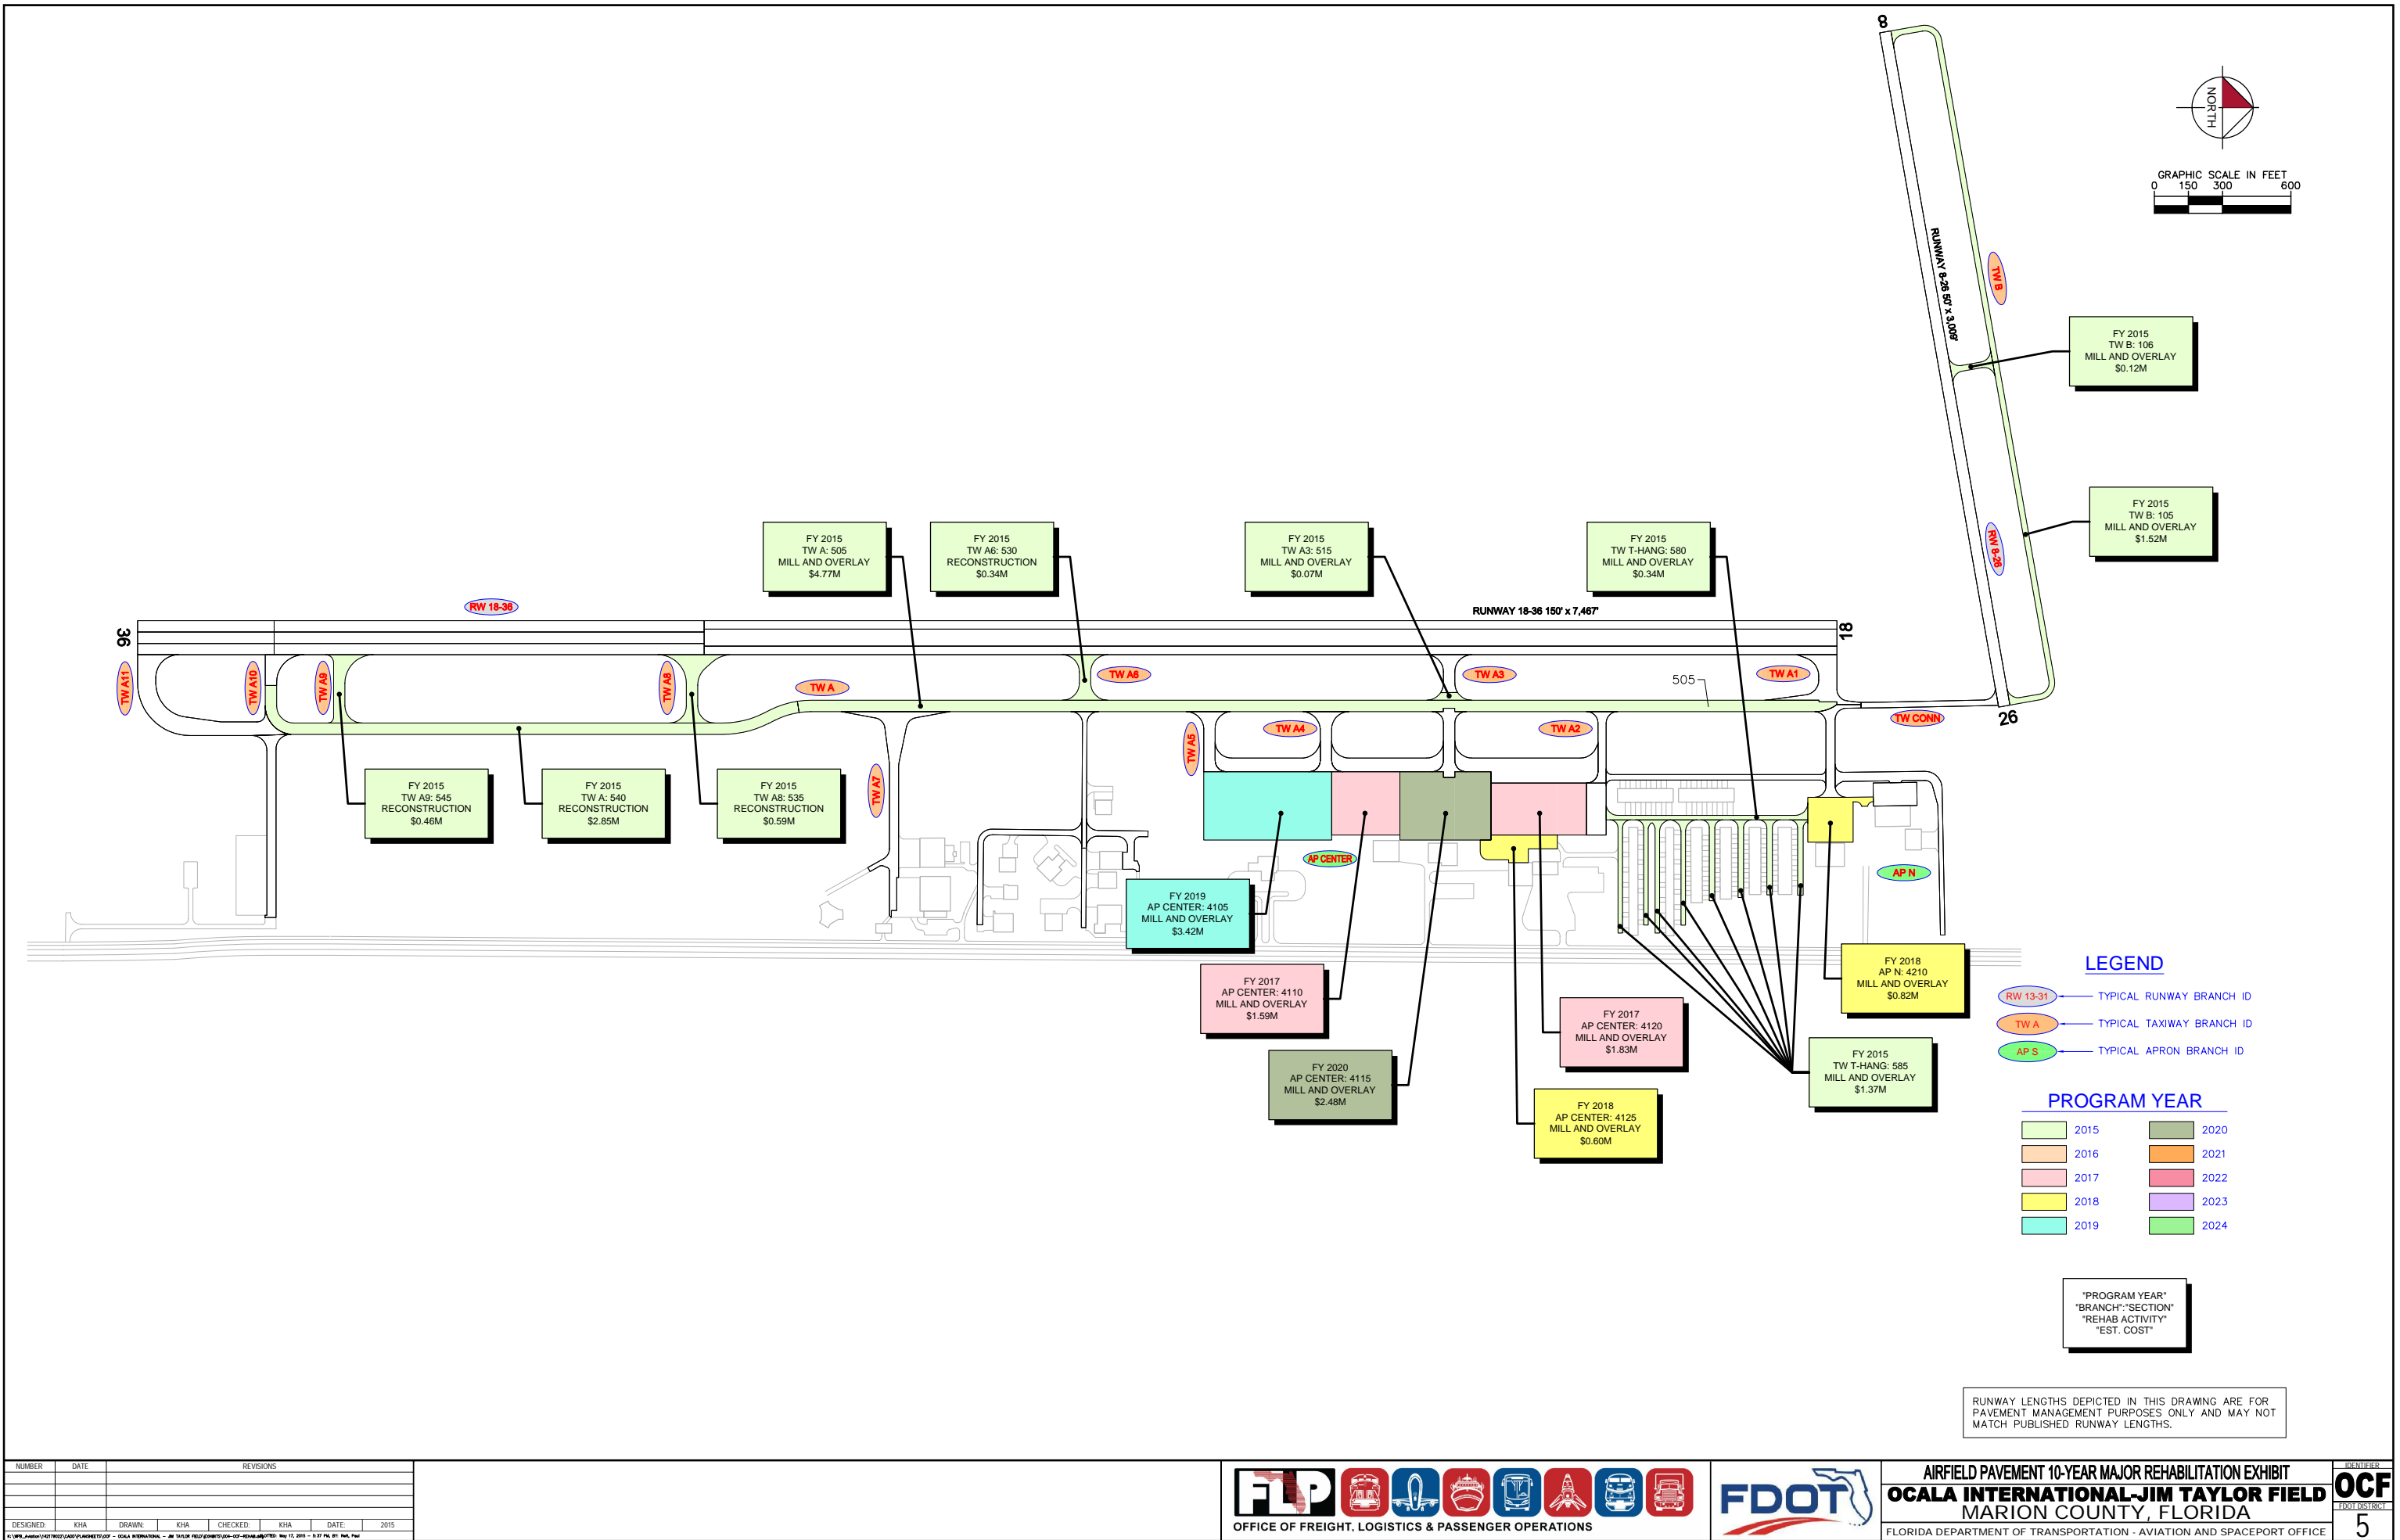
Year	Branch ID	Section ID	Major M&R Costs*	PCI Before M&R	M&R Activity	PCI After M&R
2015	TW A	505	\$ 4,766,509.00	44	Mill and Overlay	100
2015	TW A	540	\$ 2,853,081.00	27	Reconstruction	100
2015	TW A3	515	\$ 74,455.00	47	Mill and Overlay	100
2015	TW A6	530	\$ 341,067.00	35	Reconstruction	100
2015	TW A8	535	\$ 592,457.00	26	Reconstruction	100
2015	TW A9	545	\$ 459,011.00	35	Reconstruction	100
2015	TW B	105	\$ 1,517,976.00	57	Mill and Overlay	100
2015	TW B	106	\$ 123,012.00	57	Mill and Overlay	100
2015	TW T-HANG	580	\$ 340,272.00	58	Mill and Overlay	100
2015	TW T-HANG	585	\$ 1,368,504.00	55	Mill and Overlay	100
2017	AP CENTER	4110	\$ 1,592,528.00	65	Mill and Overlay	100
2017	AP CENTER	4120	\$ 1,828,519.00	65	Mill and Overlay	100
2018	AP CENTER	4125	\$ 601,363.00	64	Mill and Overlay	100
2018	AP N	4210	\$ 821,420.00	64	Mill and Overlay	100
2019	AP CENTER	4105	\$ 3,415,674.00	65	Mill and Overlay	100
2020	AP CENTER	4115	\$ 2,478,408.00	65	Mill and Overlay	100
